AFFTC-TIM-07-02

**F-16B PACER AIRCRAFT
TRAILING CONE LENGTH EXTENSION
TUBE INVESTIGATIVE STUDY
(HAVE CLETIS)**

FINAL TECHNICAL INFORMATION MEMORANDUM

**USAF TEST PILOT SCHOOL
AIR FORCE FLIGHT TEST CENTER
EDWARDS AIR FORCE BASE, CALIFORNIA
AIR FORCE MATERIEL COMMAND
UNITED STATES AIR FORCE**

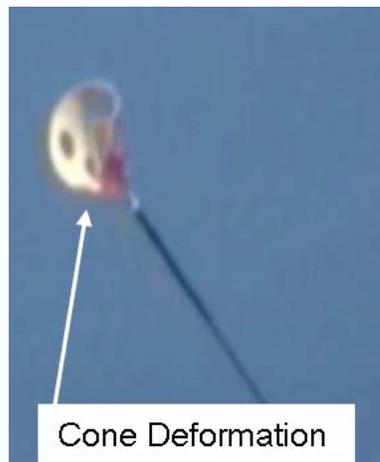
Testing of the 35-foot trailing cone system was halted at 0.92 Mach number at 10,000 feet PA (12.5 in Hg incompressible dynamic pressure) due to structural deformation of the drag cone as seen in figure 5. At this flight condition, the drag cone deformed to an oval-shaped base while rotating slowly (approximately 0.5 revolutions/second).

Figure 5. 35-foot System Drag Cone Deformation (0.92 Mach number, 10,000 feet PA)

One drag cone attached to the 35-foot and 50-foot systems and two drag cones attached to the 85-foot trailing cone system deformed during flying qualities testing. Drag cone deformation occurred at incompressible dynamic pressures ranging from 10.1 to 13.8 in Hg. To determine the cause of the drag cone deformation, each of the drag cones used during testing was weighed and the thickness of the cone measured and presented in table E-1. A relationship between drag cone weight, incompressible dynamic pressure and structural deformation was observed. As seen in figure E-6, a linear relationship between cone weight and incompressible dynamic pressure at the point of cone deformation was determined. A variation in cone thickness was also observed as seen in table E-1. The drag cone was a composite of fiberglass fiber strand mat and vinyl ester resin. The variation in cone weight and thickness, which was a function of fiber and resin content of the cone, determined the overall structural integrity of the cone and ultimately the maximum incompressible dynamic pressure the cone could withstand without deformation. **Establish a structural rigidity requirement for the drag cone as necessary to achieve desired mission requirements. (R7)** Common industry practices vary drag cone size (diameter, length) to change the overall drag force experienced by the drag cone. The influence of cone size and drag force were not investigated during testing.

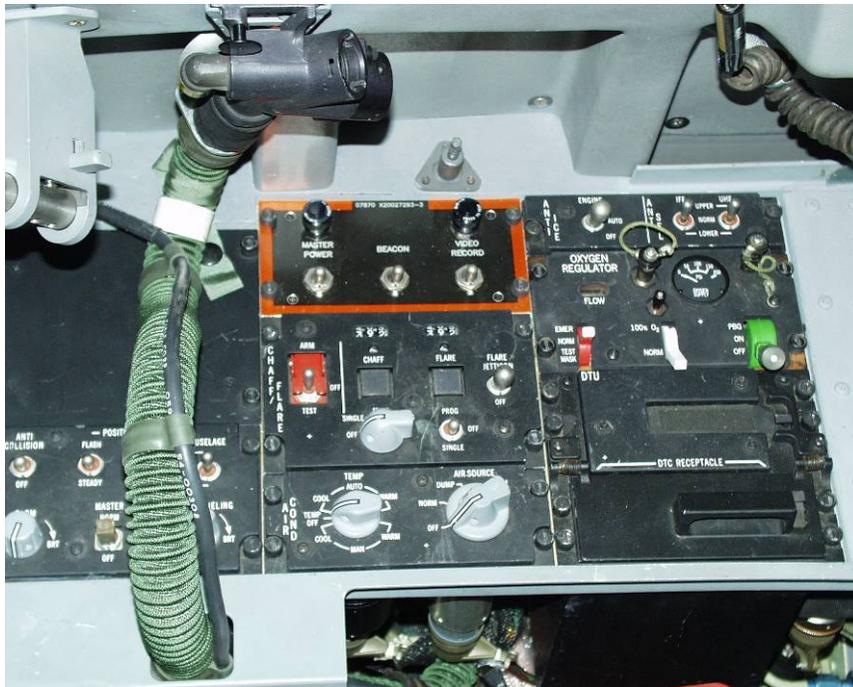
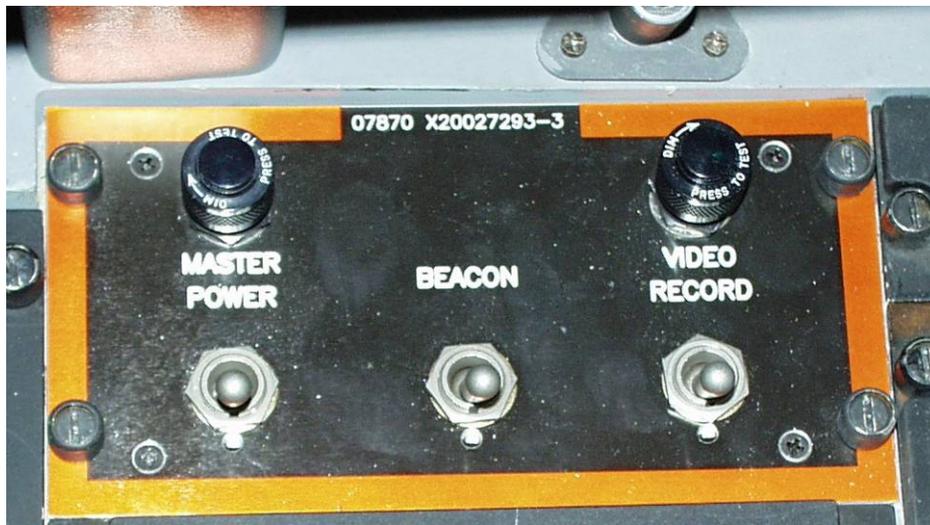
Figure B-6. Pacer Instrumentation Master Power Panel (Front Cockpit)

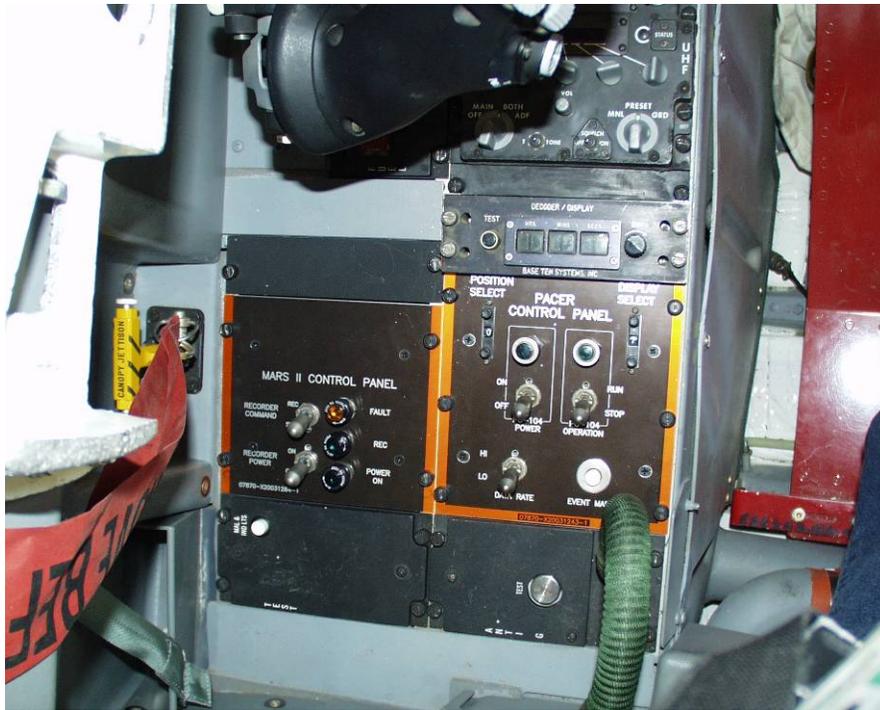
Figure B-7. Pacer Control Panel (Rear Cockpit)

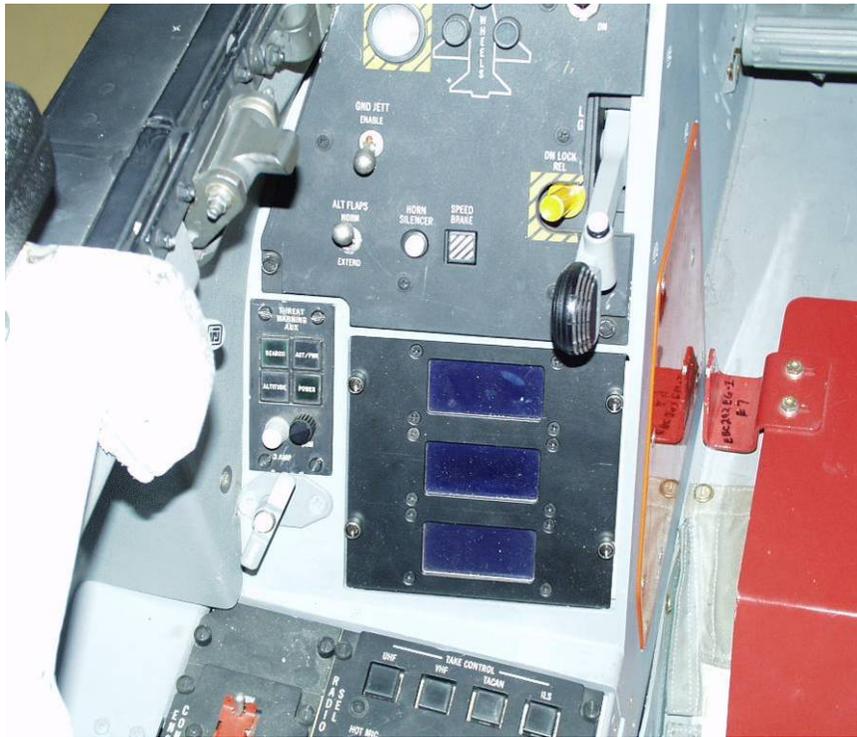
Figure B-9. Air Data Displays (Rear Cockpit)
