# **Phase II Site Investigations Report Volume I of III General Annex-Wide Information**

## **Fort Devens Sudbury Training Annex, Massachusetts**

September 1994  
Contract No. DAAA15-90-D-0012  
Delivery Order No. 0004  
ELIN A009

Prepared by:  
**ecology and environment, inc.  
1700 North Moore Street  
Arlington, Virginia 22209**

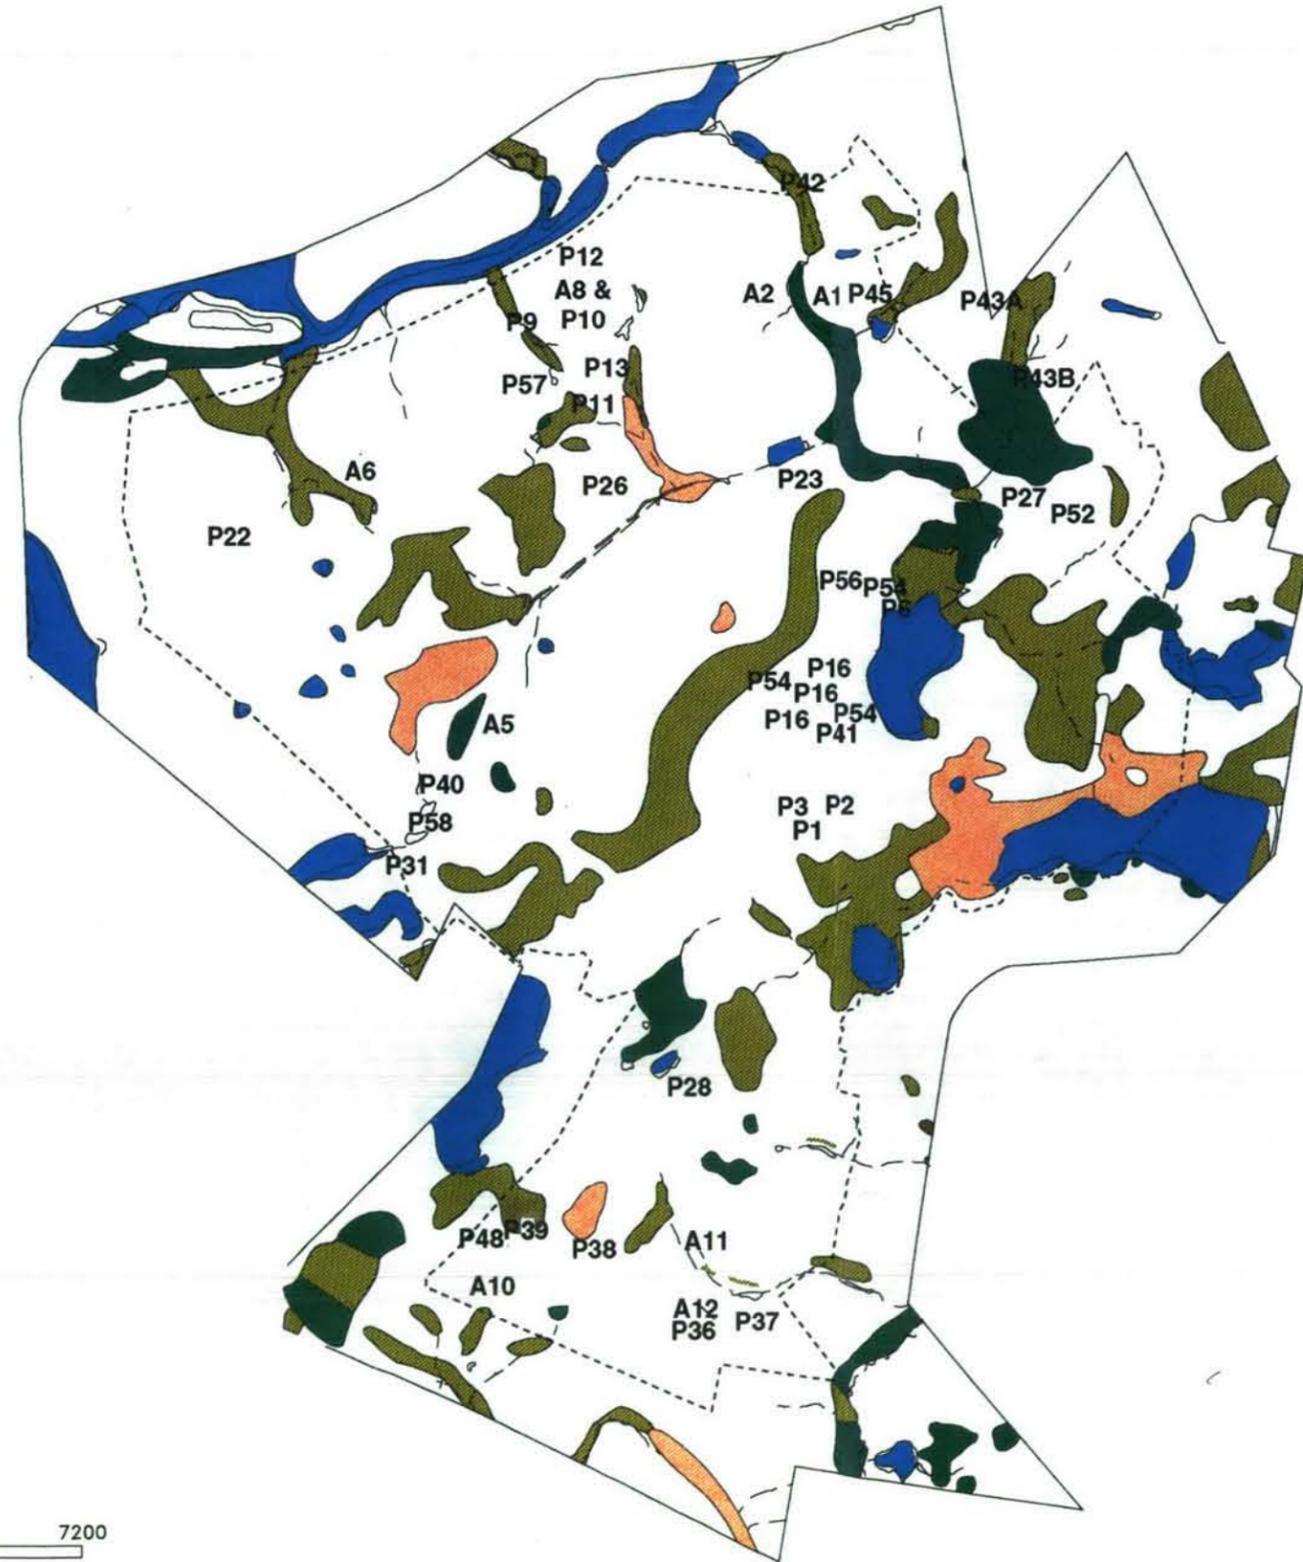
**WETLAND TYPES:**

- Open Water
- Forested
- Scrub/Shrub and Emergent
- Forest and Scrub/Shrub Wetland
- Facility Boundary

Figure 2-3 WETLAND TYPES AT THE SUDBURY ANNEX

Wetlands are transitional ecosystems that occur between upland (terrestrial) and aquatic environments. Water is the primary factor controlling these habitats and the associated plant and animal communities. Occurring in a wide variety of forms, wetlands normally have three factors in common: dominance of hydrophytes (water tolerant plants), presence of hydric (saturated) soils, and a water table at or near the ground surface for a long enough duration during the growing season to develop anaerobic conditions. The wetland types commonly found in the Annex region include forested wetlands, scrub/shrub wetlands, and emergent (i.e., herbaceous) wetlands. Each of these wetland types and communities is discussed below.

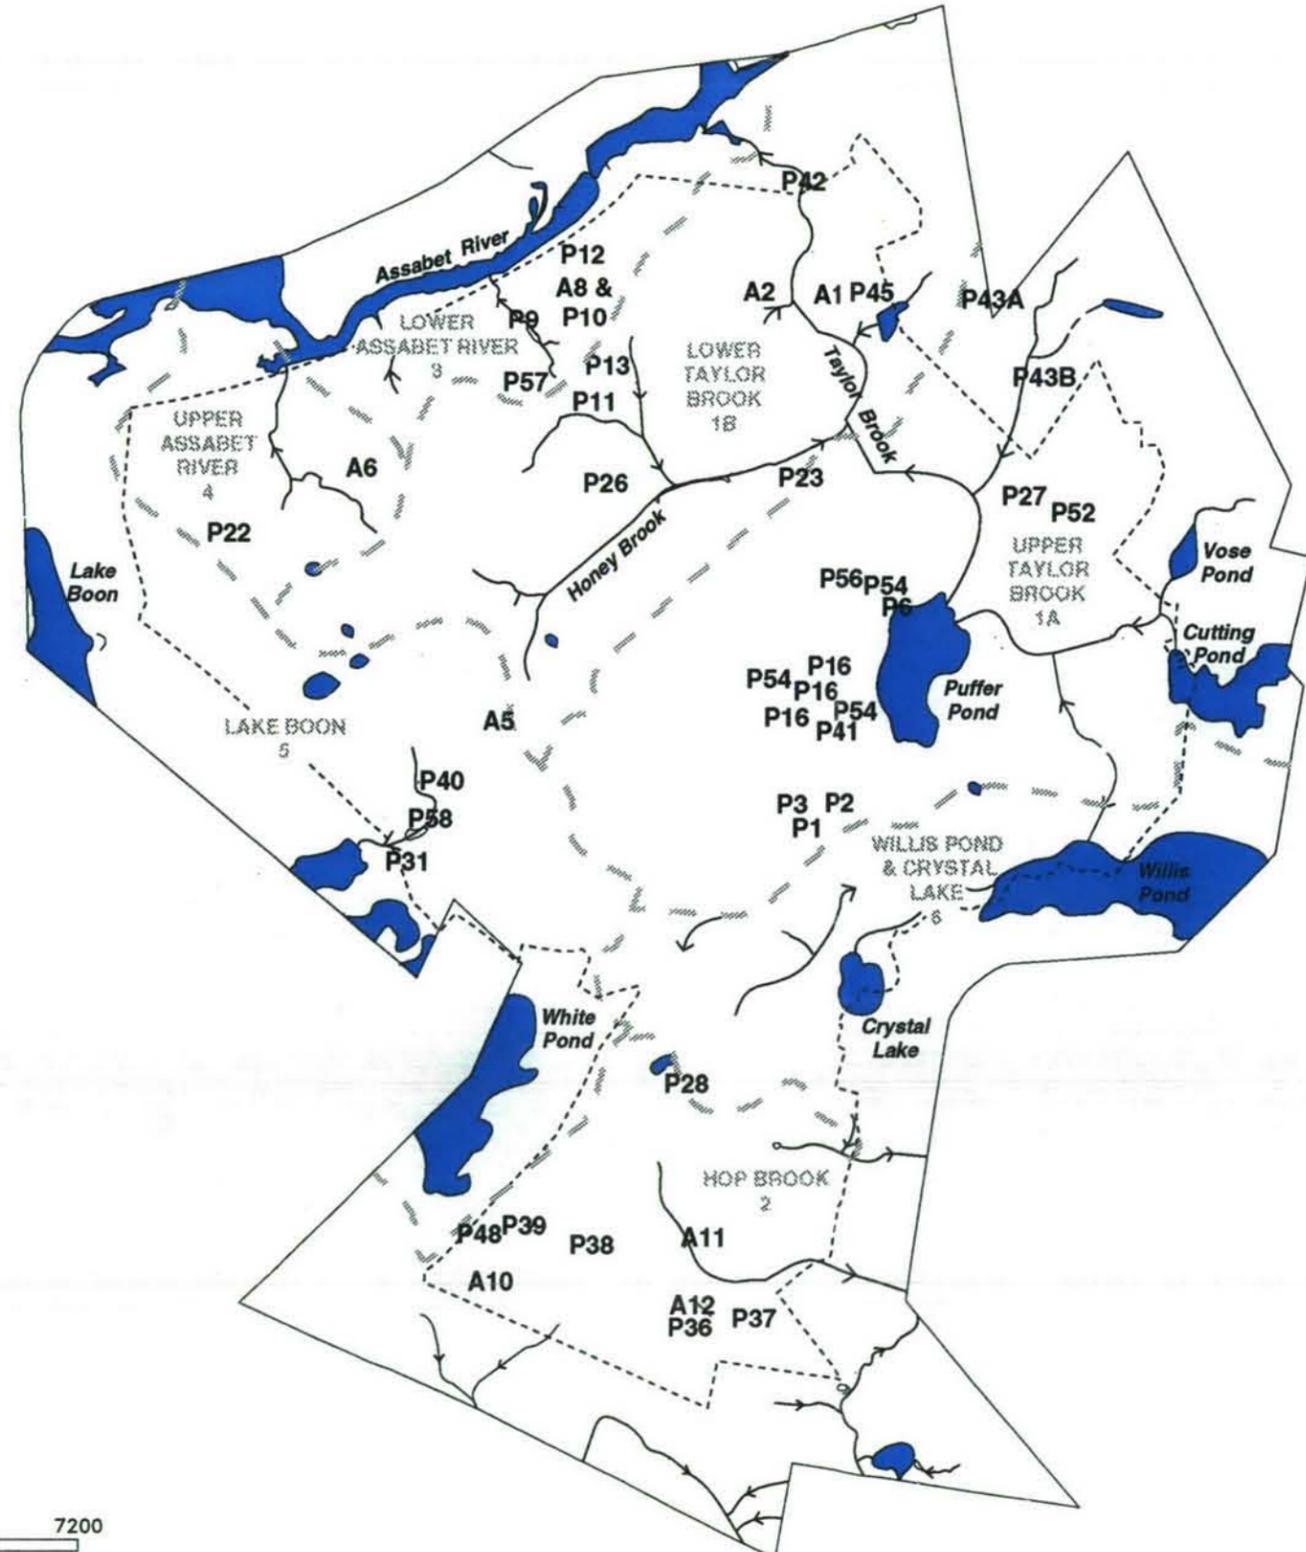
**KEY :**

- Facility Boundary
- ..... Approximate Watershed Boundary
- Surface Water Drainage Direction Indicator

The southwestern and western sides of the Annex drain primarily into either White Pond or Boons Pond, which discharge to the Assabet River. White Pond has no outlet, but the balance of evidence suggests that its use as a source of water supply serving the Town of Maynard has resulted in a net in-flow to the pond from the surrounding area. The remainder of the Annex, including nearly all of the detached portion south of Hudson Road, drains into Hop Brook or its tributaries. These include Run Brook, receiving flow from Crystal Lake and Willis Pond, and Marlboro Brook, which originates on the Annex. Hop Brook discharges to the Sudbury River, which joins the Assabet River northeast of the Annex to form the Concord River.
