Development of Inspection and Repair Technology for Heat Exchanger Tubes in Fast Breeder Reactors

A prototype probe system with a hybrid optical fiber scope was designed for inspecting and repairing heat exchanger tubes in fast breeder reactors (FBRs). It comprises a laser processing head combined with an eddy current testing unit. Ultrashort laser pulse ablation is used to remove work-hardened layers. And spot laser welding is used to repair cracks. This system is both a safe and economical option for the maintenance of FBRs because it extends the lifetime of the heat exchangers.

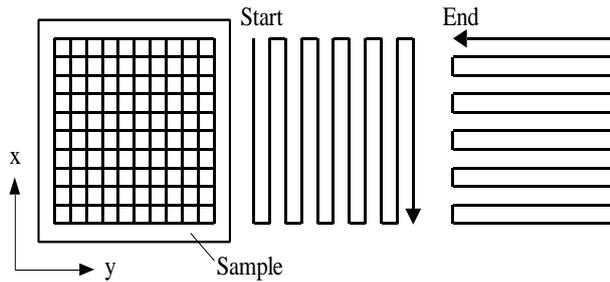
Fig. 1 Scheme of laser pulse scanning

The relation between the laser scanning directions is shown in Fig. 1. One scanning cycle means that the scanning in the x-direction begins from “start” and then the scanning in the y-direction returns to “end.” Each scan has a 1 mm shift at the return. One scanning cycle takes 131 seconds. Table 1 shows the combination of the number of scanning cycles and the spot diameter on the sample surface. Nine laser-processed samples and one reference sample without laser processing were prepared.

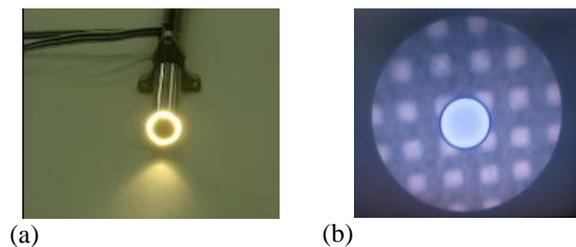
Fig. 3 Composite-type optical fiber
(a) telescope section, (b) image view of 0.15 mm mesh

Figure 3(a) shows the telescope section of a composite-type optical fiber. The telescope, which relays images from the inner surface to the edge of the optical fiber, consists of quartz lenses in a stainless steel sleeve. The fiber is made of synthetic quartz with three cylindrical structures. Each structure has its own function. A 0.2-mm-diameter center fiber delivers the processing high-energy laser beam. Image fibers, which deliver the visible image for the endoscope, surround the center fiber. The picture elements of the endoscope are laid parallel like a honeycomb and can directly send images from one end to another. There are 20,000 image fibers, so the processing images are transmitted with high clarity and resolution. Light guide fibers, which supply illumination intensity, are located on the outer side of the image fibers. The total length of the composite-type optical fiber is 10 m. Figure 3(b) shows a view of 0.15 mm mesh through the telescope.

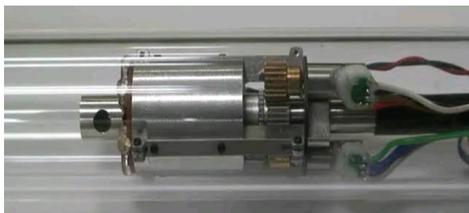
Fig. 4 Laser processing head

The laser processing head was specifically designed to access the inner walls of heat exchanger tubes. It comprises a movable sleeve that is driven by two pulse motors. Both rotational and longitudinal motion are possible on the sleeve, which has a 45° tilted mirror at the inside end and an oval hole where a high-energy laser beam and images are transmitted. Figure 4 is a photograph of the laser processing head inserted in a 1-inch acrylic pipe. The outer diameter was designed to be less than 20 mm. The movable sleeve is supported by ball bearings in a housing, which make it possible to move the processing head 5 mm in the longitudinal direction and rotate it by $\pm 185^\circ$.

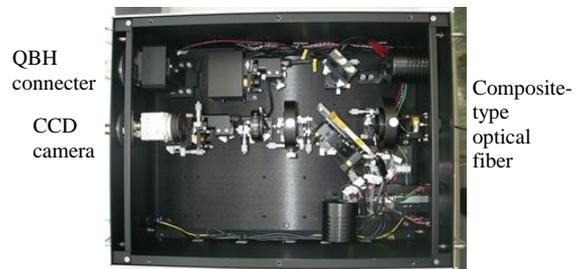
Fig. 6 Inside view of the coupling device housing

The function of the coupling device is to axially combine the processing laser beam and the images of the inner tube walls. Figure 6 shows the inside view of the coupling device housing. A laser beam supplied with a QBH connector goes into a laser beam collimator. The collimator was specifically designed for the NA value of the laser beam. A dielectric coating mirror at a 45° angle reflects the 1.07- μm collimated laser beam to a focusing lens. At the end of the composite-type optical fiber, the collimated laser beam is focused on its center core fiber at a 0.2-mm diameter. Visible light coming from the composite-type optical fiber faces in the opposite direction and goes through the dielectric coating mirror to a charge-coupled device (CCD) camera. Reflection loss on the optical components in the coupling device was designed to be less than 10%. Temperature rise is monitored by thermocouples. The housing of the coupling device is sealed and the micro particle density is monitored.

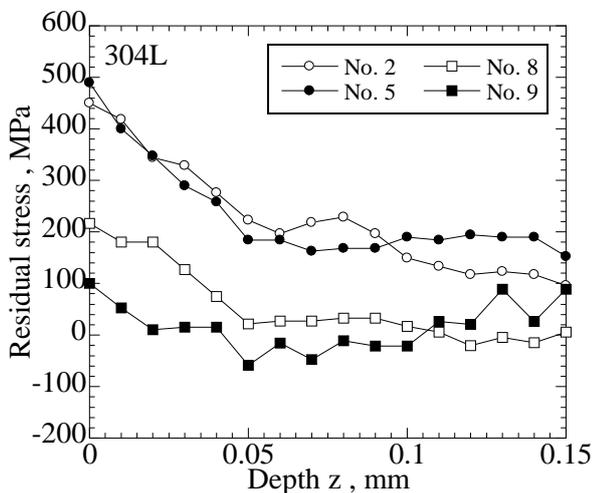
Fig. 7 Distribution of residual stress

Figure 7 shows that the surface to the depth of 0.05 mm has high tensile residual stress. The improvement for residual stress is not significantly effective, as shown in the plots of No. 2 and No. 5. However, the improvement for residual stress becomes effective in the plots of No. 8 and No. 9. For No. 2 and No. 5, the laser spot diameter is equal to or less than the trace spacing of 0.6 mm or the scanning shift of 1 mm. The residual stress distribution was improved at the laser spot diameter of 0.9 mm at No. 8. Further improvement was achieved as the number of scanning cycles reached 7 at No. 9. It shows the compressive residual stress condition at the depth of approximately 0.05–0.07 mm. Most of the hardened layers were ablated by ultrashort laser irradiation. During free expansion, the solid density plasma compressed the target on the order of tens of GPa. High pressure with ultrashort time duration enables the generation of intense shockwaves and freezes the iron phase in the nonequilibrium state [11]. Here, the residual compressed stress is also apparent evidence of high pressure. For laser peening in industrial applications, frequency doubling Q-switched YAG laser pulses in water have been commonly used. The ultrashort laser ablation has similar effects even in dry condition.

layer [4] and can be applied for mitigation against SCC. However, improvement of internal residual stress has not yet been clarified. In the present study, stress measurements were performed on the laser ablation samples. The synchrotron radiation X-ray in BL22XU at SPring-8 was applied [9]. The energy of the X-ray was 66.84 keV, which is capable of detecting internal residual stress distribution. The stress distribution from the surface to the depth of 0.15 mm was observed using a strain scanning method with a Ge (111) analyzer [10].

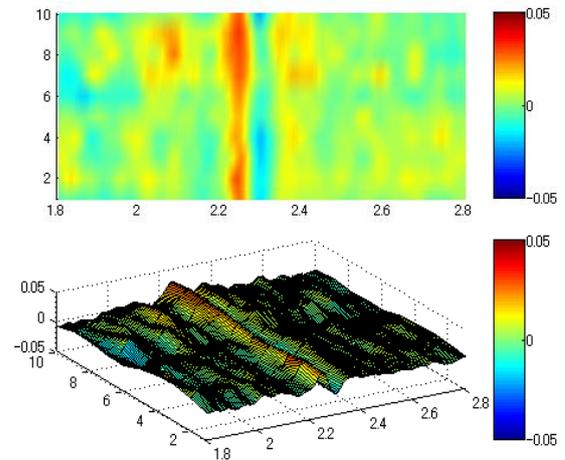
Fig. 8 ECT detection for a crack on a 1 inch diameter tube
(a) noise filtered signal, (b) stereoscopic view

Figure 8 is a demonstration of a detection result by the ECT sensor unit. The artificial crack was 0.5 mm wide with a 10% tube thickness, fabricated by electrical discharge machining. ECT signals from a 10-channel A/D convertor created an original waveform. Noise filters were applied to the original signal. A low pass filter reduced spiky noise and a band cut filter suppressed the periodic pattern in space. A band cut filter successfully extracted the artificial crack, as indicated by the red color in Fig. 8(a). The periodic pattern, the yellow colour, was suppressed, which was supposed to indicate the initial deformation on the heat exchanger tube. Generally speaking, the hot rolling process sometimes causes slight deformation. The software also has a function to indicate stereoscopic effect, which is shown in Fig. 8(b).

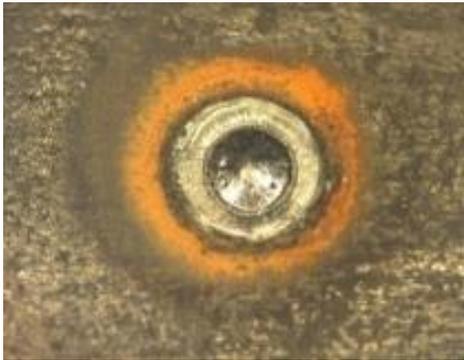
Fig. 9 Molten pool on a heat exchanger tube

Figure 9 shows a laser welding demonstration by a high power fiber laser. An ytterbium fiber laser and the composite-type optical fiberscope were connected in the

coupling device. The laser output was increased to 1 kW. The target was a STBA24 tube containing 2.25% Cr. The working distance from the fiberscope to the target was 19 mm. A shielding glass plate was set to protect the fiberscope lens. An input power of 300 W with 1 second irradiation had sufficient heat-load for spot welding. The target surface had a shallow dimple of 0.52 mm in diameter and a surrounding molten zone with a diameter of 0.87 mm. Oxide particles were deposited up to a diameter of 1.5 mm. As the input power was increased over 400 W, surface evaporation and fume generation at the molten pool became strong. Contamination on the shielding glass plate prevented a laser power of over 400 W from reaching the target surface. Therefore, it is determined that a high brilliant fiber laser of 300 W is satisfactory for spot laser welding.
