PERFORMANCE OF THE DARHT SECOND AXIS INDUCTION CELLS*

Abstract

I. Cell and Driver Configurations

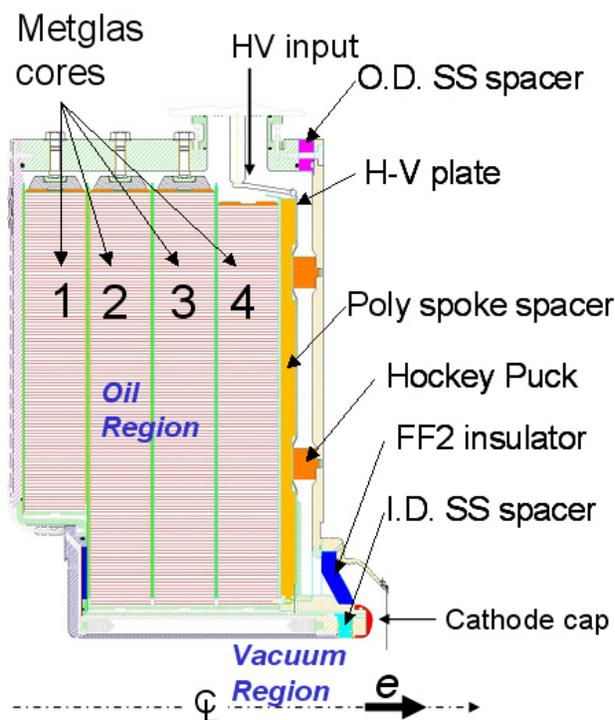
The upgraded induction cell is shown in Fig.1. The accelerator is formed by a series of 74 identical cylindrically symmetric shaped cells. The cell accepts a HV pulse from the driver and delivers this pulse to the annular gap in the inner cylindrical surface (beam line). The inner conductor is surrounded by annular ferromagnetic cores to reduce loss current from the HV plate to ground. Each cell is 73" in diameter and weighs 16,000 lbs. Each cell is driven by 4 PFN Marx stages in series, Fig. 2. Between the top stage of the Marx and the grounded lid are a set of diodes and series resistors that

Figure 1. Cross-section of the upgraded DARHT II induction cell.

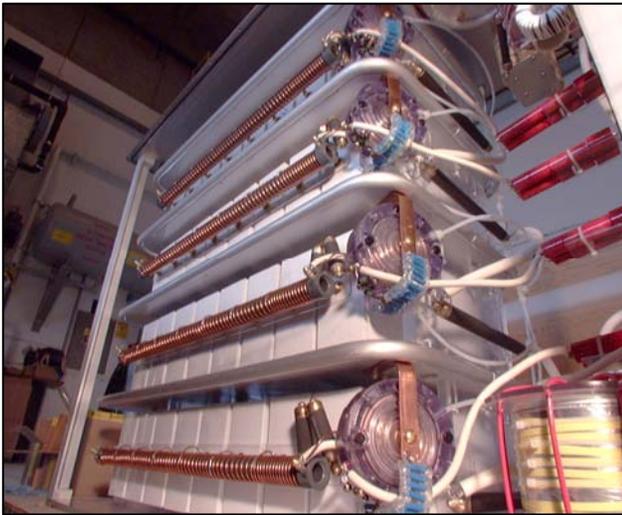
clamp voltage reversal at the cell. Reversal occurs due to saturation of the Metglas cores late in the pulse. The flat top on the cell voltage is achieved by varying the number of turns on the inductor between each capacitor, a PFN section.

Figure 2. Each cell is driven by an independent PFN/Marx. Each stage is an 8 section PFN.

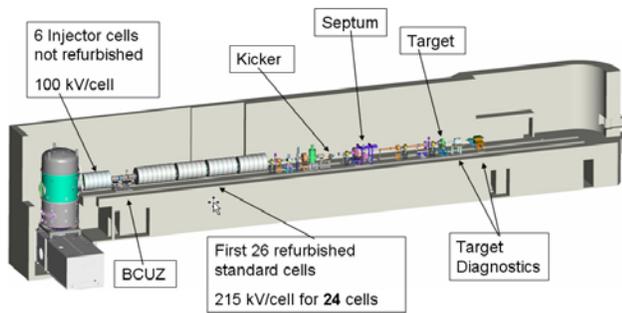
The first 26 refurbished cells were assembled in the Scaled Accelerator, Fig.3, to provide the beam needed for

a scaled test of the Kicker and multi-pulse Target. The six Injector cells used on the Scaled Accelerator were not refurbished. As a result the first 8 cells were operated at a reduced voltage because the gas supply and pressure is common to all 8 PFNs and their Marx spark gaps.

Figure 3. Configuration of the Scaled Accelerator.

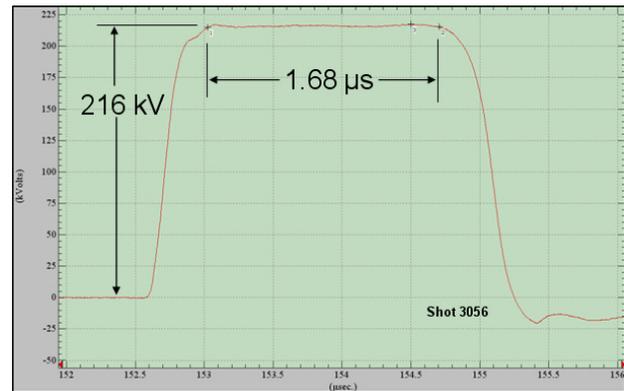
Figure 4 shows a typical average waveform for the refurbished cells on the Scaled Accelerator. The waveforms are a result of adding together the voltages on

the 24 refurbished cells and then dividing by 24 to give the average cell voltage.

Figure 4a. The average cell voltage on the Scaled Accelerator Test exceeded the design goal of 200 kV per cell.

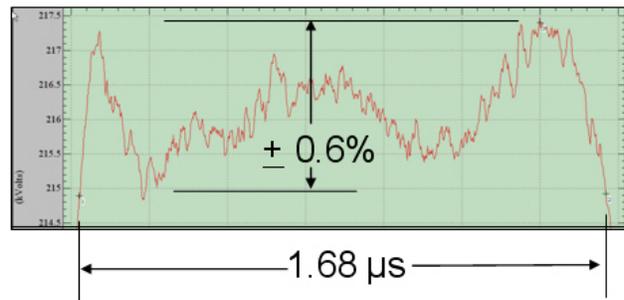
Figure 4b. The average cell voltage on the Scaled Accelerator Test exceeded the design goal of flatness to $\pm 1.0\%$.

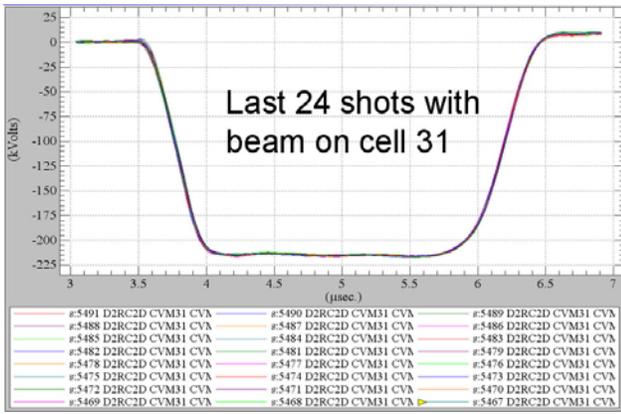
Displayed in Fig. 5 are the last 24 shots in the Scaled Accelerator Test series on the next to last cell in the accelerator. This is an example of the data demonstrating that jitter and flat top are consistently good on the individual cells as well as on the average cell voltage. The individual waveform on the cells for the last shot of the test series are shown in Fig. 6. A spread of voltages is used to achieve the flat tops, because the amount of Metglas in the cells varied from 480- to 515 mVs. In an effort to identify the status of cells 9 – 31 after completion of the Scaled Accelerator Tests, we fired 200 shots at 250 kV on these cells, Fig 7. The conclusion was that the cells had not been degraded in spite of the large number of shots or debris in the vacuum regions.

Figure 5. The spread in PFN erection was less than 30ns and the voltage top flat to $\pm 1\%$ for each cell.

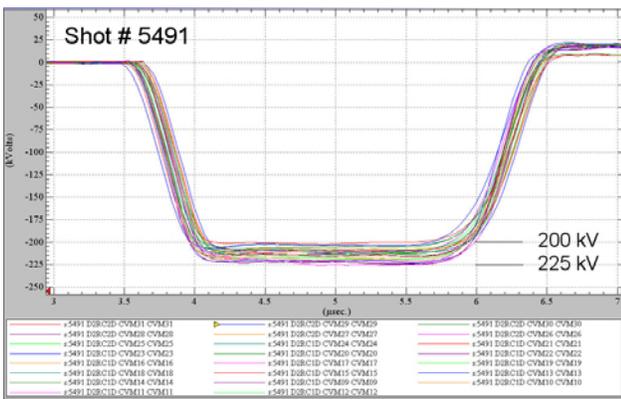
Figure 6. The 24 refurbished cells operated between 200 and 225 kV.

The 24 refurbished cells in the Scaled Accelerator have performed flawlessly for > 2000 shots at 200 – 230 kV and beams > 1 kA. Concerns about good finger stock contacts in the return current path and possible UV were not experienced. At no time did any cell experience a voltage breakdown, neither in the oil nor the vacuum regions. The one exception was in the vacuum region on cell position 32, at the end of the accelerator, on Shot 4874. Debris and a pressure burst resulted from inserting a downstream aperture on the 3 preceding shots. The fourth such shot, #4874, resulted in a breakdown. The voltage on this cell was reduced by 15 kV and it was successful for all 650 subsequent shots.

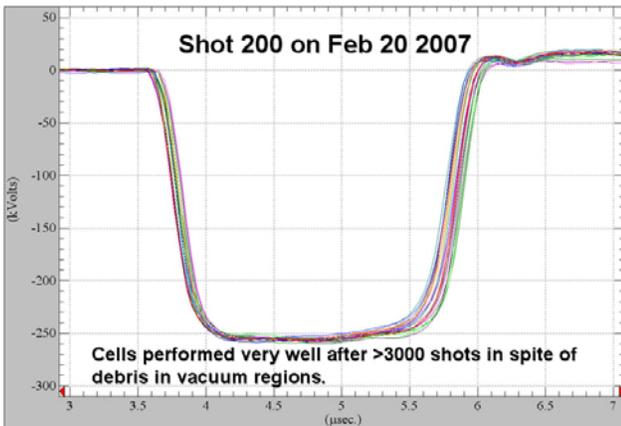
Figure 7. Cells 9-31 were fired at 250 kV for 200 shots at conclusion of the Scaled Accelerator Tests.
