Cleaning Verification Monitor Technique Based on Infrared Optical Methods

PP-1138

Final Report

Shane Sickafoose, David Ottesen, Douglas Scott
Sandia National Laboratories
Livermore, CA 94550

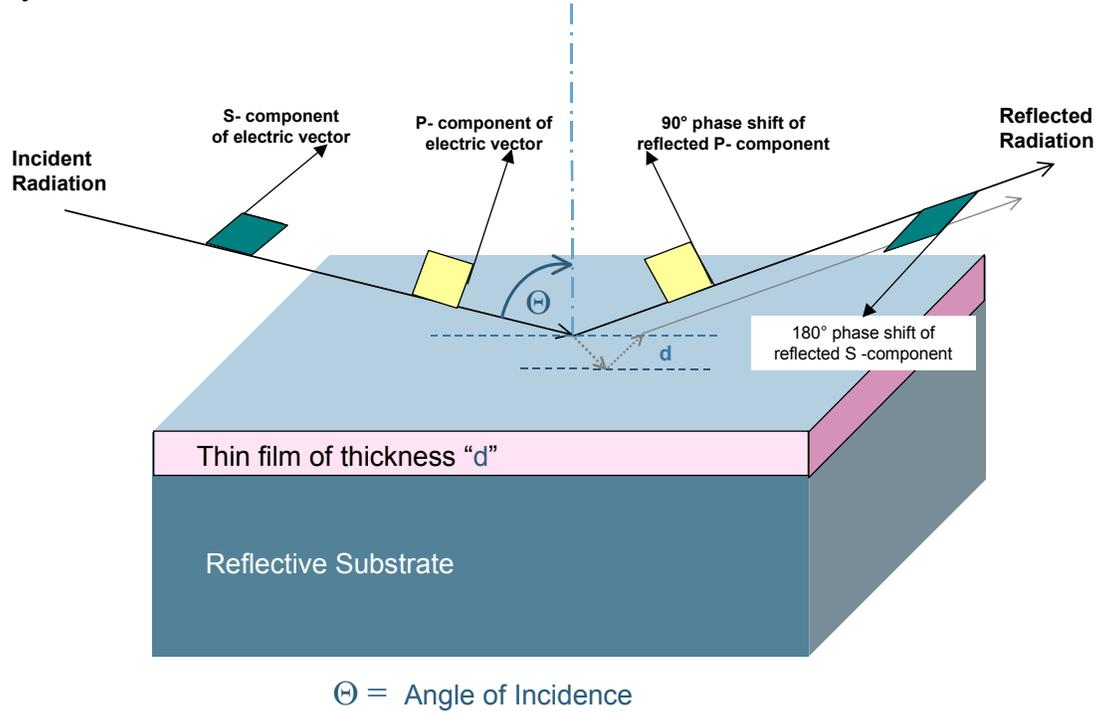
Figure 1. Experimental arrangement and definition of important quantities in reflection-absorption spectroscopy.

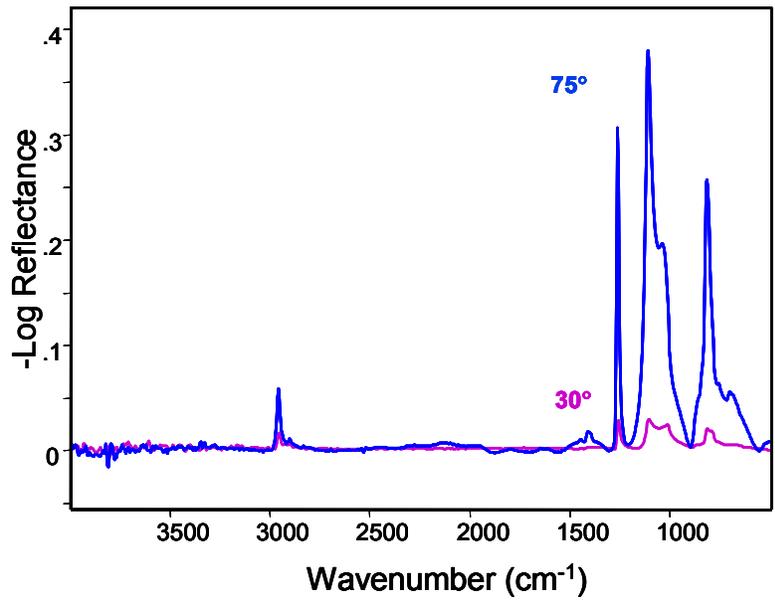
Figure 2. FTIR spectrum of $0.2 \mu\text{m}$ thick film of silicone on aluminum at 30° and 75° angle of incidence.

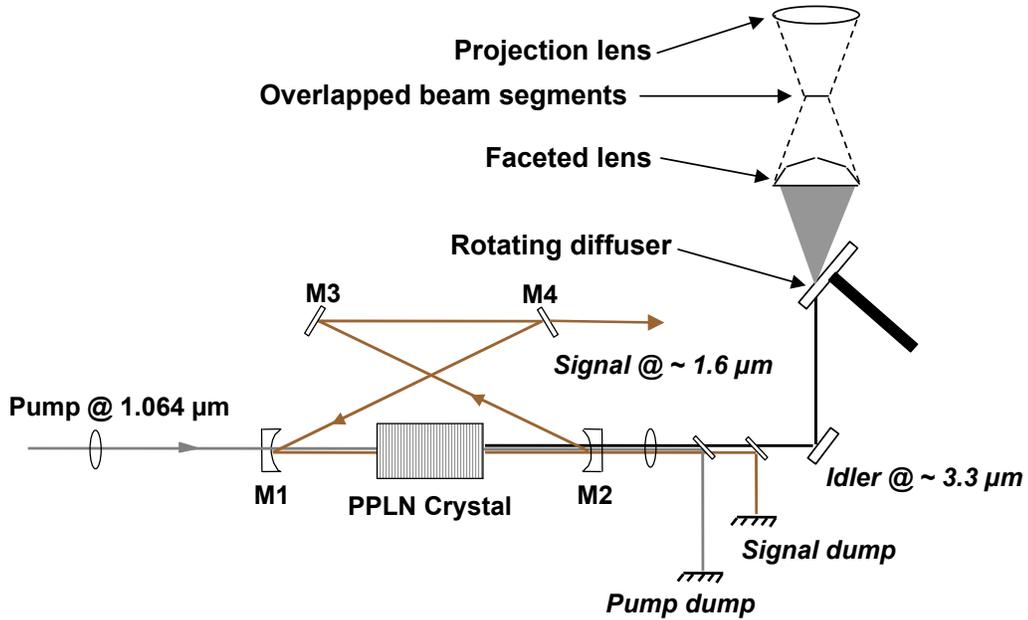
Figure 3. Diagram of the PPLN OPO and projection optics.

As shown in Figure 3, the OPO used in the imaging sensor is of the “bowtie-ring” design. A diode-pumped, cw, multimode Nd:YAG laser (Lightwave Electronics) that is capable of generating at least 11 W of output power at 1064 nm is used as the OPO pump source. Two flat mirrors (M3 and M4) and two curved mirrors (M1 and M2, 50-mm radius of curvature), all coated to be highly reflective at the signal and highly transmissive at the pump and idler wavelengths, form the bow-tie-shaped singly resonant ring oscillator designed to resonate the signal wave. An anti-reflection-coated lens, positioned between the pump laser and the OPO cavity, serves to image the gaussian pump beam into the PPLN crystal. In this way, a beam waist (E-field radius) of $70 \mu\text{m}$ is created in the center of the crystal, which itself is centered between the two curved cavity mirrors. During normal operation, the OPO resonates on a single signal mode for minutes at a time, whereupon it hops to another cavity mode. The idler bandwidth is, however, determined by that of the pump beam, which is $10\text{--}15 \text{ GHz}$.

The raw output of the OPO contains the idler beam as well as portions of the signal and pump beams and some higher-order (red, green) beams created spuriously in the PPLN crystal. Spectral filtering is used to dump all but the idler beam. Prior to illumination of the sample, the idler is passed through a set of projection optics. The first of these is a ZnSe diffuser (mean roughness of $\sim 3\text{-}4\ \mu\text{m}$) that is mounted on a motor-driven spindle. The diffuser serves to destroy the phase coherence of the idler to minimize laser speckle noise in the transmitted beam and in the reflected light viewed by the IR camera. The cone of radiation leaving the diffuser is collected by a ZnSe faceted lens (Laser Power Optics). The faceted lens forms an expanded beam that is segmented into 32 different square beamlets that are subsequently overlapped at a distance of 2" from the surface of the lens. The square-shaped overlap region is then imaged onto the target converting the Gaussian profile of the idler beam into a uniform square illumination on the sample surface.

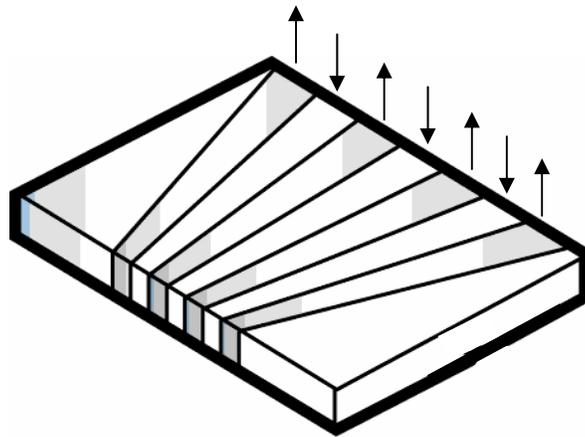
Figure 4. Schematic diagram of a “fan-out” PPLN crystal, in which the period continuously varies across the crystal width. The arrows indicate the orientation of the crystallographic z-axis. In reality, the periods of inversion are much narrower than indicated (typically $\sim 29\text{-}31\ \mu\text{m}$).

In a QPM medium, phasematching is engineered into the medium by causing the crystal to have a periodically inverting optical axis (see Figure 4). The engineering process increases conversion efficiency by allowing the use of much stronger nonlinear coefficients of the crystal, and frees the system from reliance on birefringence, thereby increasing tunability. As the light beams cross the crystal-axis-inverting boundaries, any relative dephasing of the waves is corrected. For a crystal of a given periodicity, the rephasing is effective for a particular set of pump, signal, and idler frequencies. Some degree of tuning of these waves can be achieved within the crystal phasematching bandwidth (typically 10-20 cm^{-1}). Broader tuning is achieved by accessing a portion of the same crystal having a different periodicity, or by changing the temperature of the crystal. The “fanout” grating in Figure 4, for example, allows the periodicity to be continuously changed by translating the crystal through the pump laser beam.

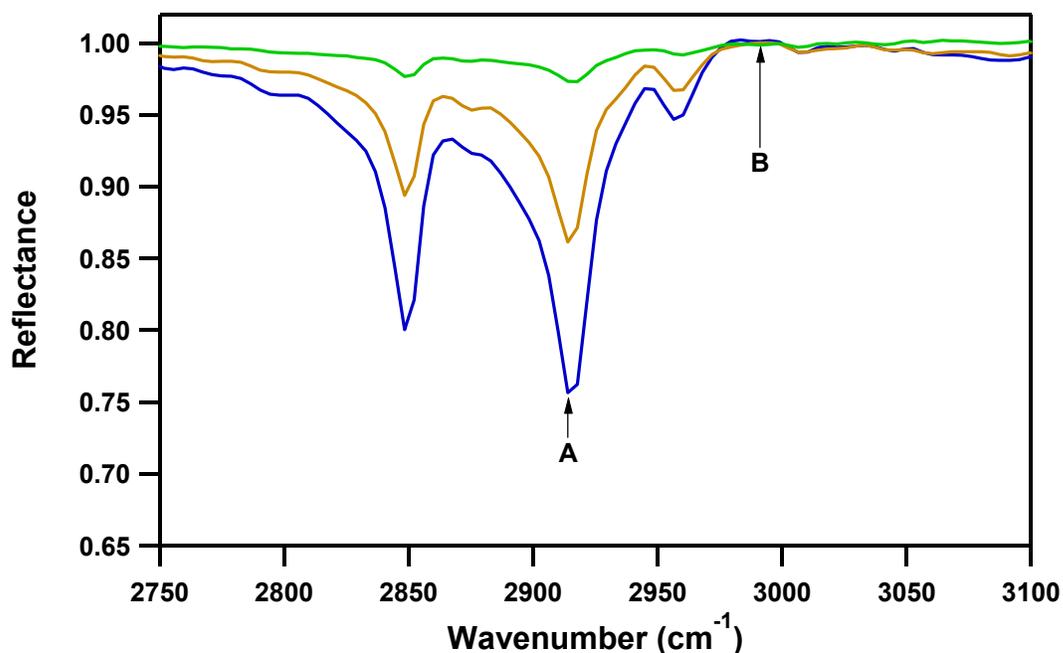
Figure 5. FTIR spectrum of C-H stretch absorption feature used for laser imaging. Wavelength A is used for measurement of hydrocarbon residue. Wavelength B accounts for surface reflectivity.

normalized by the average image ratio of a clean surface taken at the same wavelengths. The relative positions of these wavelengths can be seen in Figure 5.

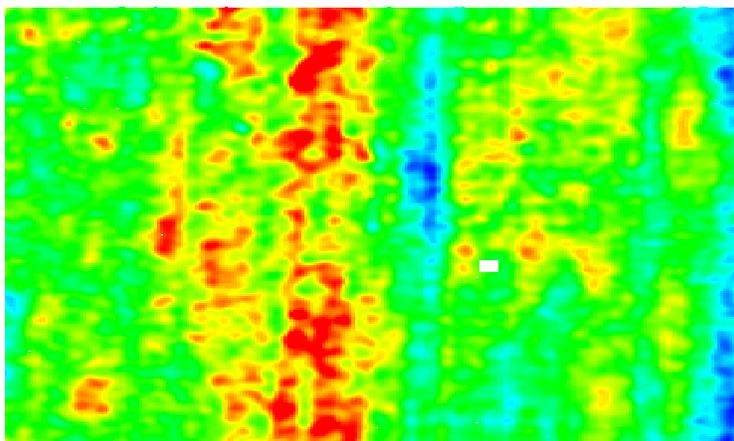
Figure 8. Ratio of laser images seen in Figures 6 and 7. False color is added to aid interpretation of image. Blue areas are clean and red areas have contaminant.

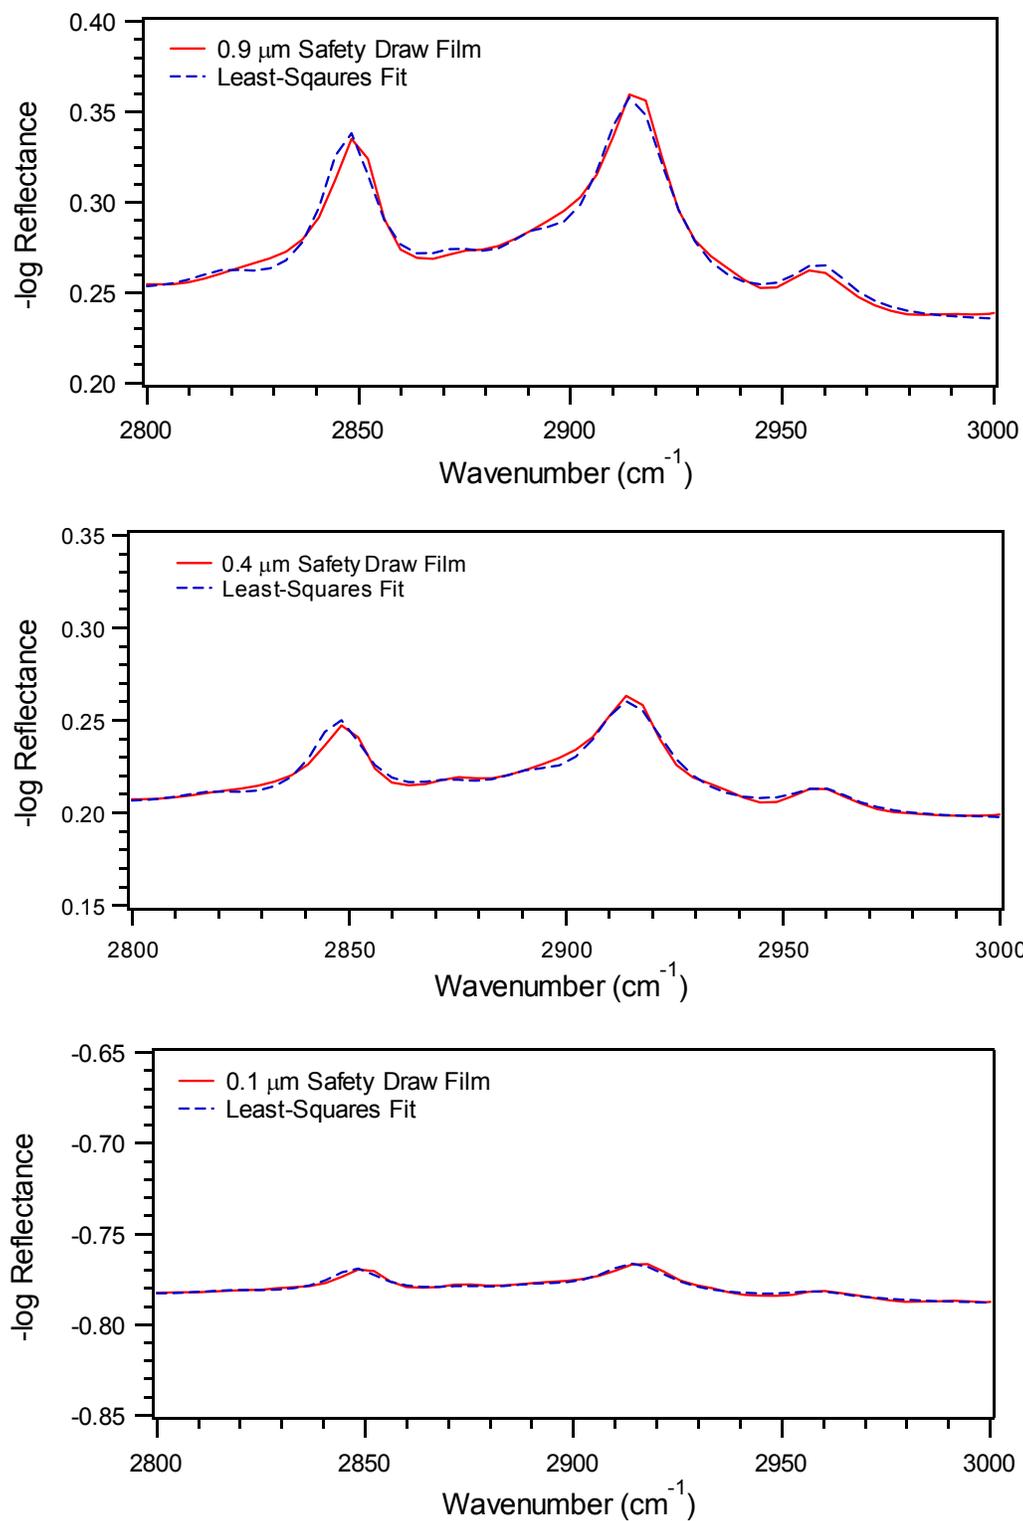
Figure 9. Linear least-squares fit of experimental reflectance-absorption data for safety draw lubricant on 600 grit polished aluminum surfaces. Average film thickness: (Top) 0.9 μm , (Middle) 0.4 μm , (Bottom) 0.1 μm .

The pronounced non-linearity in slope for the thickest films at 75° was unexpected, although an additional enhancement in sensitivity does occur for the reflectance-absorption of a film with increasing angle of incidence [1]. Under appropriate conditions this may cause a non-linear response for thicker films. Such an interpretation is not substantiated by calculated spectra for the present measurement conditions, however, due to the small change from 60 to 75° in angle of incidence. Furthermore, such a non-linear effect would be most pronounced for measurements on the smoothest substrate (Figures 11, filled circles) where the effective local orientation of the surface is most constant with respect to the illumination beam. In contrast, these are by far the most linear sample series for the 75° data.

We attribute the pronounced non-linearity of the 75° data for the thickest Safety Draw films to the morphological characteristics of the material as deposited on the aluminum test panel surface. As described above, Safety Draw is a highly viscous material that forms a visibly heterogeneous white film at $1 \mu\text{m}$ thickness. Variations in the deposition process produce relatively thick local areas of Safety Draw film and result in accretion of solid residue along the polishing grooves and ridges of the aluminum substrate. Under these circumstances, illumination of the surface with the FTIR beam at an angle of 75° results in shadowing by contaminant material on ridge structures for all except the smoothest (600 grit polish) surface. The 12-mm diameter focal area of the infrared beam is elongated by a factor of four

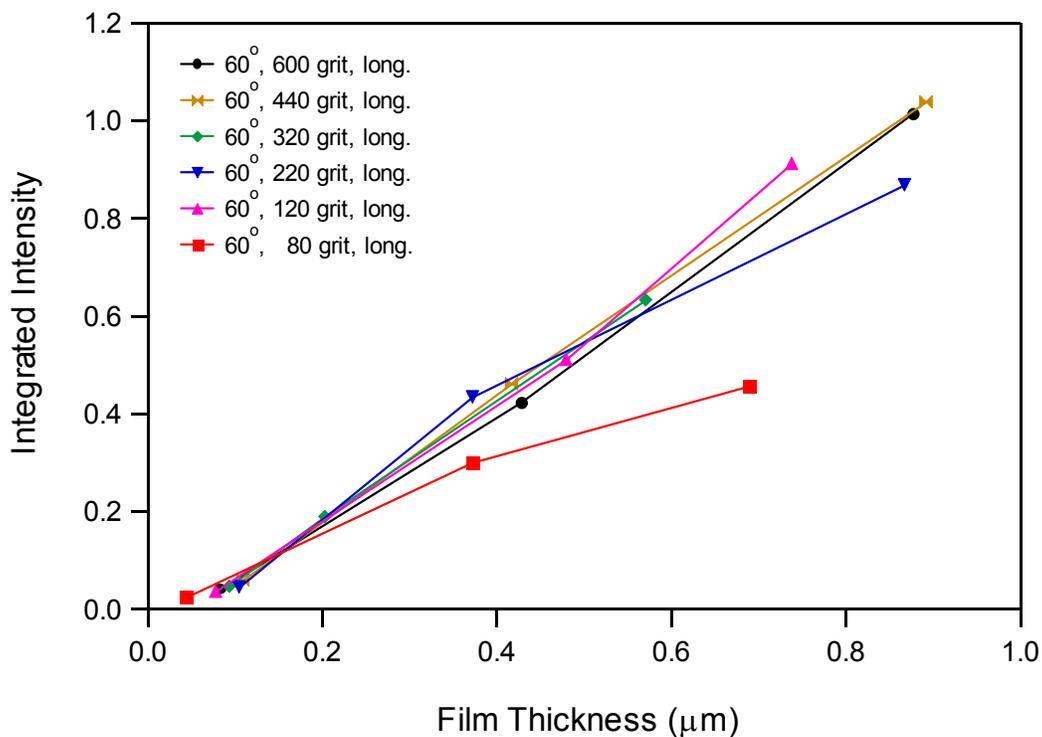
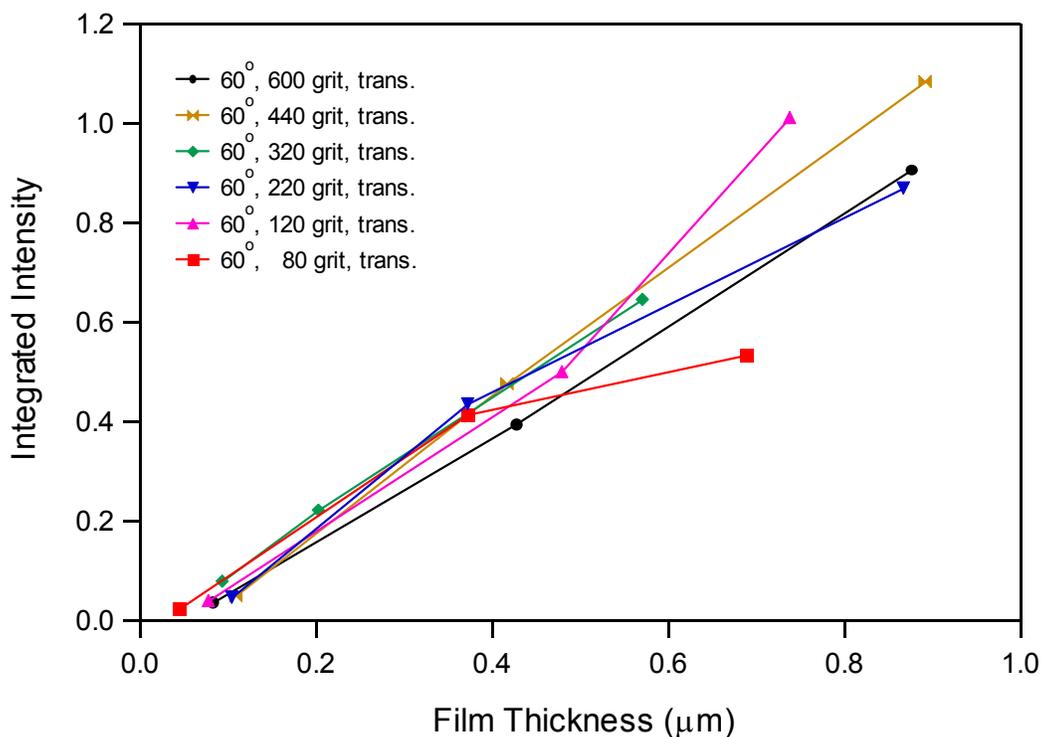
Figure 10. Integrated reflection-absorption intensity at 60° angle of incidence for C-H stretching bands of Safety Draw films deposited on aluminum test coupons with varying degrees of surface roughness (longitudinal, top; transverse, bottom).

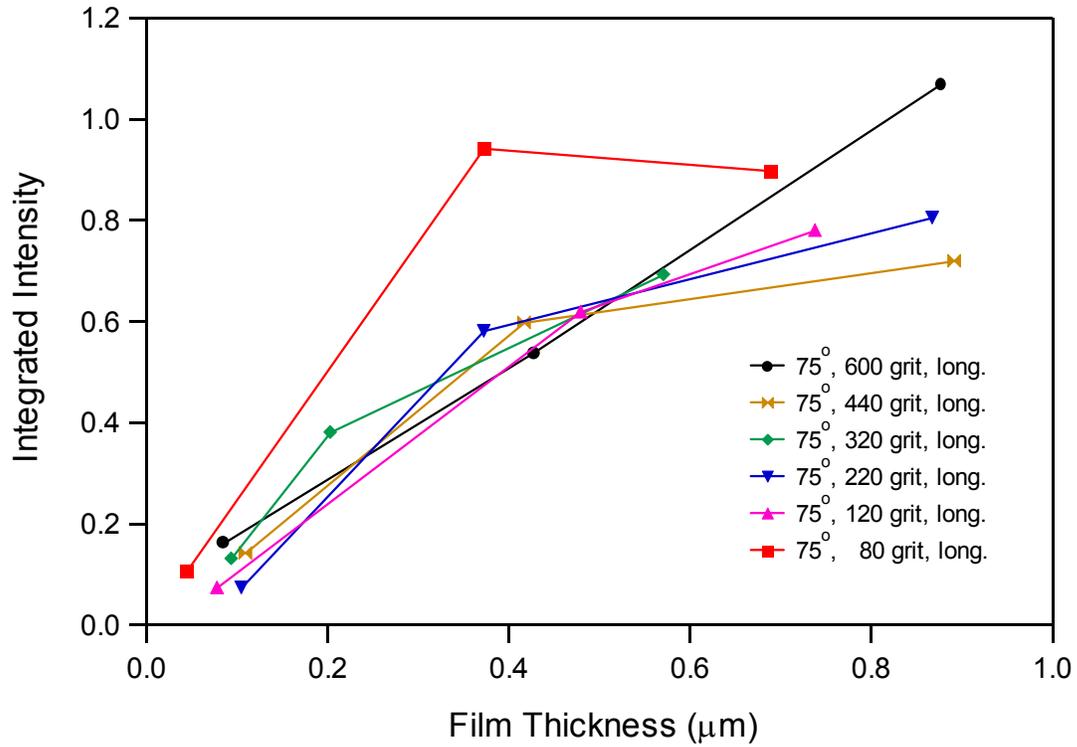
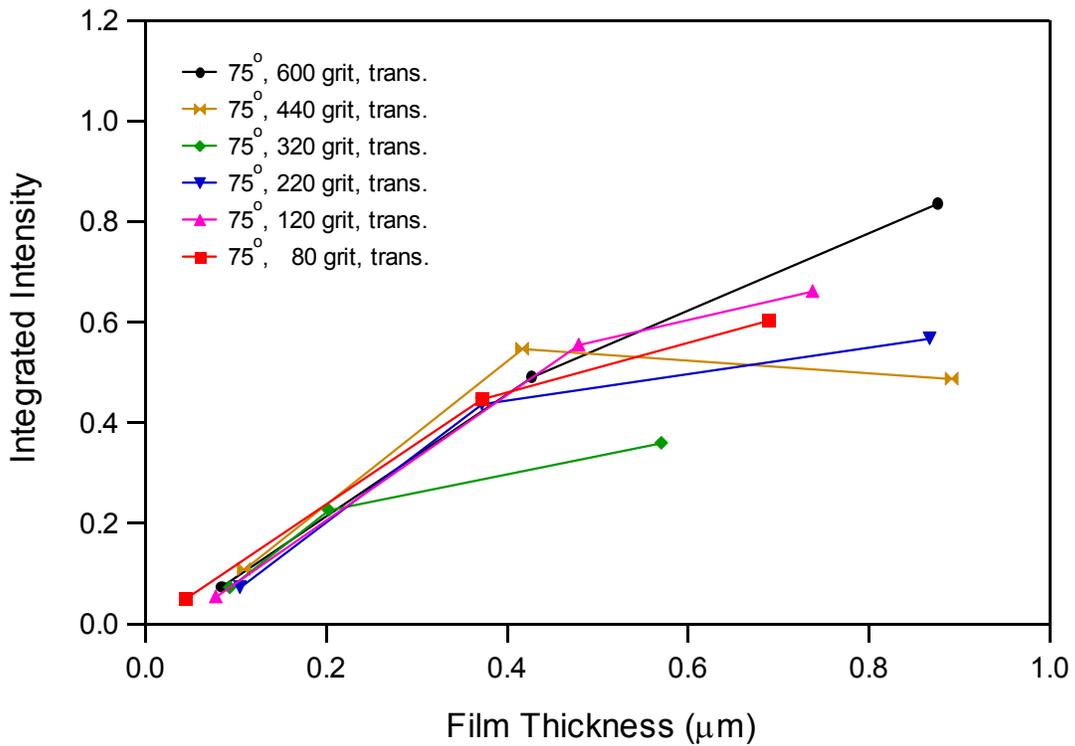
Figure 11. Integrated reflection-absorption intensity at 75° angle of incidence for C-H stretching bands of Safety Draw films deposited on aluminum test coupons with varying degrees of surface roughness (longitudinal, top; transverse, bottom).

to 48 mm for this angle of incidence. In contrast, reflectance measurements at 60° result in only a factor of 2 elongation, and minimize the shadowing effect of thick films except for ridges on the roughest (80 grit polish) surfaces.

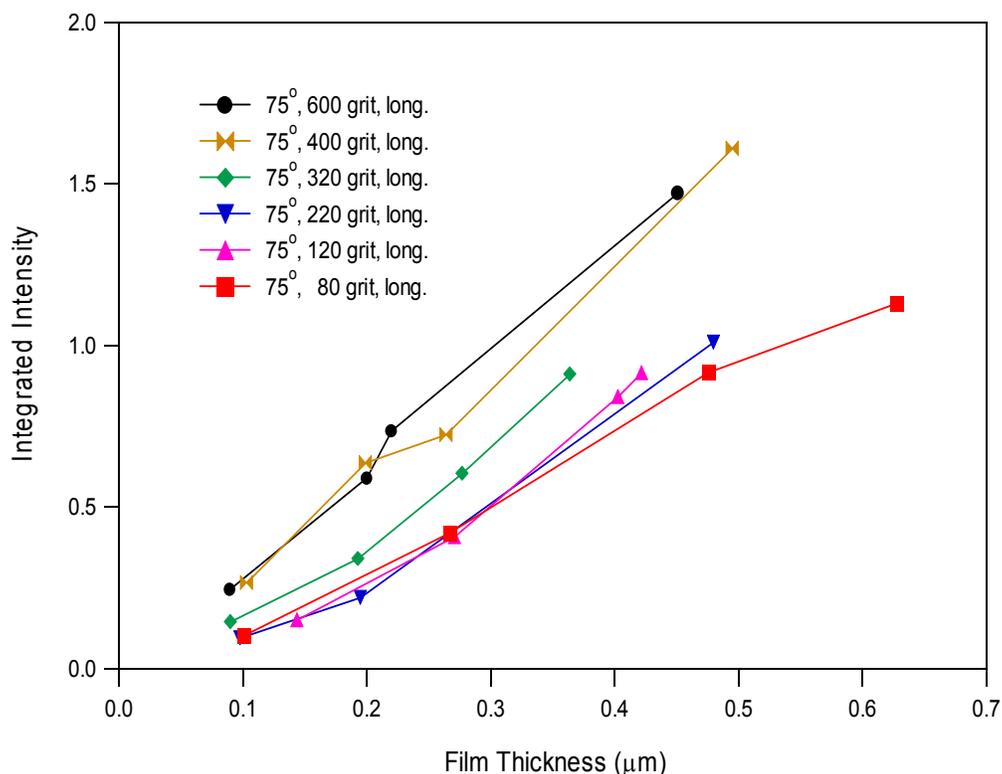
Figure 12. Initial reflection-absorption intensities of C-H stretching bands for Cosmoline films deposited on aluminum test coupons with varying degrees of surface roughness.

This interpretation is substantiated by reflectance data for the second material test set (Cosmoline). FTIR reflectance measurements have been made at a 75° angle of incidence for a test series similar to that of the Safety Draw set. A preliminary analysis of the C-H stretching frequencies shows a strikingly more linear dependence of instrument response with film thickness (with the exception of a single point for one of the panels with a 220 grit surface finish). We believe that this is due to the more fluid characteristic of the Cosmoline material, which allows the deposited film to conform much more closely to the surface topography of the test coupons. These results are shown for longitudinal reflectance measurements in Figure 12.

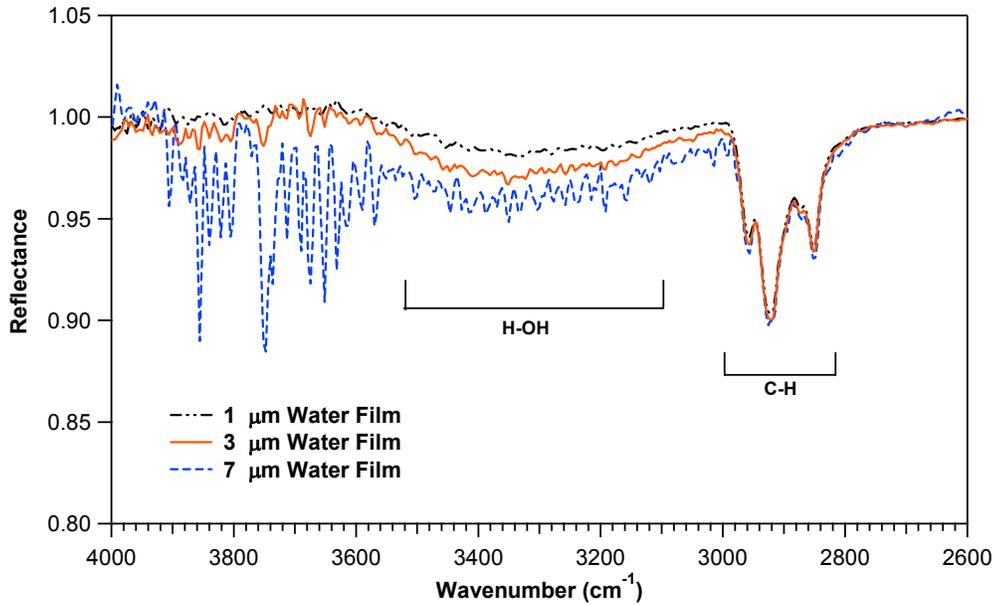
Figure 13. Potential interference effects of water on C-H stretching bands due to hydrocarbon contaminants. Three thicknesses of water film were examined (1 μm , top; 3 μm , middle; and 7 μm , bottom).

Reflection-absorption spectra are presented for three water films on the Cosmoline test panel in Figure 13. These water films range from very thin (1 μm , not visible to the eye) to relatively thick (7 μm , clearly visible to the eye). Substantial interference is present in the 1700 cm^{-1} spectral range (not shown) due to the strong H-O-H bending mode. This obscures carbonyl absorption features that may be present in some, but not all, hydrocarbon contaminant species. The C-H stretching bands near 2900 cm^{-1} , however, are not obscured by the broad H-OH stretching bands centered near 3400 cm^{-1} . This is particularly important for the effective and accurate use of the tunable infrared-laser imaging instrument, since

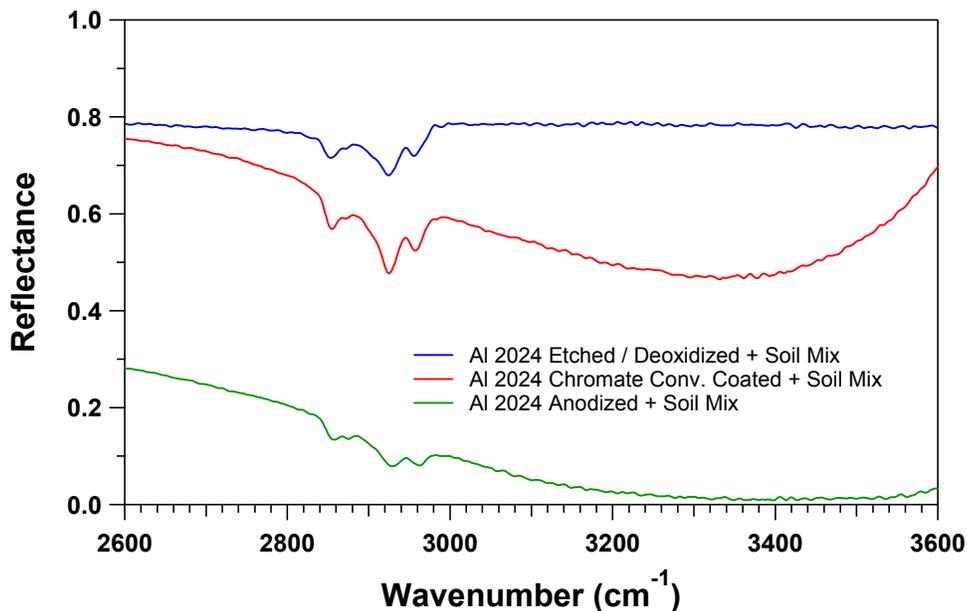
Figure 14. Comparison of infrared reflection spectra for hydrocarbon-contaminated aluminum surfaces from NAVDEP North Island (etched and deoxidized – top; chromate-conversion coated – middle; sulfuric acid anodized – bottom).

In a related problem, metallic, oxidized-metallic, and non-metallic surfaces present varying baselines. For these materials, the baseline infrared reflectance is no longer constant as a function of wavelength over the laser tuning range. This phenomenon is illustrated in Figure 14 for chromate-conversion and sulfuric anodized coatings on aluminum provided by NAVDEP North Island. The FTIR reflectance spectrum for an etched and deoxidized aluminum surface is also shown (top curve) in the figure for comparison.

Residual absorption bands near 2900 cm^{-1} due to C-H stretching modes in hydrocarbon contaminants are visible. These features are superimposed on the shoulder of a broad O-H stretching band due to hydroxyl species present in the oxide layers of the treated metal surfaces. This variation in baseline is important in the application of the laser imaging technique.

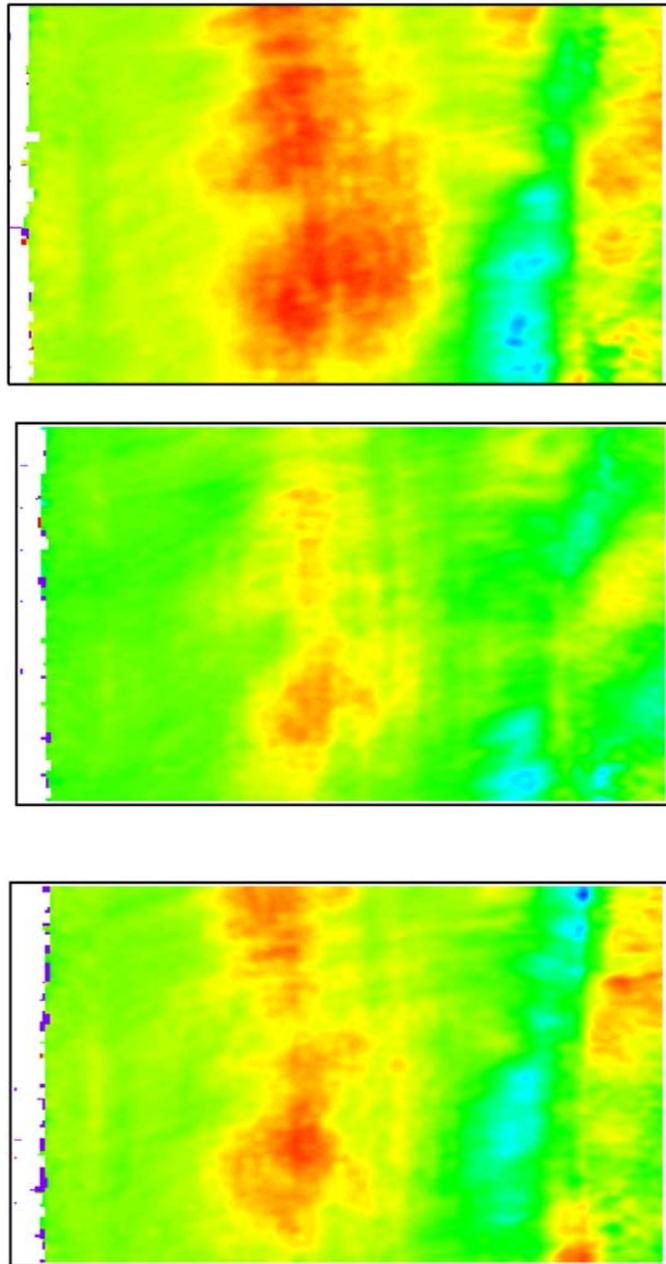
Figure 15. False-color reflectance-ratio images of NAVDEP chromate conversion aluminum surfaces contaminated with a hydrocarbon soil mixture: $40.5 \mu\text{g}/\text{cm}^2$ (top), $28.1 \mu\text{g}/\text{cm}^2$ (middle), and $14.3 \mu\text{g}/\text{cm}^2$ (bottom) average surface deposit.

In general, the North Island soil mixture forms a very non-homogeneous layer on the metal surface. This property can be clearly seen in all three images by splotchy nature of the

images. In comparing the last two images in Figure 15 an unexpected result is seen. The bottom image represents a sample with a lower average surface deposit ($14.3 \mu\text{g}/\text{cm}^2$) than the middle image ($28.1 \mu\text{g}/\text{cm}^2$), but displays a larger contaminant spot in the image. This indicates that there is a larger deposit in the area of the bottom panel that we selected for

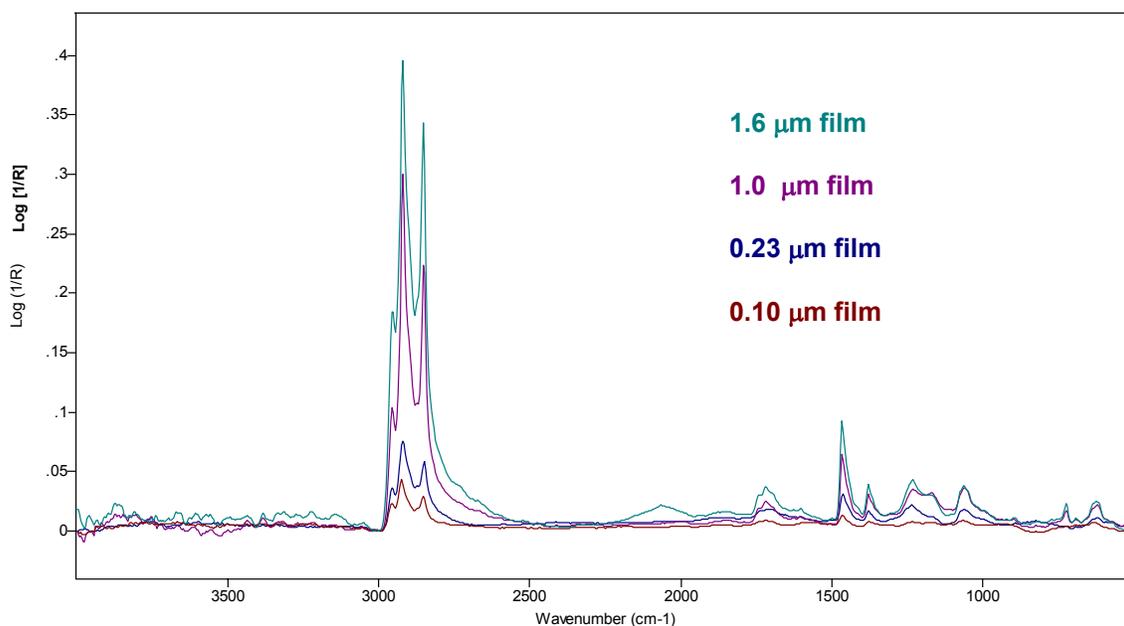
Figure 16. FTIR reflectance spectra for Cosmoline on aluminum cylinders (1-cm radius) at 75° angle of incidence and longitudinal orientation.

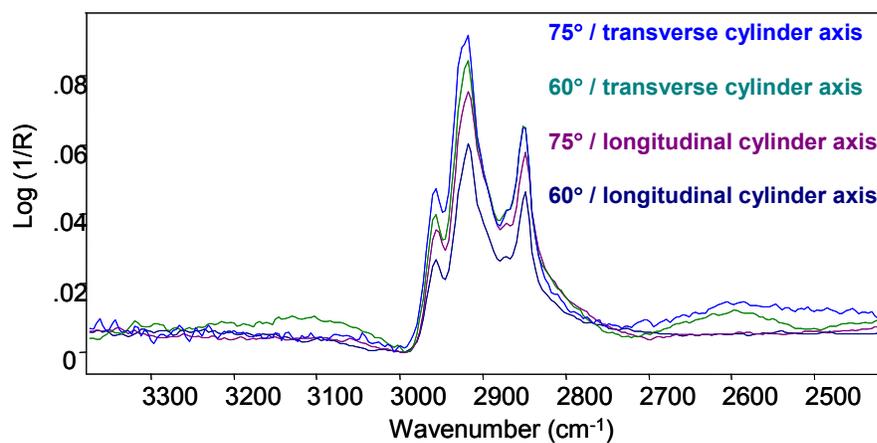
Figure 17. FTIR spectra of a 0.2 μm Cosmoline film on aluminum cylinder at 75° and 60° angle-of-incidence for transverse and longitudinal beam orientations.

The effect of orienting the samples with their cylindrical axis both longitudinally and transversely to the infrared beam is shown in Figure 17 for the 0.2- μm film sample. As expected, reflectance spectra acquired at 75° angle-of-incidence show an enhancement of absorption intensity relative to those at 60°. We observe, however, that the absorption intensities are also greater for the transverse sample orientations at both angles of incidence. This trend is the opposite behavior observed for flat test coupons above (due to the effect of increased scattering from directional polishing marks on the flat panels). Orientation effects for measurements on non-flat surfaces are due primarily to a critical dependence on sample alignment with the optical interface collection optics. The observed behavior in these measurements probably represents the relative difficulty in collecting longitudinally reflected light from the highly curved surfaces.

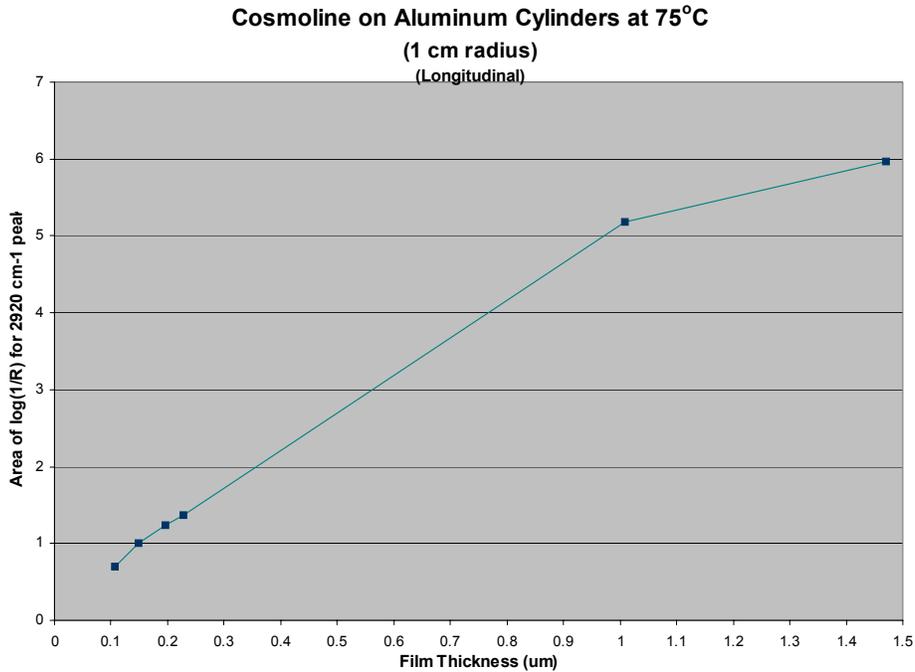
Figure 18. Integrated peak area for Cosmoline on aluminum cylinder at a 75° angle of incidence as a function of film thickness.

Peak integration yielded a reasonably linear response of the measured reflectance intensities with film thickness for these samples, as seen in Figure 18. These excellent results are due, in part, to the smoothness of the aluminum cylinder surfaces (> 600 grit). An increase in the surface roughness would be expected to result in degradation of spectral quality.

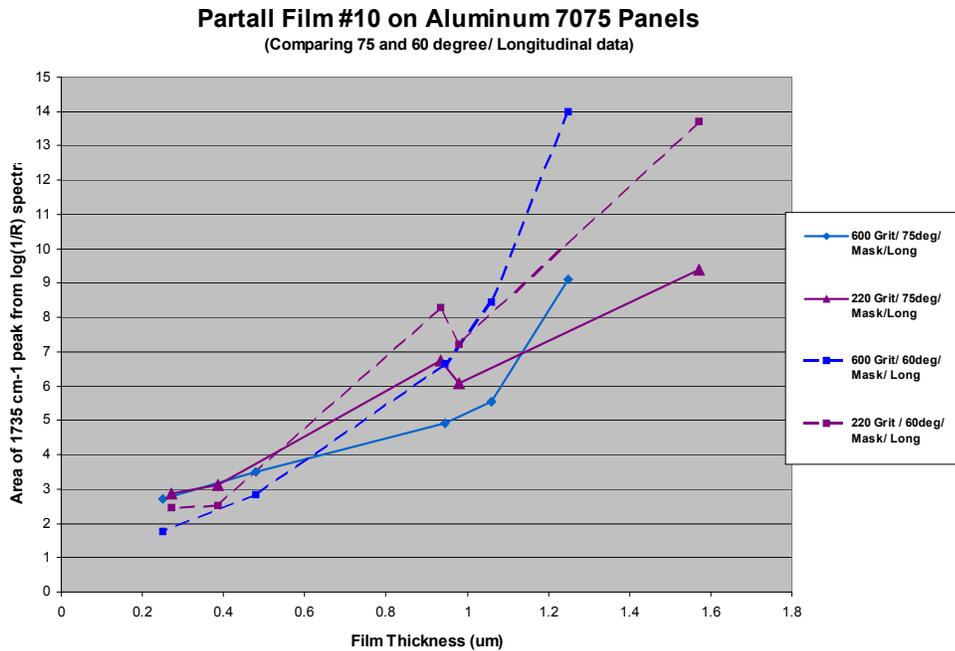
Figure 19. Integrated peak areas of the 1735 cm⁻¹ band in the FTIR reflectance spectra of aluminum panels contaminated with Partall Film #10 as a function of angle-of-incidence.

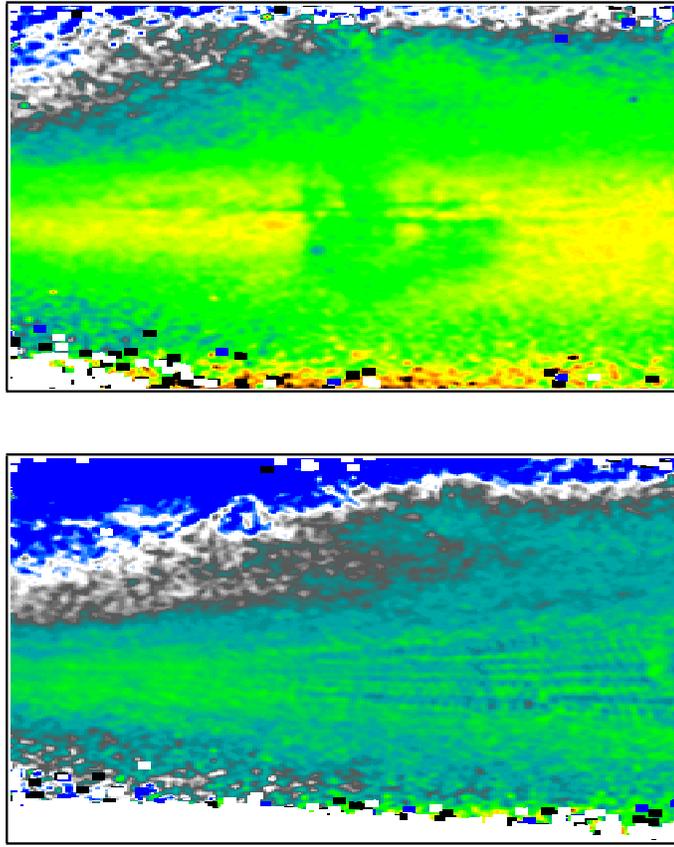
Figure 20. False-color laser-image ratios for Cosmoline contaminated cylindrical surfaces: $89.3 \mu\text{g} / \text{cm}^2$ (top) and $20.4 \mu\text{g} / \text{cm}^2$ (bottom) average surface deposit.

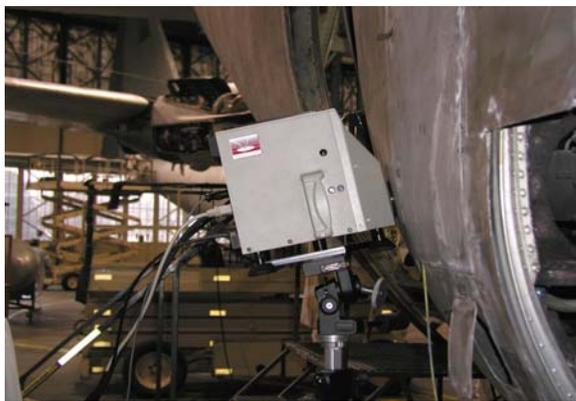
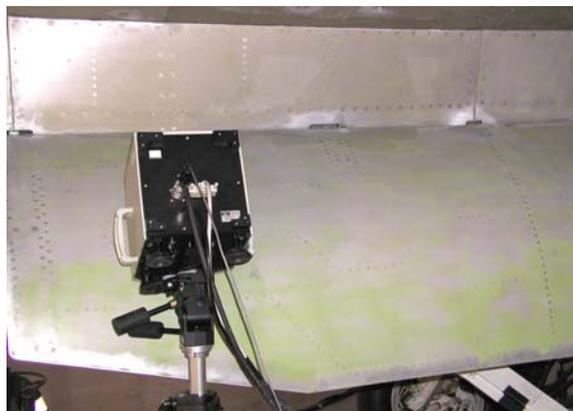
Figure 21. Portable FTIR analyzing (A) C130 bare aluminum belly and (B) an area containing yellow epoxy primer on an F-16.

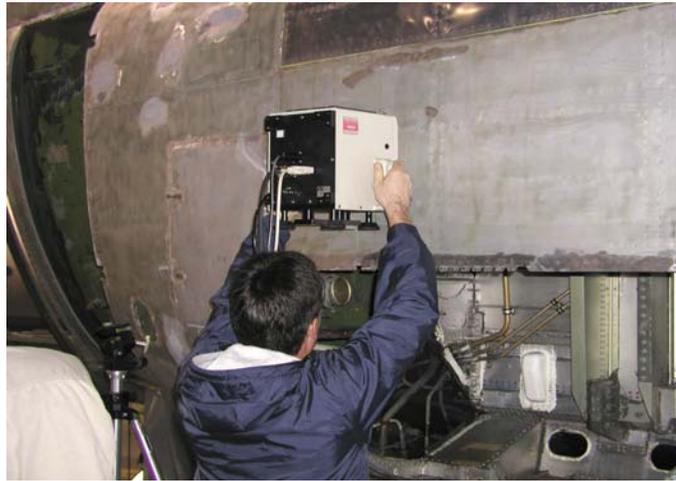
Figure 22. FTIR operator at the C130 demonstrating handheld FTIR operation.

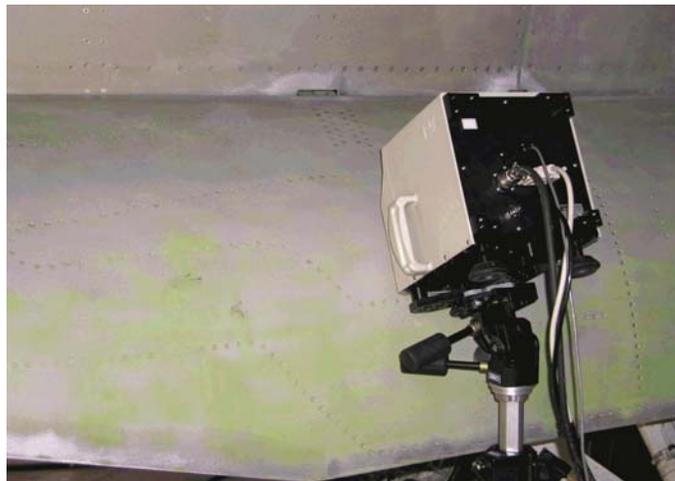
Figure 23. FTIR operating on a camera tripod to analyze the F-16.

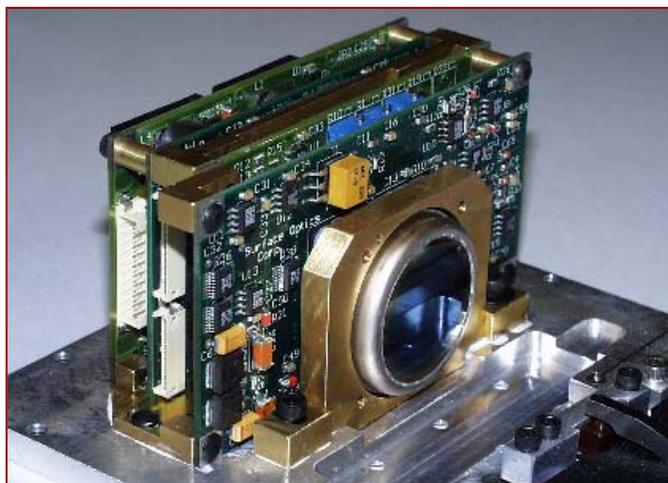
Figure 24. The new thermoelectrically-cooled silicon microbolometer array with attendant electronics.

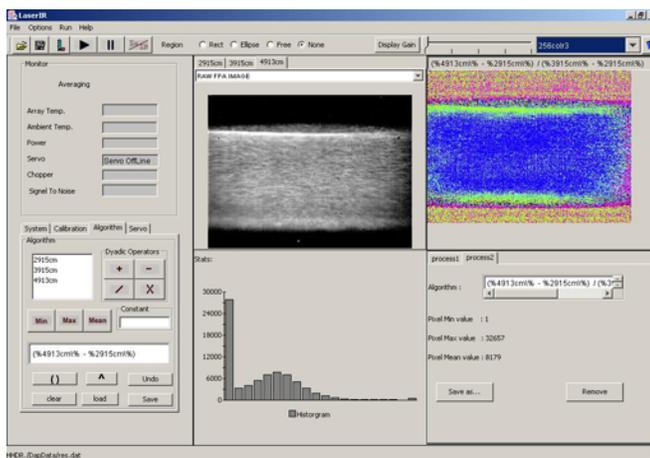
Figure 25. A screen capture of the control and data analysis software developed in conjunction with the microbolometer array.
