***FISC Puget Sound
Manchester Fuel Department***

**Maintenance,
Leak Detection in Large
Underground Storage
Tanks**

Glenn E. Schmitt, P.E.
Environmental Director
Fleet and Industrial Supply Center
Puget Sound

| 13. SUPPLEMENTARY NOTES Presented at the NDIA Environment, Energy Security & Sustainability (E2S2) Symposium & Exhibition held 4-7 May 2009 in Denver, CO. | | | | | |

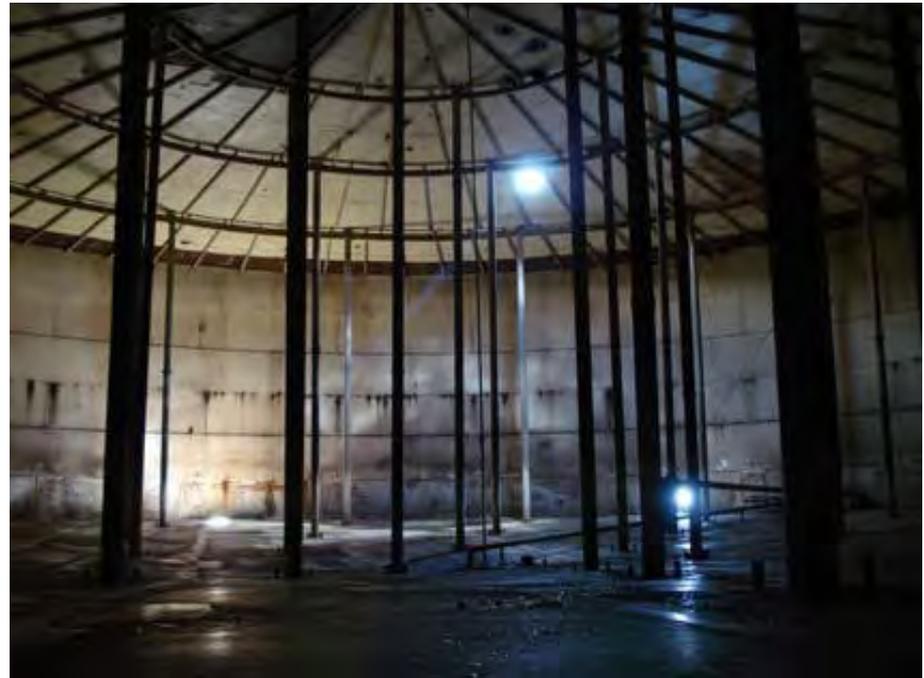
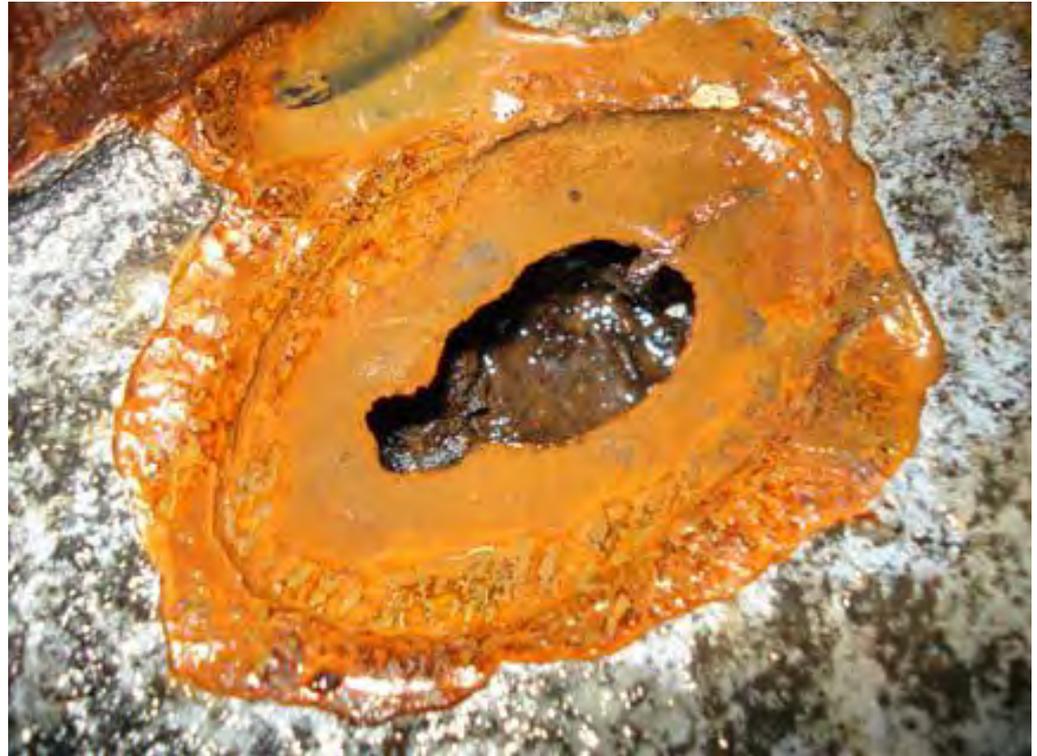
◆ April 26, 2007 FISC Pearl Harbor Reports a loss of 366,000 gallons from tank 1403 (AST) (later revised to 359,000 gallons)

- ◆ Results – a 1 inch by 3 inch hole in sump
- ◆ Operator Error detecting loss

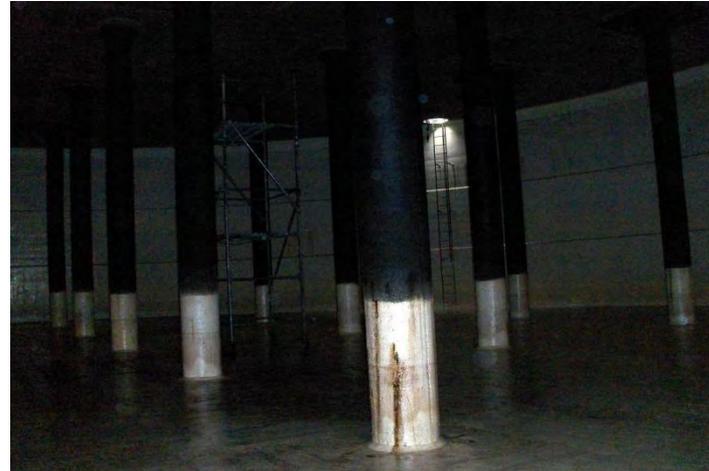
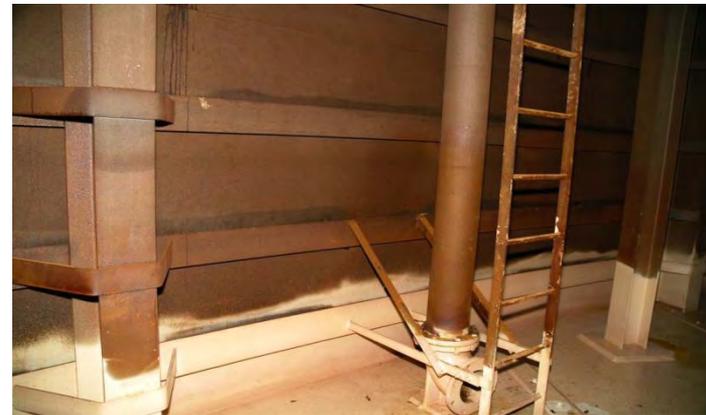
Types of USTs

- ◆ **Concrete**
 - ◆ *Cut and covered*
 - ◆ *Underground Construction*

- ◆ **Steel**
 - ◆ *Cut and covered*
 - ◆ *Riveted Tanks*
 - ◆ *Welded tanks*

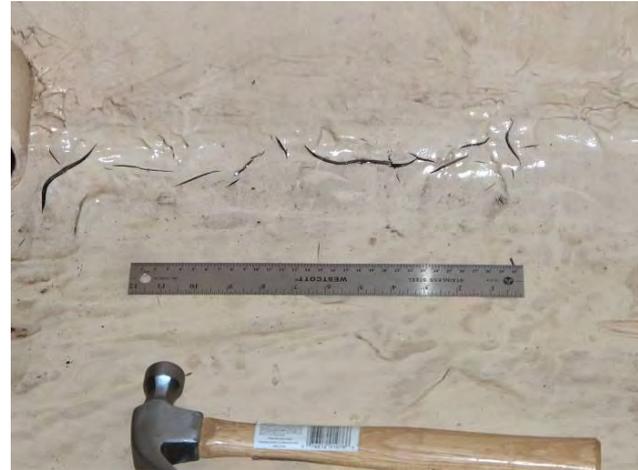
◆ Failure at the Tank wall joint (cove Failure

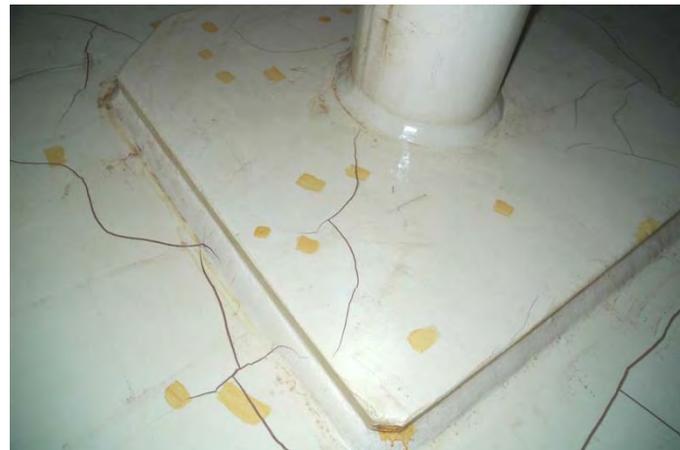
◆ Failure of floor coating

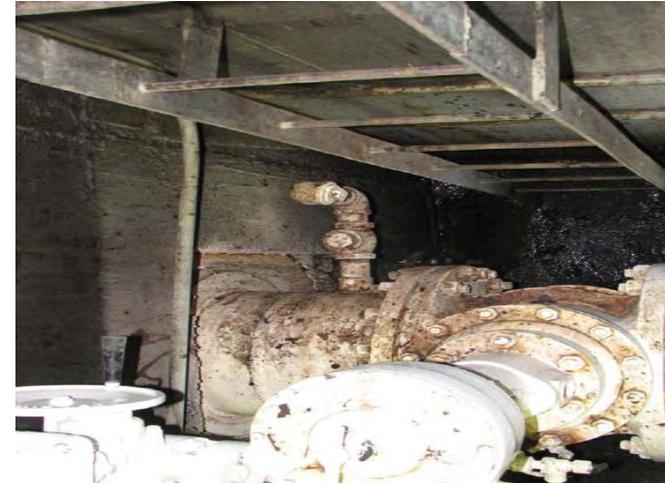
◆ **Leaking Skin
Valves/Pipe nipples**

◆ **Leaking older
Tank Penetrations**
