**REPAIR, EVALUATION, MAINTENANCE, AND  
REHABILITATION RESEARCH PROGRAM**

TECHNICAL REPORT REMR-CS-11

**IN SITU REPAIR OF DETERIORATED  
CONCRETE IN HYDRAULIC STRUCTURES  
LABORATORY STUDY**

Final Report

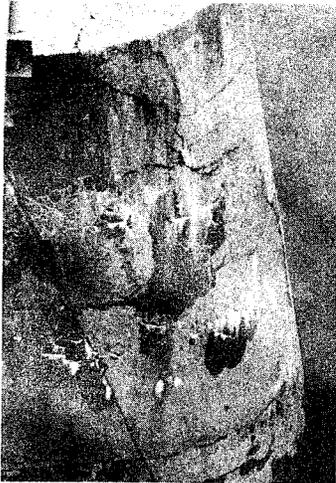
TOP — Repair of slab by injection using a plastic syringe

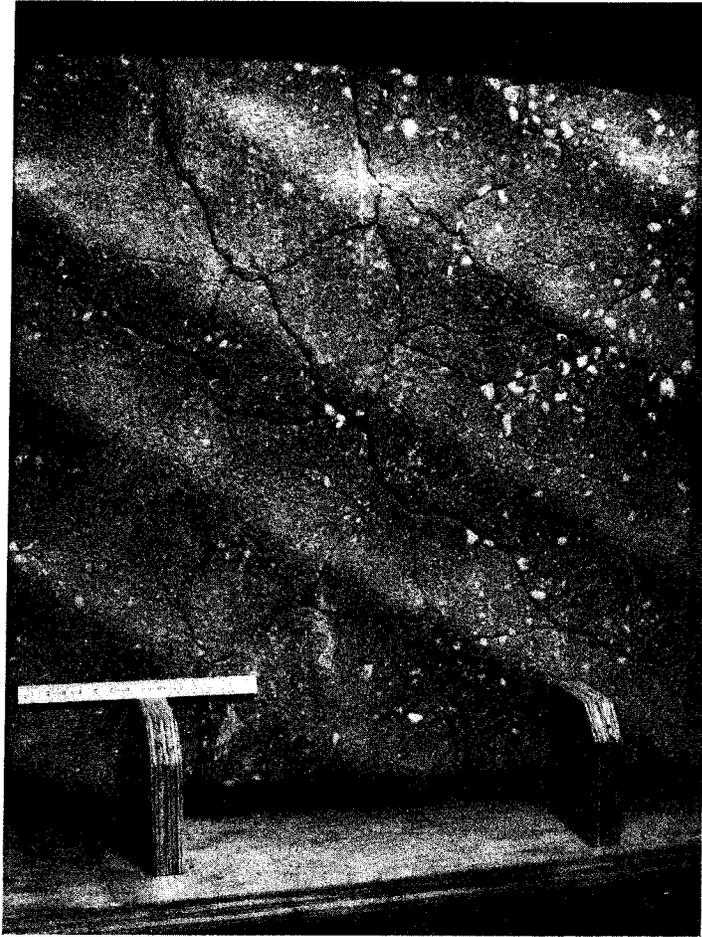
Figure 1. Typical "cracked" concrete slab.

10. The "cracked" slabs were fabricated by casting them individually into sheet metal forms. After the mixture had taken its initial set (3 to 4 hr after being fabricated), the corners of the forms were opened, and the slabs were flexed by hand until cracks began to open up in the surface. Cracks varying in width from hairline to 1/4 in. could be created this way (Figure 1). All slabs were sandblasted prior to being repaired.

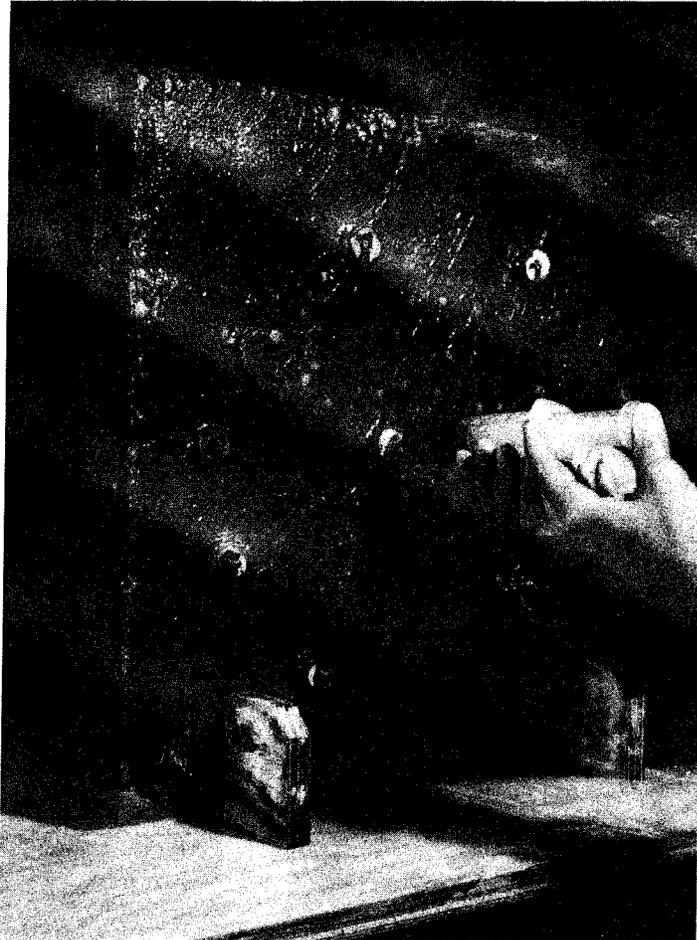
Figure 2. Repair of slab by injection using a plastic syringe.

25. The water-saturated slabs were soaked in water for a minimum of three days between steps 2 and 3. They were then patted dry to a SSD condition before the injection ports (1-in. diam wooden dowel into which a hole had been drilled) were glued to the surface. Because of the small quantities of materials used to repair the slabs, all the injection work was done by hand using plastic syringes (Figure 2).

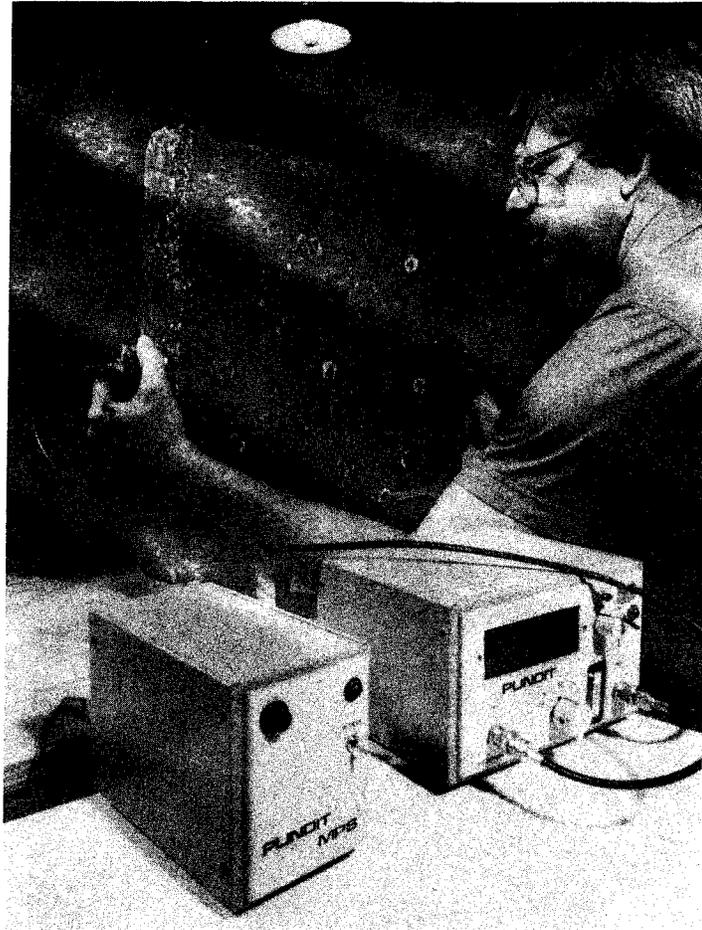
Figure 3. Ultrasonic pulse velocity test.

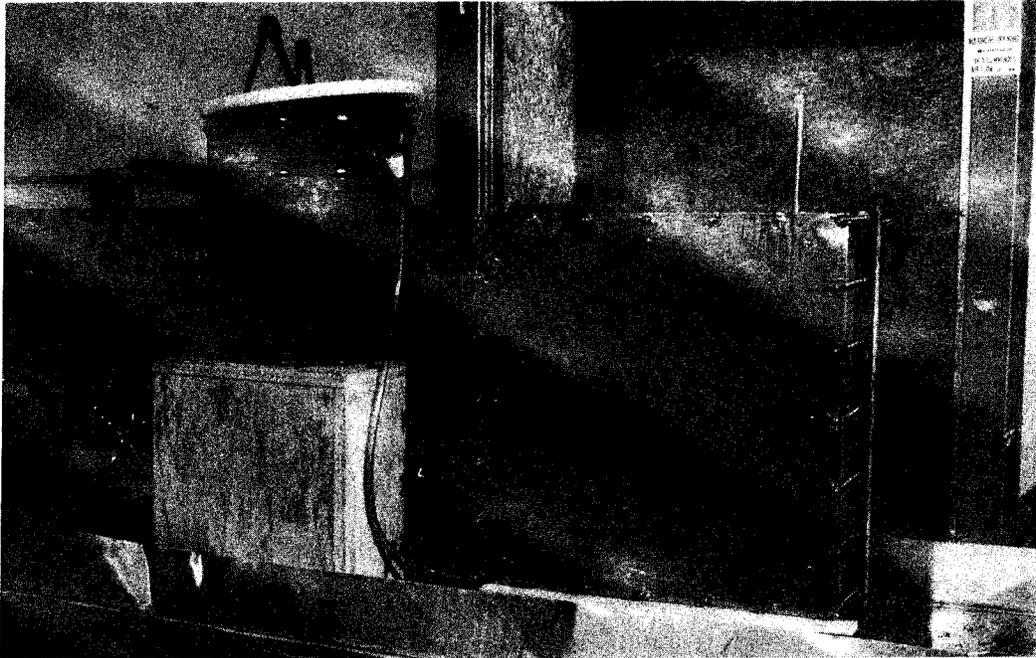
A. Laboratory set-up for vertical impregnation studies.

37. All vertical impregnations were done using a soaking jacket which was braced against the face of the slab (Figure 6). The soaking jacket was made of 0.05 in. thick stainless steel sheet with a 0.5 in. thick stainless steel spacer around the edge of the jacket. A closed-cell polyurethane was used as a gasket material to seal the soaking jacket to the face of the slab. The sides and back of all slabs were coated with a gel epoxy to prevent leakage of monomer during soaking.

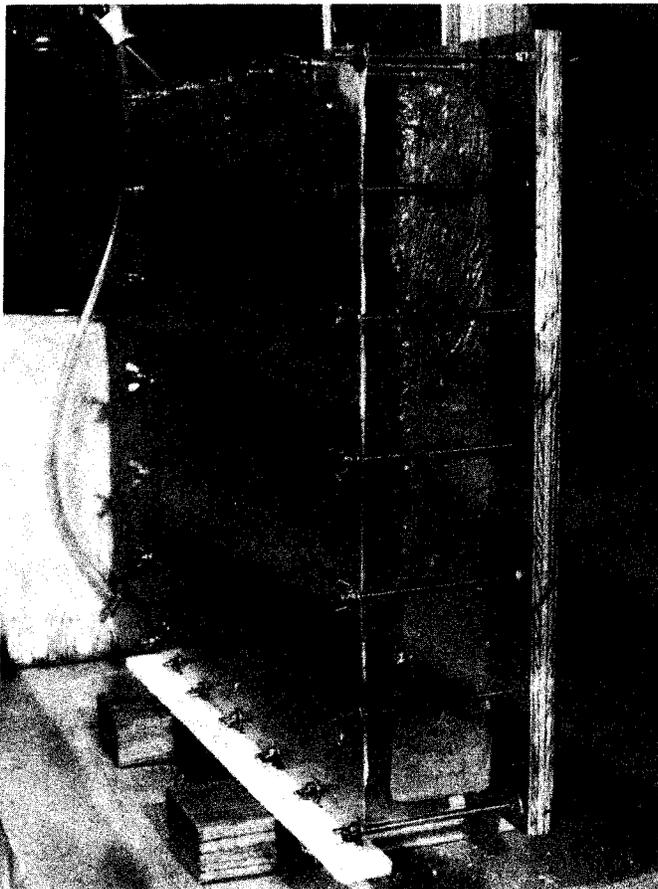
B. Close-up of slab  
inside impregnation  
soaking jacket.
