NATIONAL ADVISORY COMMITTEE FOR AERONAUTICS

WARTIME REPORT

By William N. Turner and Betty Adams

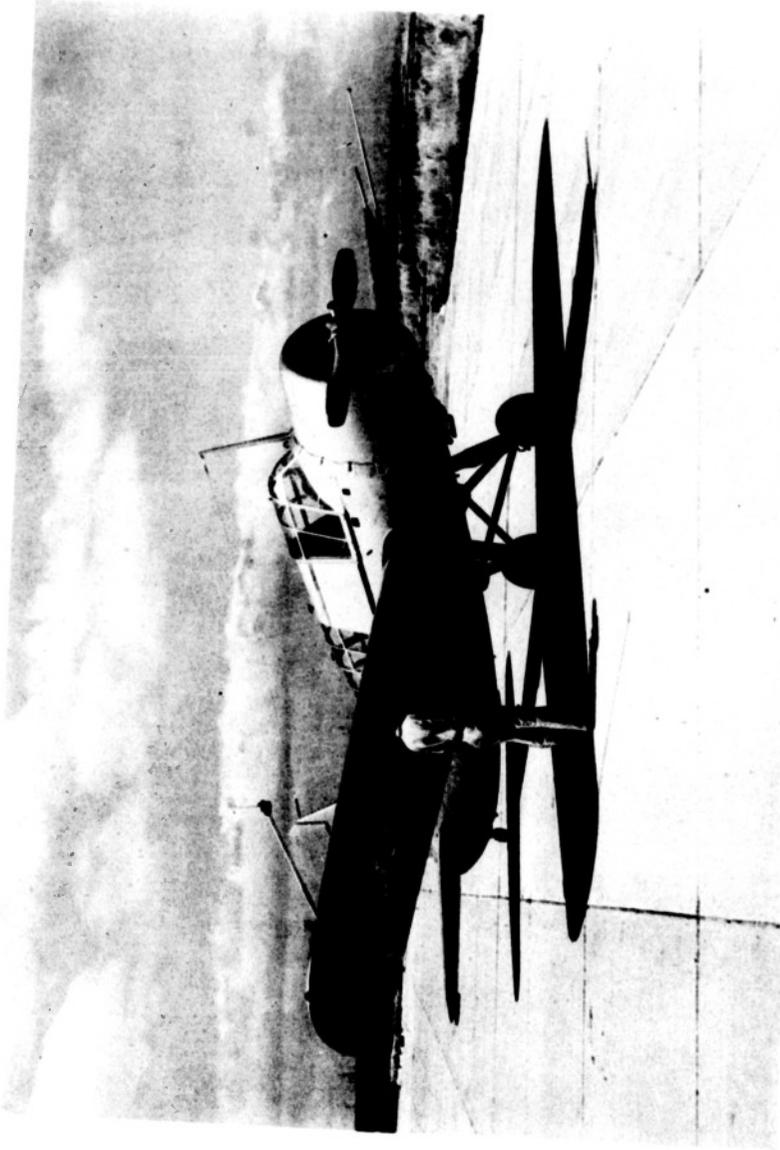
Figure 1.- Three-quarter front view of the test airplane as instrumented for flight tests.

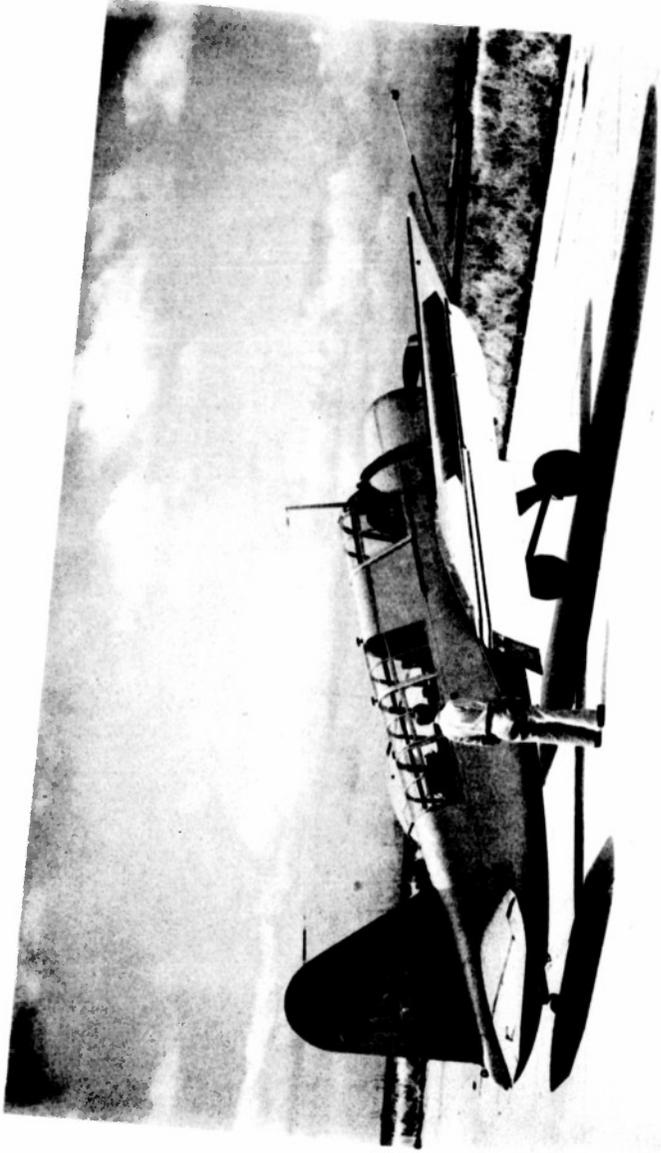
Figure 2.- Three-quarter rear view of the test airplane as instrumented for flight tests, showing deflected flap, drooped aileron, deflected spoiler, and open slot.

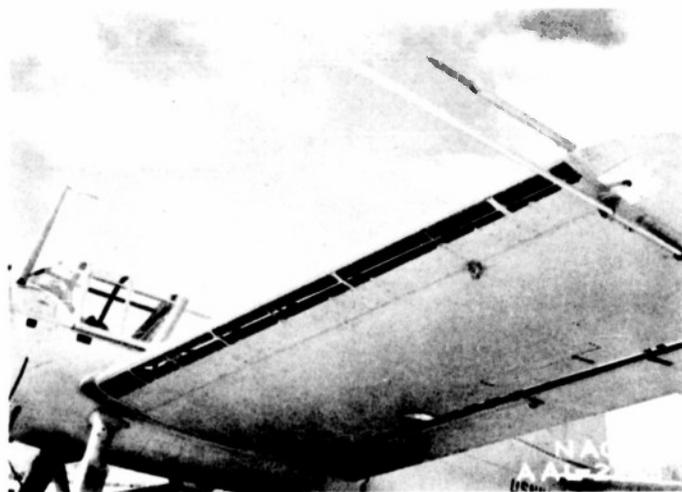
Figure 3.- Detail of Maxwell slot installation, slots open.
Spoiler paddle balance is also visible flush with wing
ahead of aileron.

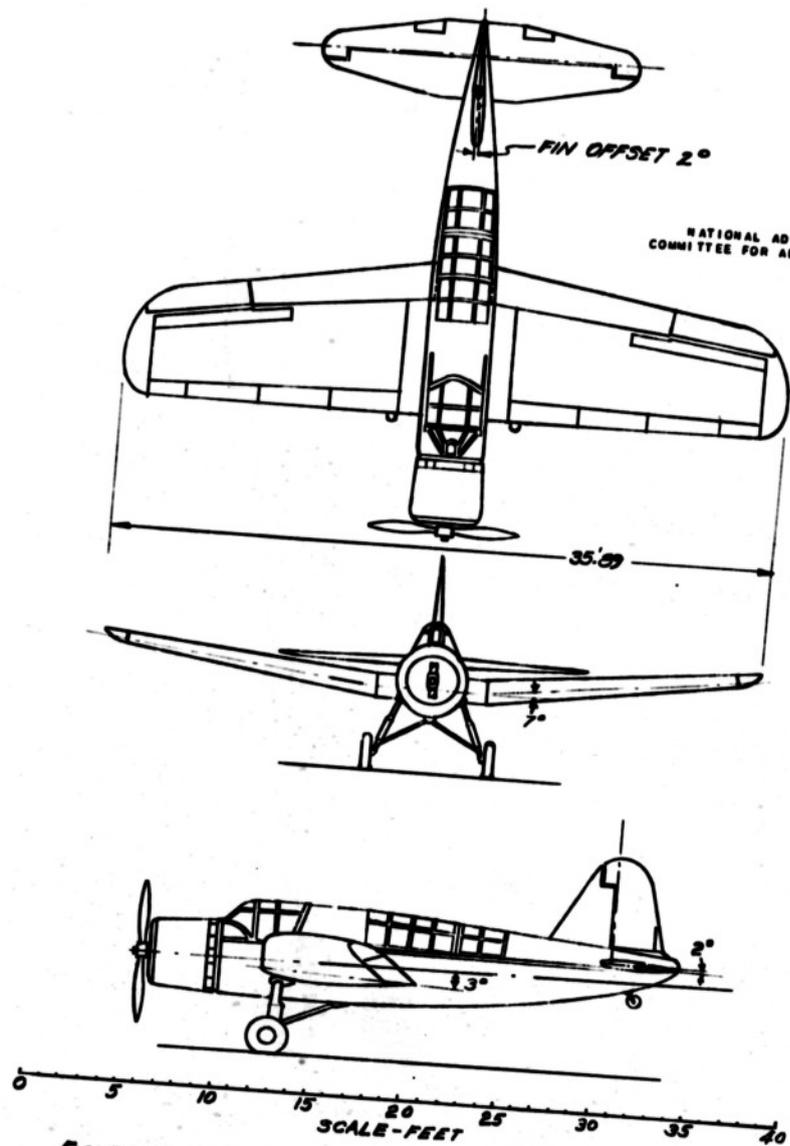
FIGURE 4.-THREE-VIEW DRAWING OF TEST AIRPLANE.

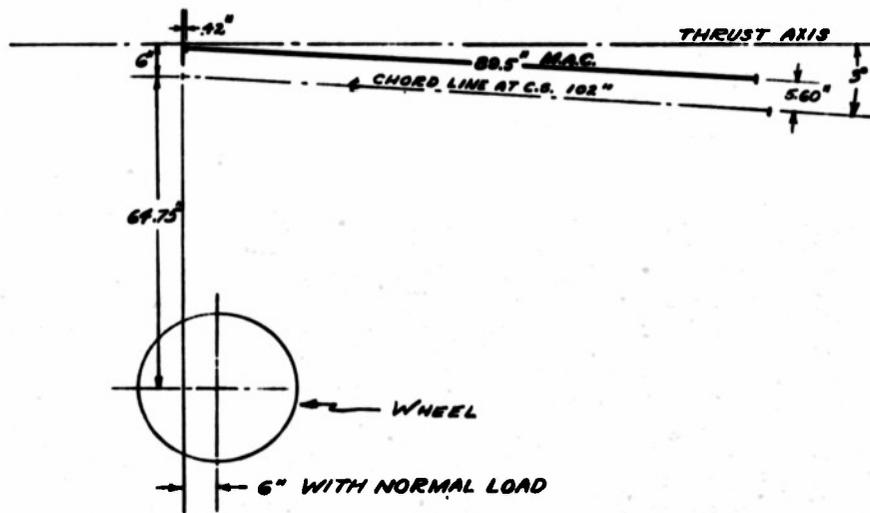
Figure 5.- Sketch showing location of mean aerodynamic chord on test airplane.

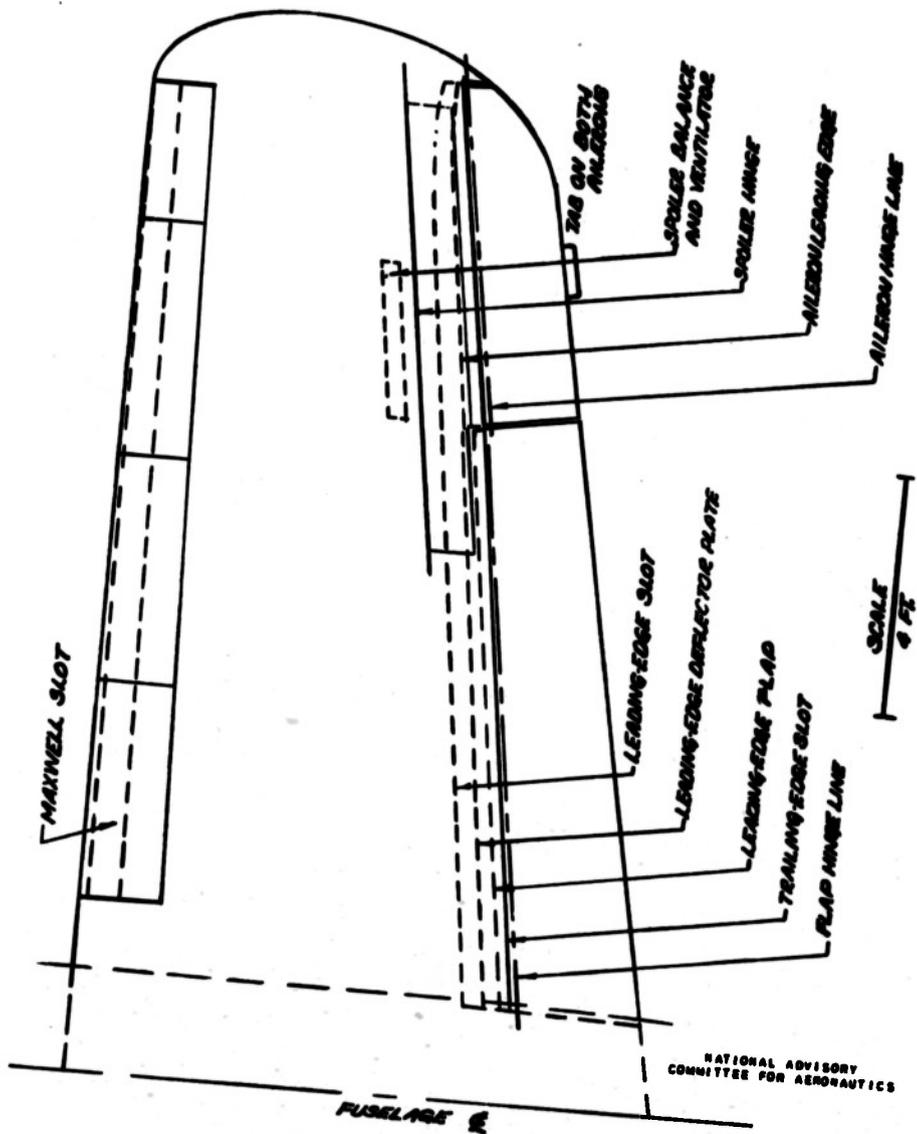
Figure 6.- Plan view showing high-lift and lateral-control devices of test airplane.

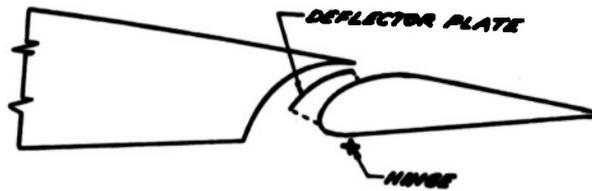
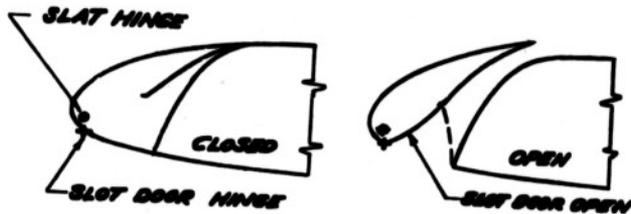
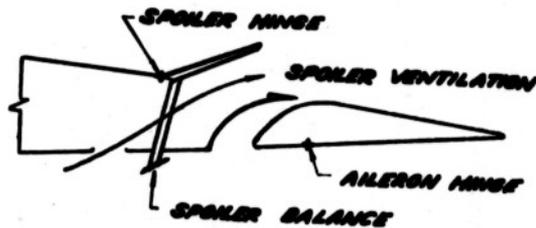
TYPICAL FLAP SECTION

TYPICAL SLOT SECTION

TYPICAL AILERON SECTION SHOWING PARTIALLY DEFLECTED SPOILER

Figure 7.- Typical sections of high-lift and lateral-control devices of test airplanes.

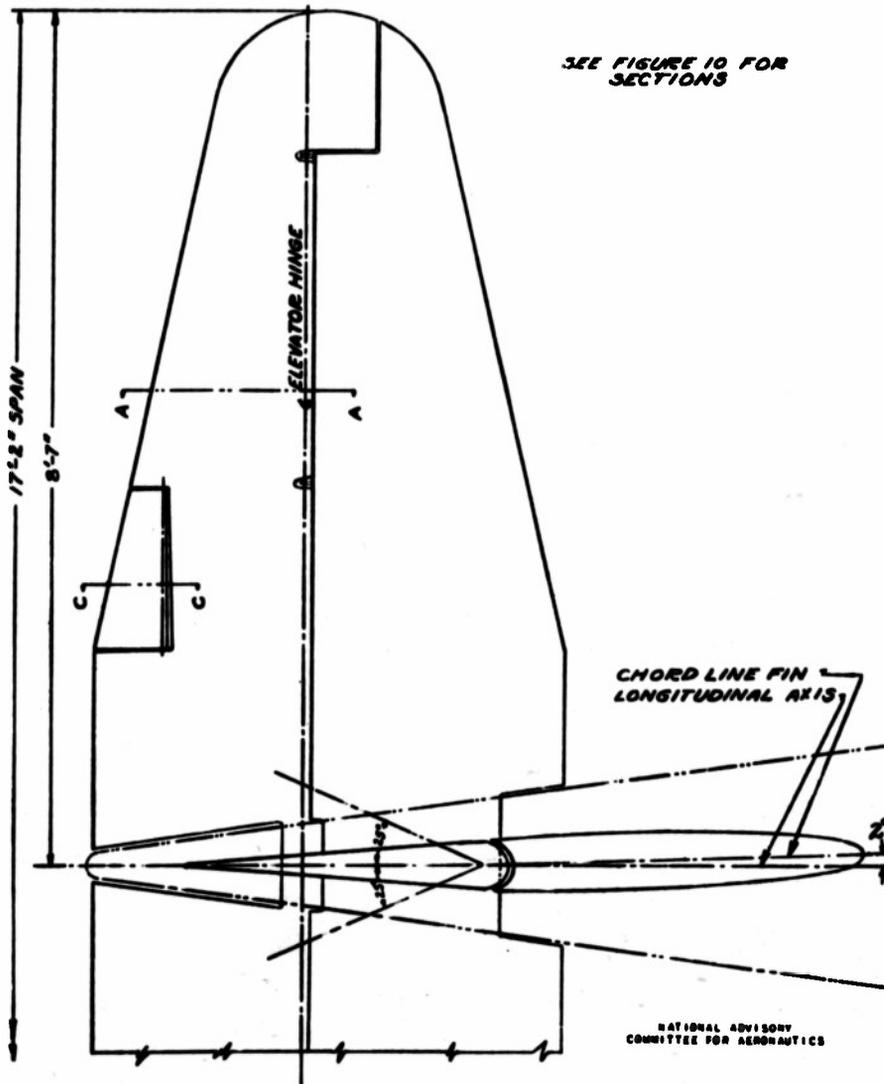
Figure 8.- Plan view of the horizontal tail on the test airplane.

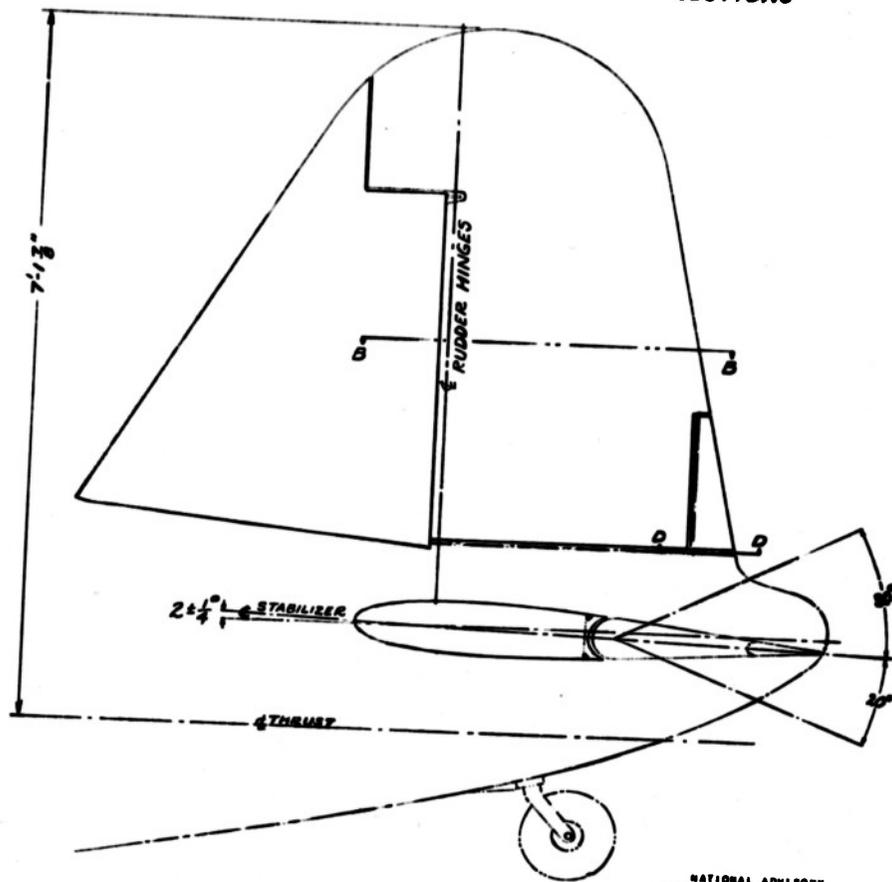
Figure 9.- Side view of the vertical tail of the test airplane.

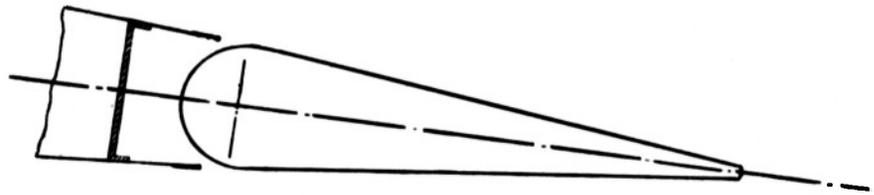
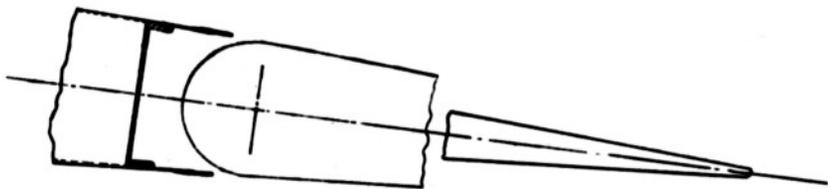
Figure 10.- Section views of empennage control surfaces
and tabs on test airplane.

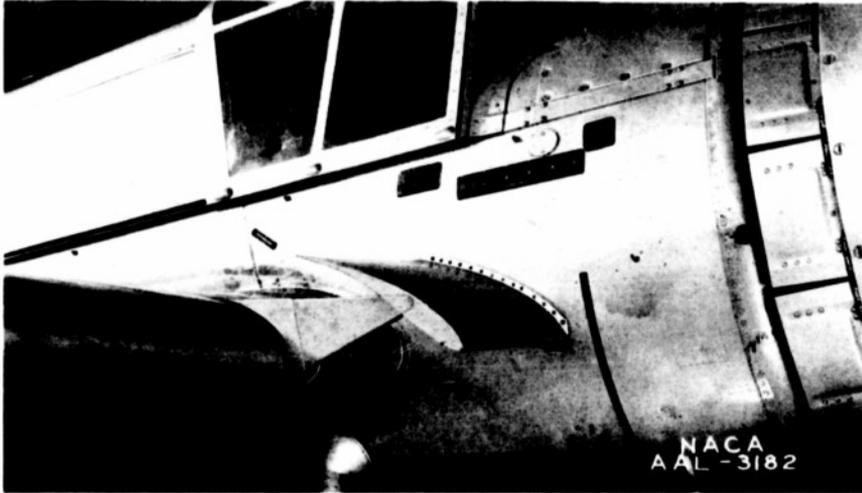
Figure 11.- Auxiliary slat installed on test airplane.

Maximum lift with modification 1 (auxiliary slats).-As shown in table II, the addition of the auxiliary slats delayed the center-section breakdown sufficiently to cause increases of up to 0.37 in the maximum lift coefficient. The detrimental effect of opening the slats was also eliminated, although no consistent increase in lift coefficient due to opening the slats was measured. As in the original condition, in the landing conformation (flaps down, hoods open), the lowest stalling speed was attained with the cowl flaps open.

It was found that installation of the auxiliary slats reduced the top speed of the airplane 7 miles per hour.

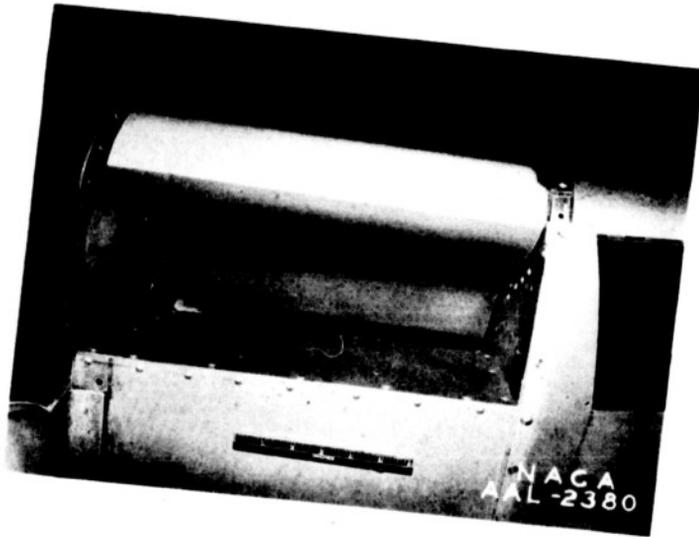
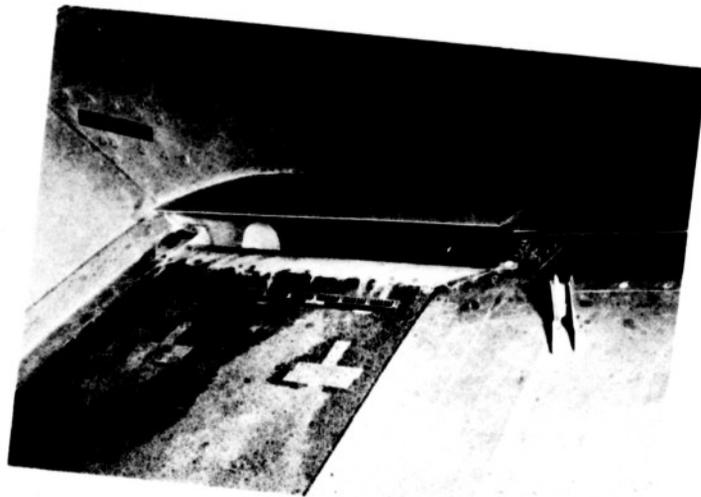
Figure 12.- Lower front and upper rear views through Maxwell slot extension.

Maximum lift with modification 2 (Maxwell slot extensions).-Extending the Maxwell slots to the fuselage offered a small increase in maximum lift with the slot-open over the slot-closed condition (table III). The lowest stalling speed with the hoods open was obtained when the cowl flaps were open. The Maxwell slot extensions were slightly less effective than the auxiliary slats in reducing the stalling speed.

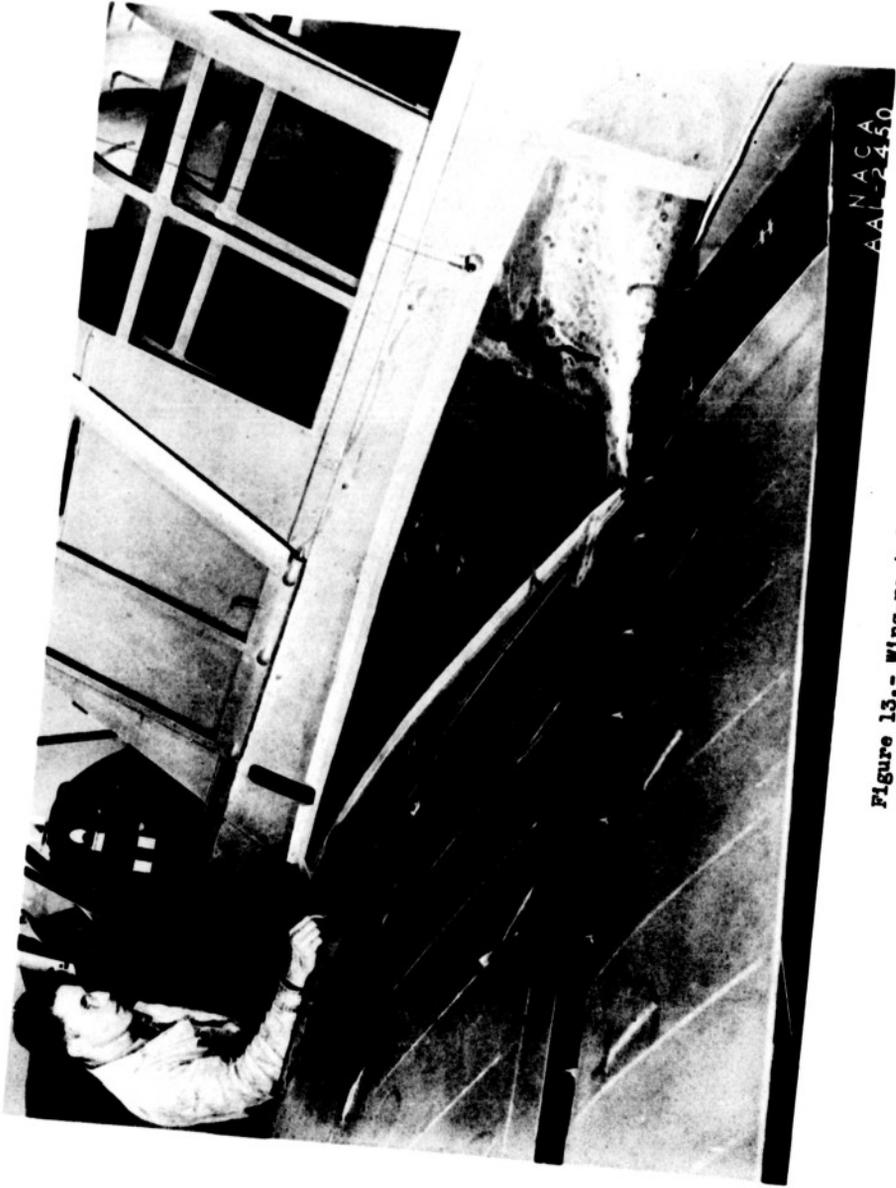
Figure 13.- Wing-root fillet.

Modification 4.- In addition to the slot extensions, expanding wing-root fillets (fig. 13) were installed. The fillets started with approximately zero radius at the slot extension lip and expanded to a radius approximately equal to the width of the wing walkway at the trailing edge of the wing proper. From there the fillet was gradually faired back into the fuselage. The uncovered part of the wing walkway was in its original rough condition.

Maximum lift with modification 4 (Maxwell slot extensions with wing-root fillets).-The combination of Maxwell slot extensions and wing-root fillets produced the best improvement in power-off maximum lift (table V). In the landing condition, the highest lift coefficient (1.97) was again obtained with the cowl flaps open. Tests made with partial cowl-flap openings in the landing condition (hoods open, flaps down) showed that it was necessary to have them at least three-quarters open to secure a beneficial effect.

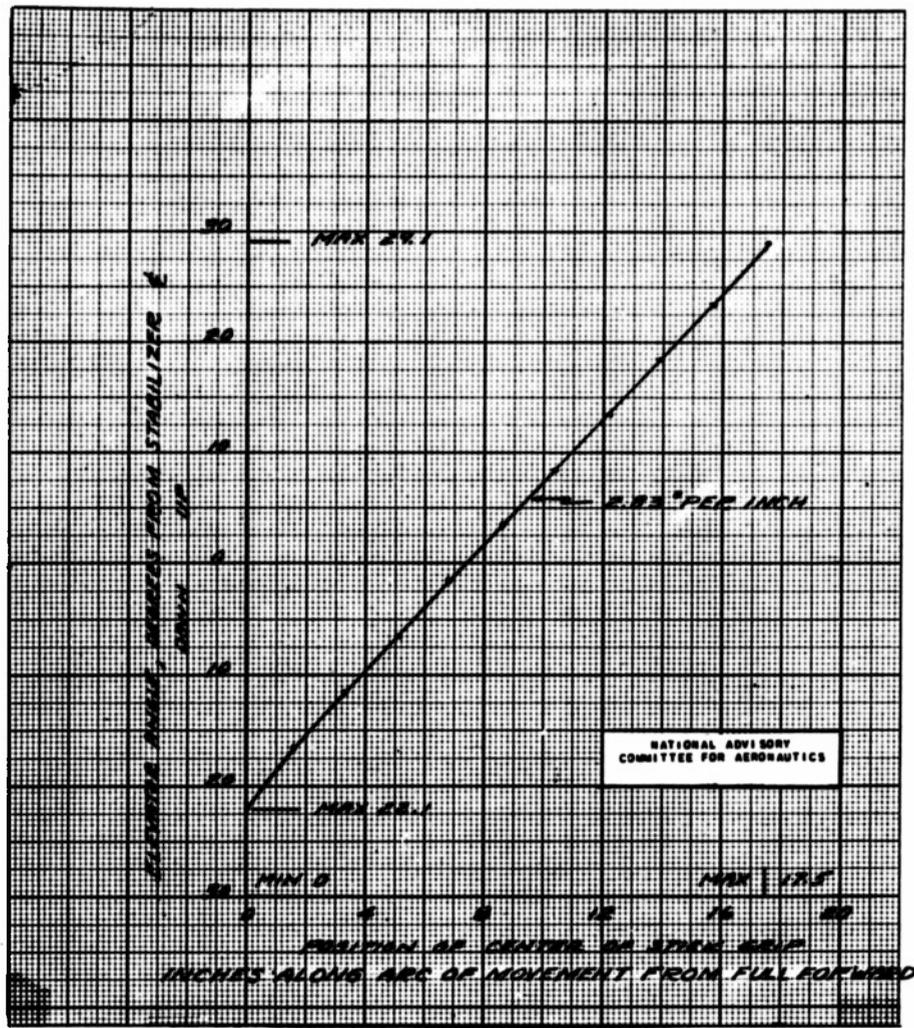
Figure 15.- Variation of elevator angle with stick position as measured on the ground with no load on the surfaces.

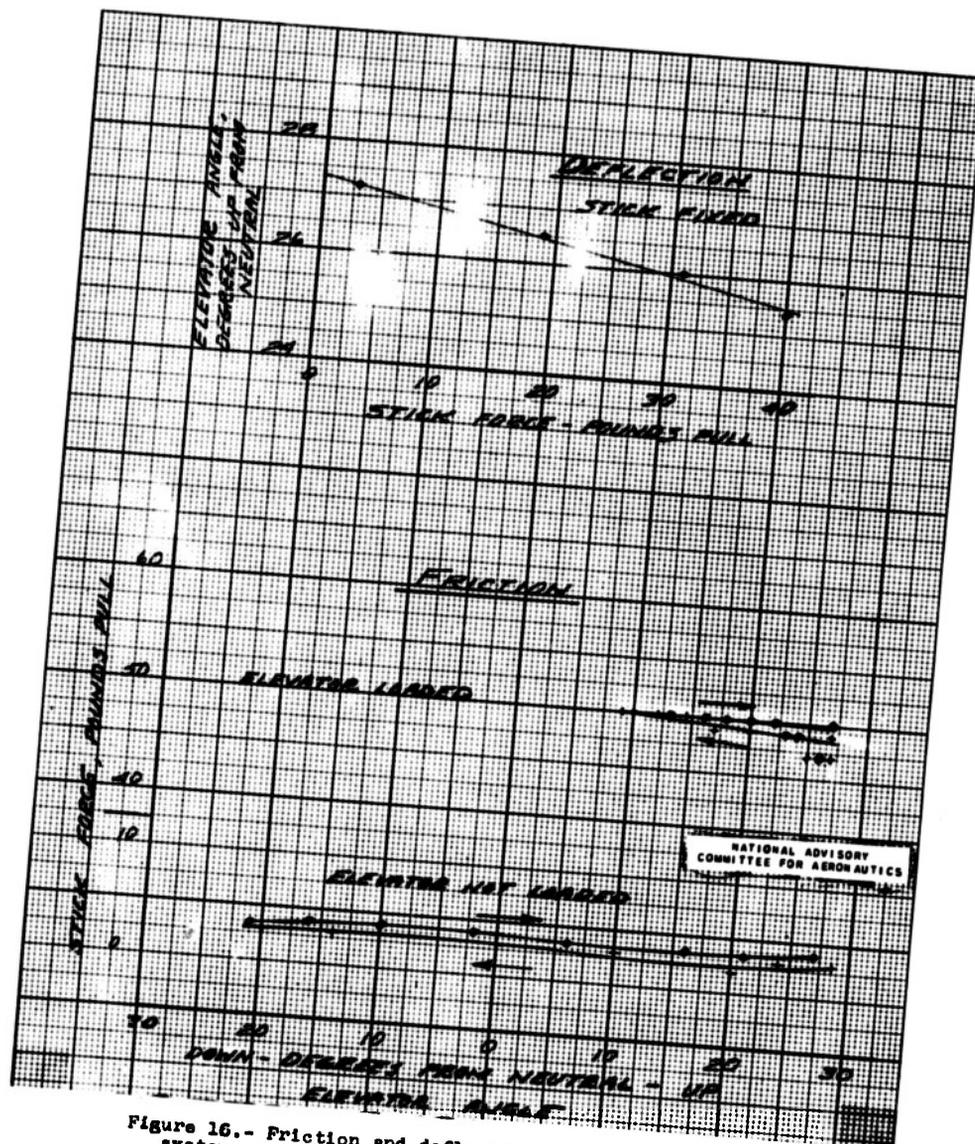
Figure 16.- Friction and deflection in the elevator control system as measured on the ground.

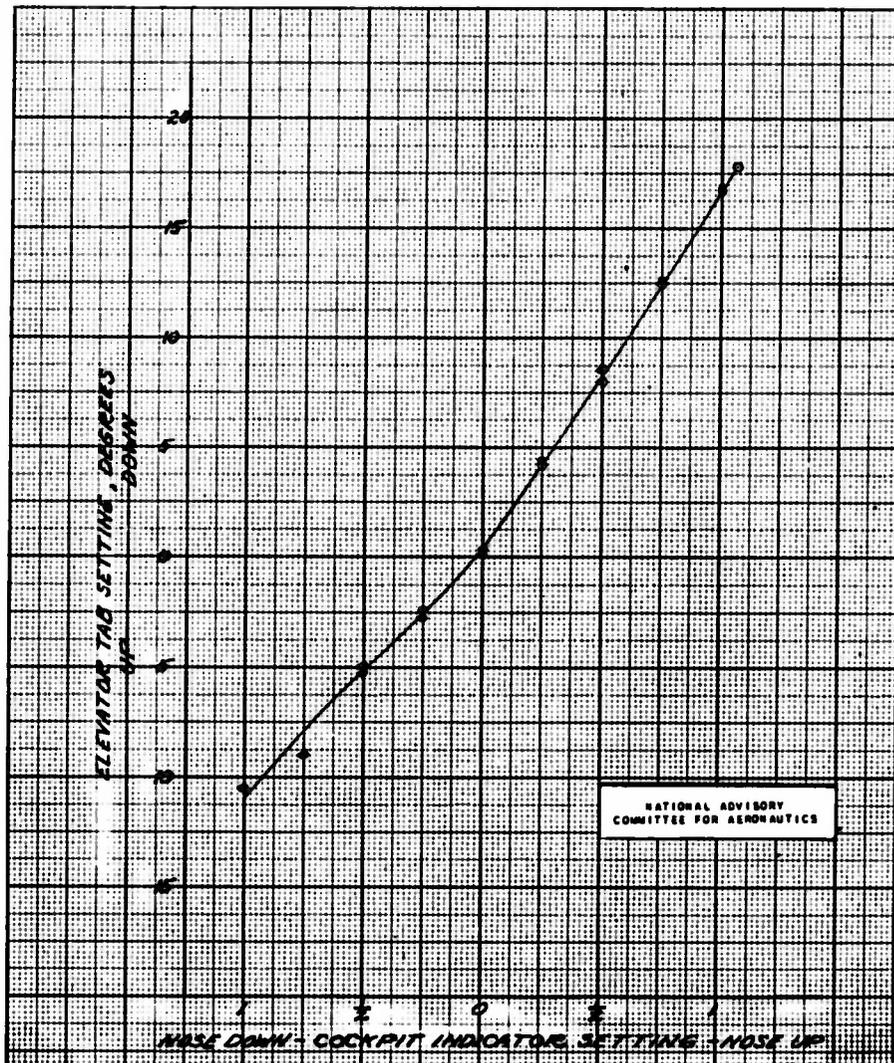
Figure 17.- Variation of elevator tab position with cockpit control setting.

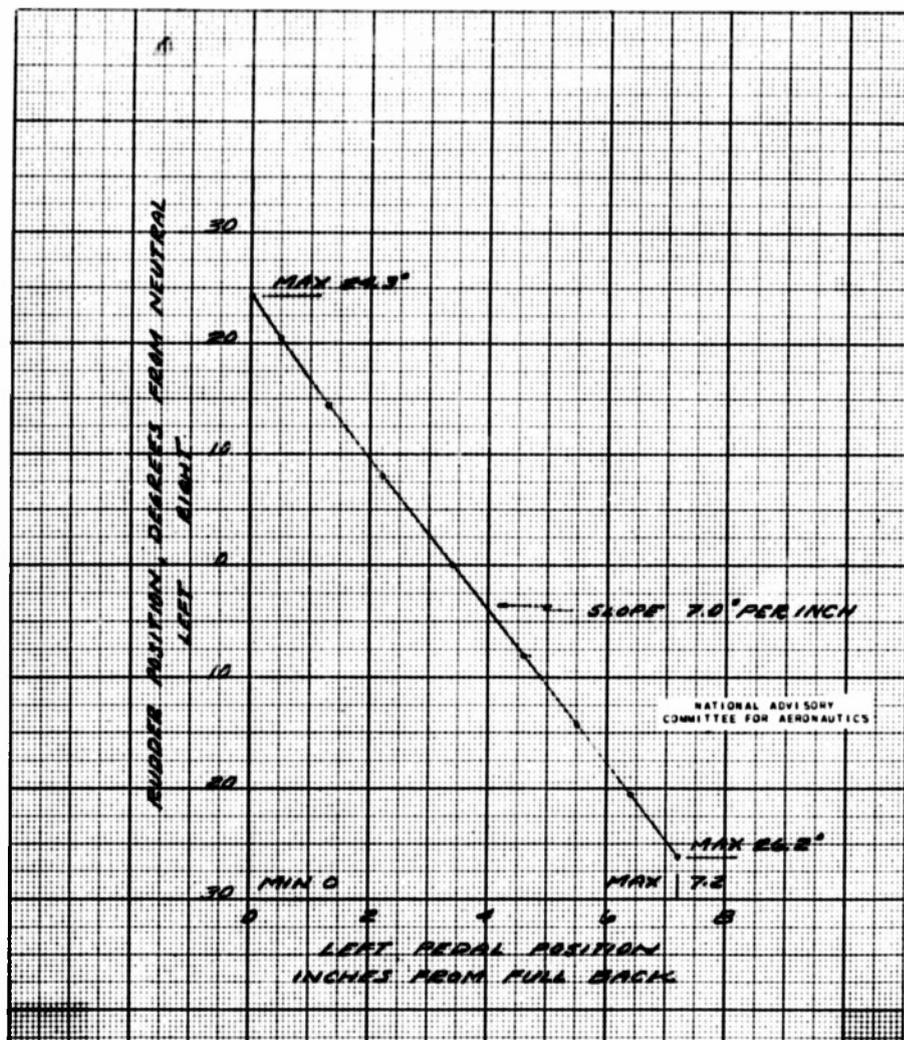
Figure 18.- Variation of rudder angle with left rudder pedal position as measured on the ground with no load on the surfaces.

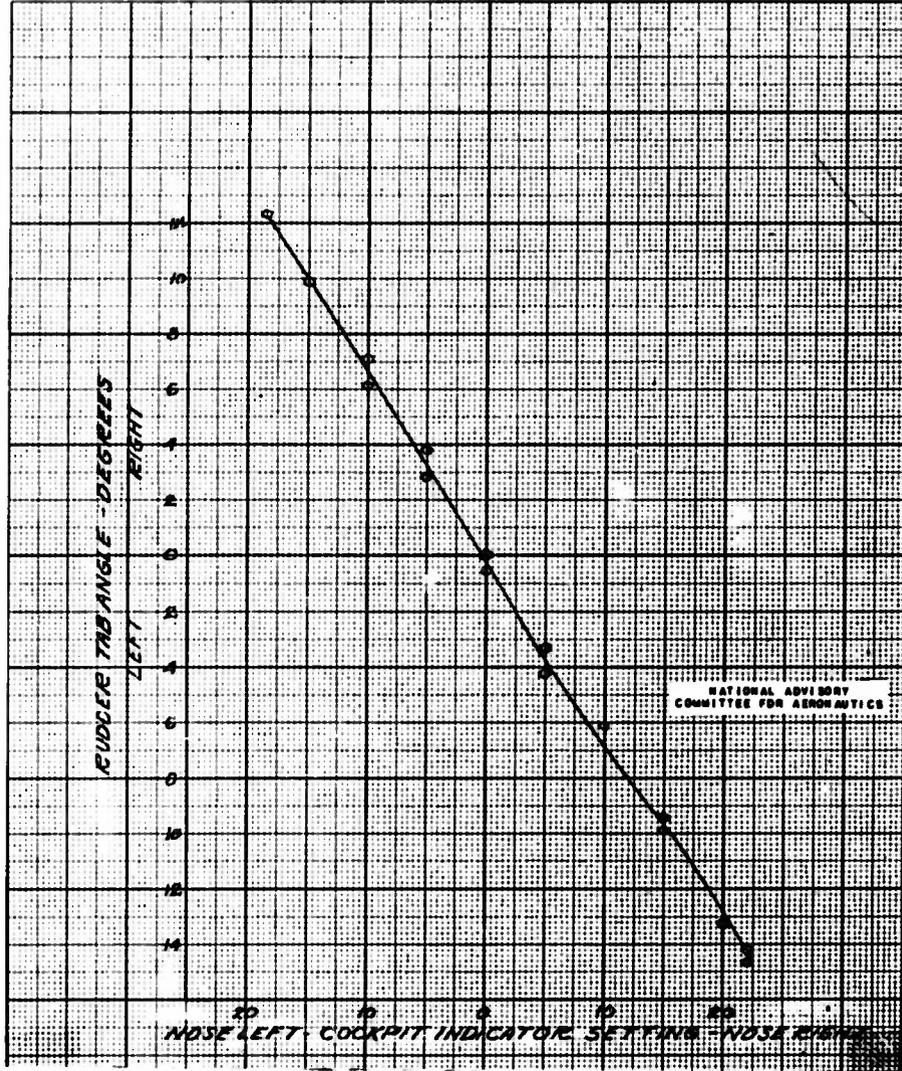
Figure 19.- Variation of rudder tab angle with cockpit control setting.

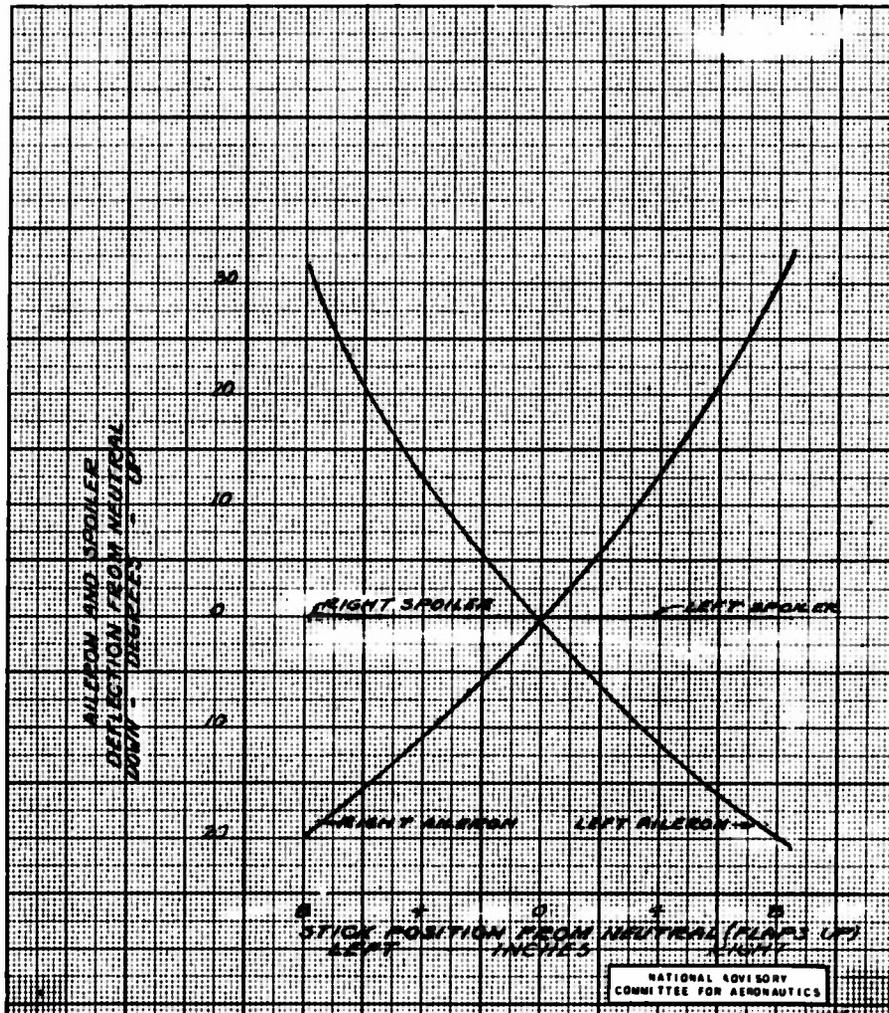
Figure 20.- Variation of aileron and spoiler angles with stick position as measured on the ground with no load on the surfaces. Test airplane with flaps up.

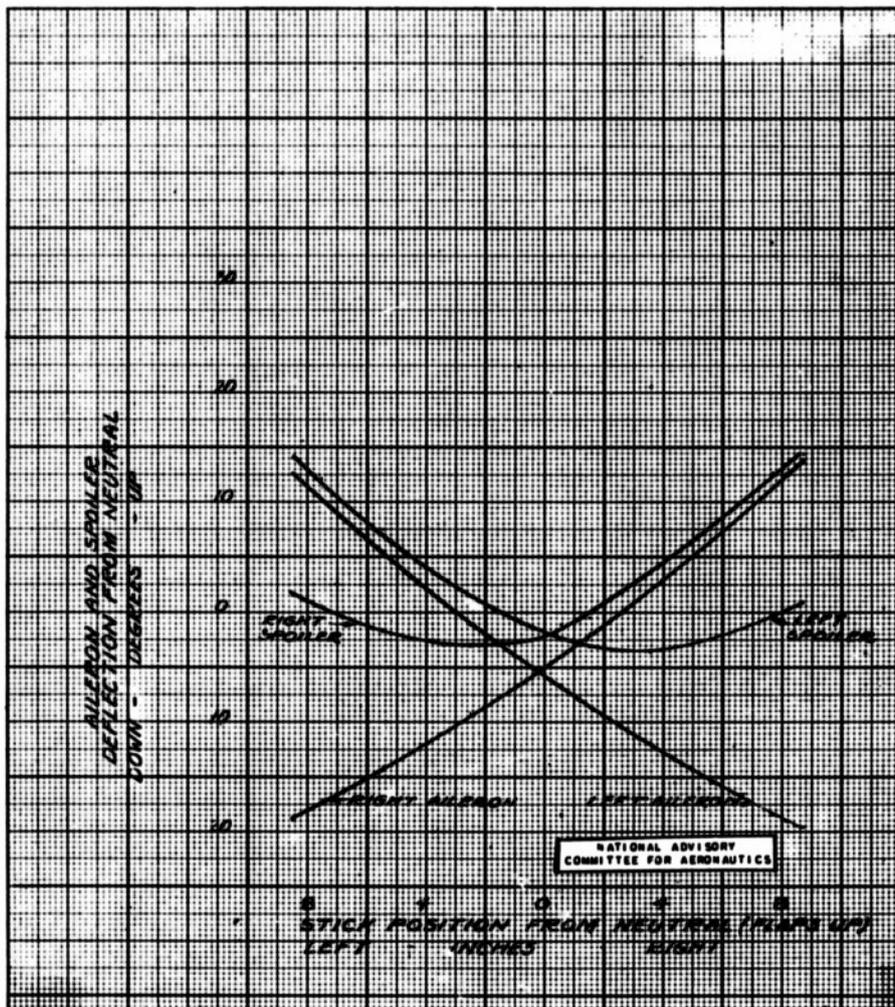
Figure 21.- Variation of aileron and spoiler angles with stick position as measured on the ground with no load on the surfaces. Test airplane with flaps 1/3 down.

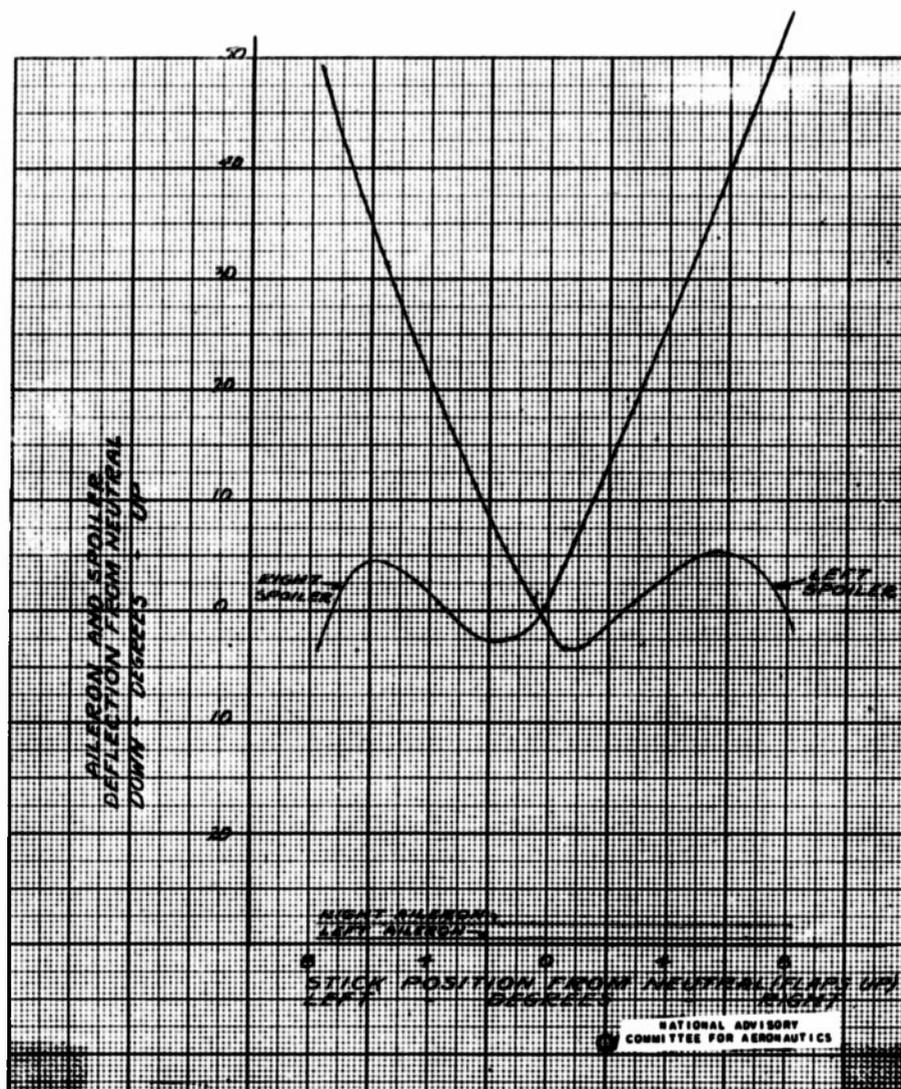
Figure 22.- Variation of aileron and spoiler angles with stick position as measured on the ground with no load on the surfaces. Test airplane with flaps full down.

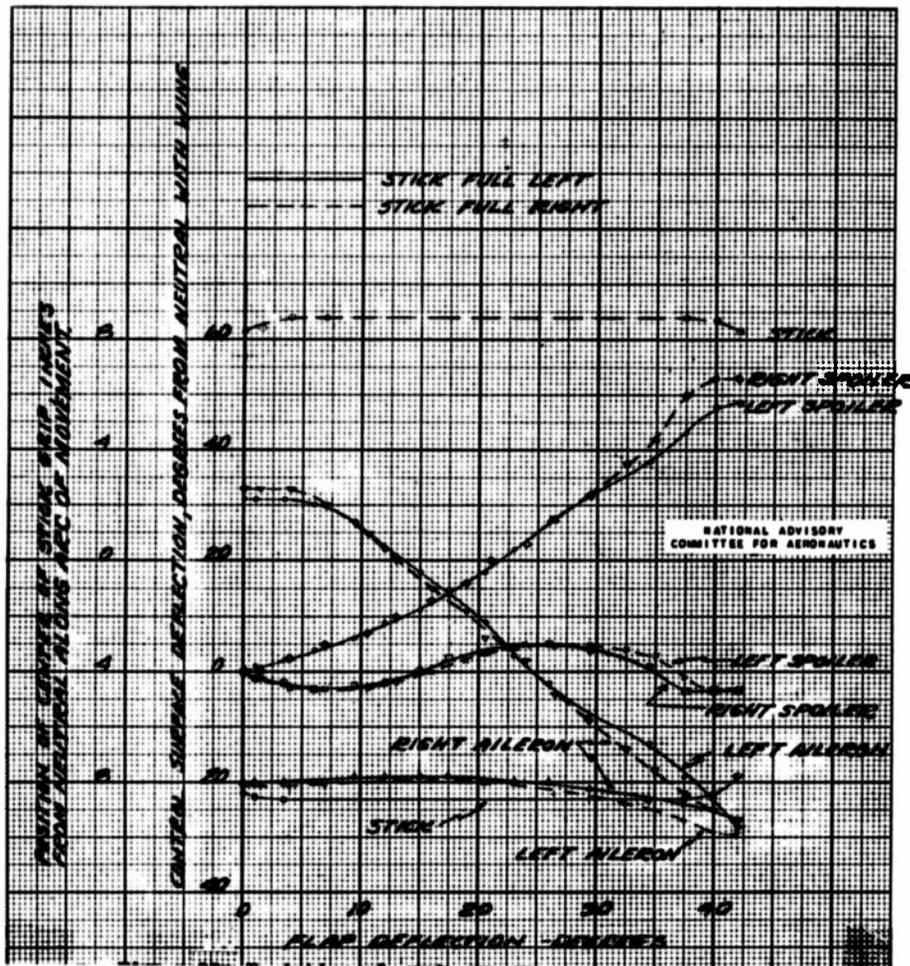
Figure 23.- Variation of maximum movements of ailerons and spoilers with change in flap position.

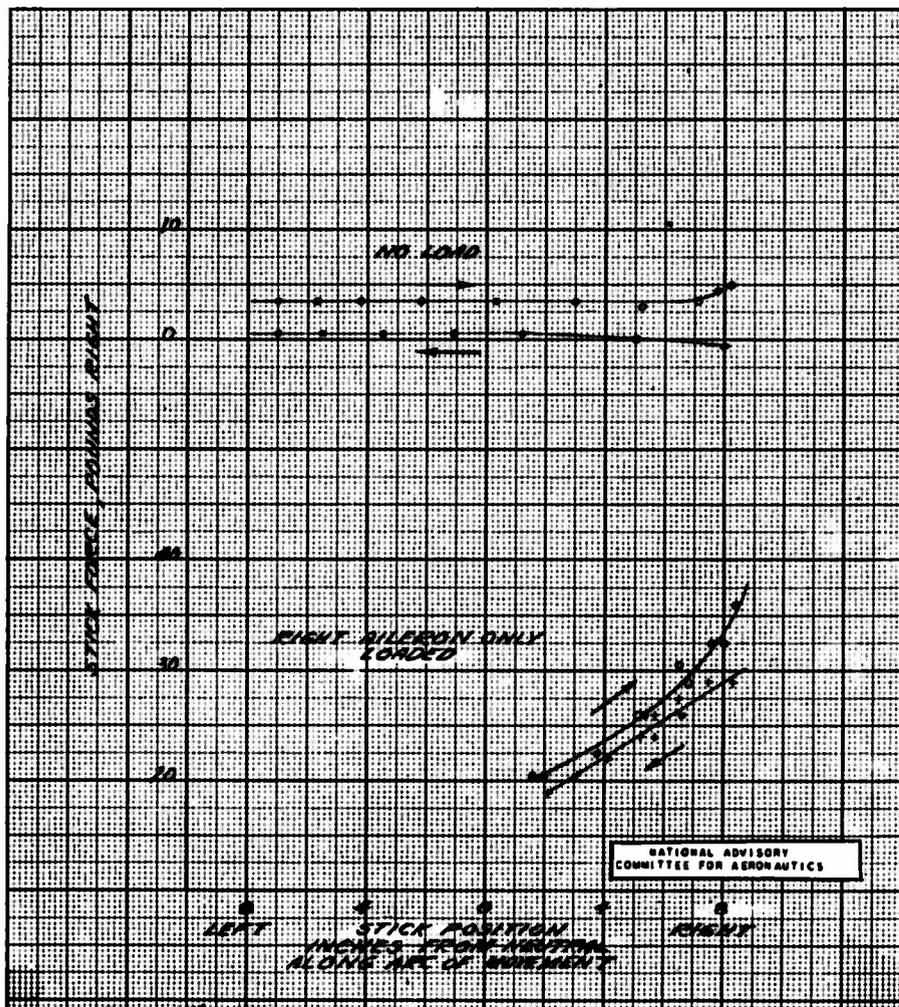
Figure 24.- Friction in the lateral control system, flaps up, as indicated by the stick force required to move the controls on the ground.

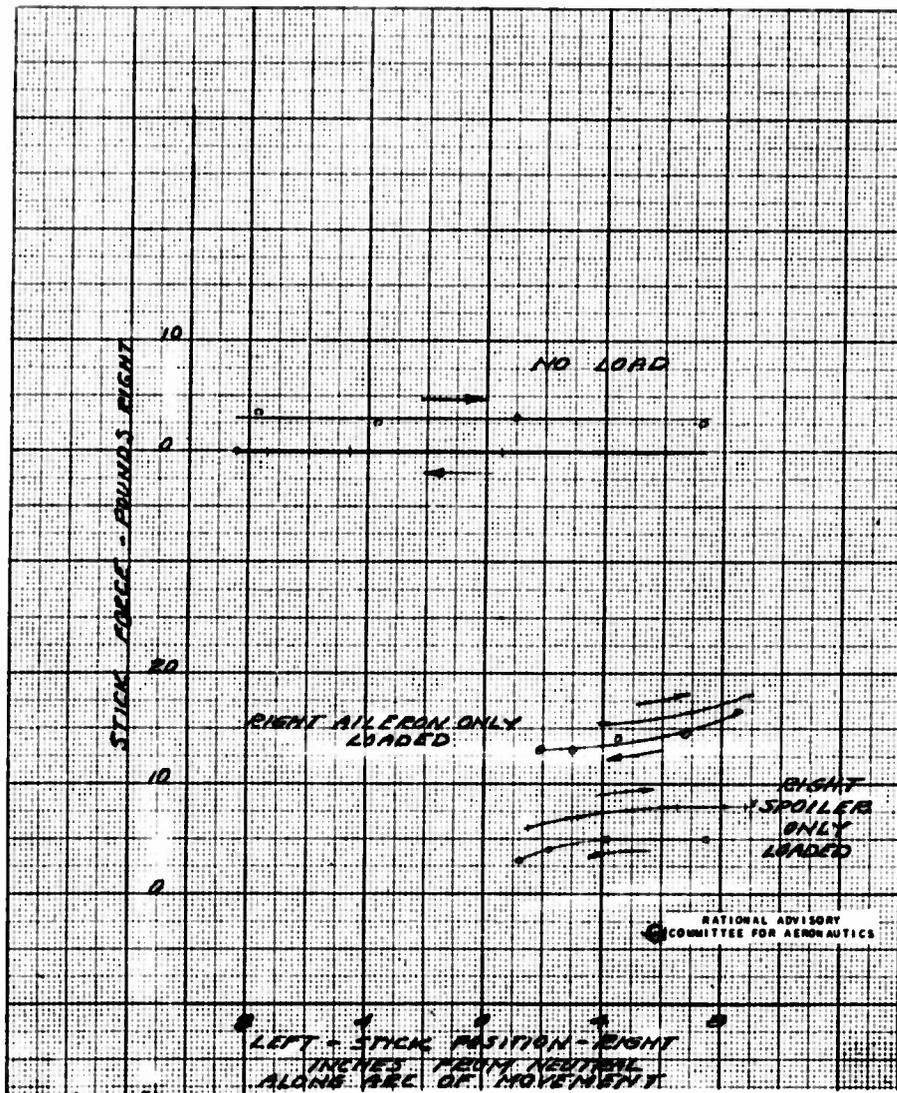
Figure 25.- Friction in the lateral control system, flaps 1/3 down, as indicated by the stick force required to move the controls on the ground.

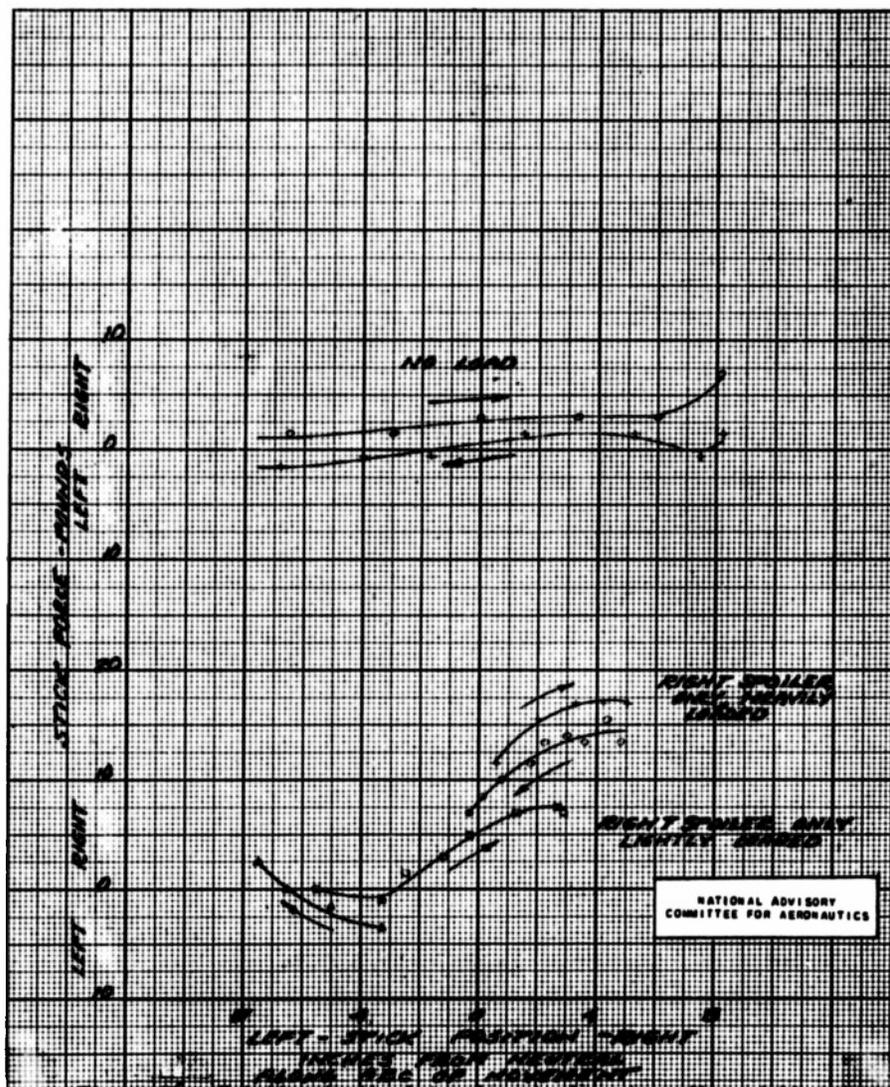
Figure 26.- Friction in the lateral control system, flaps full down, as indicated by the stick force required to move the controls on the ground.

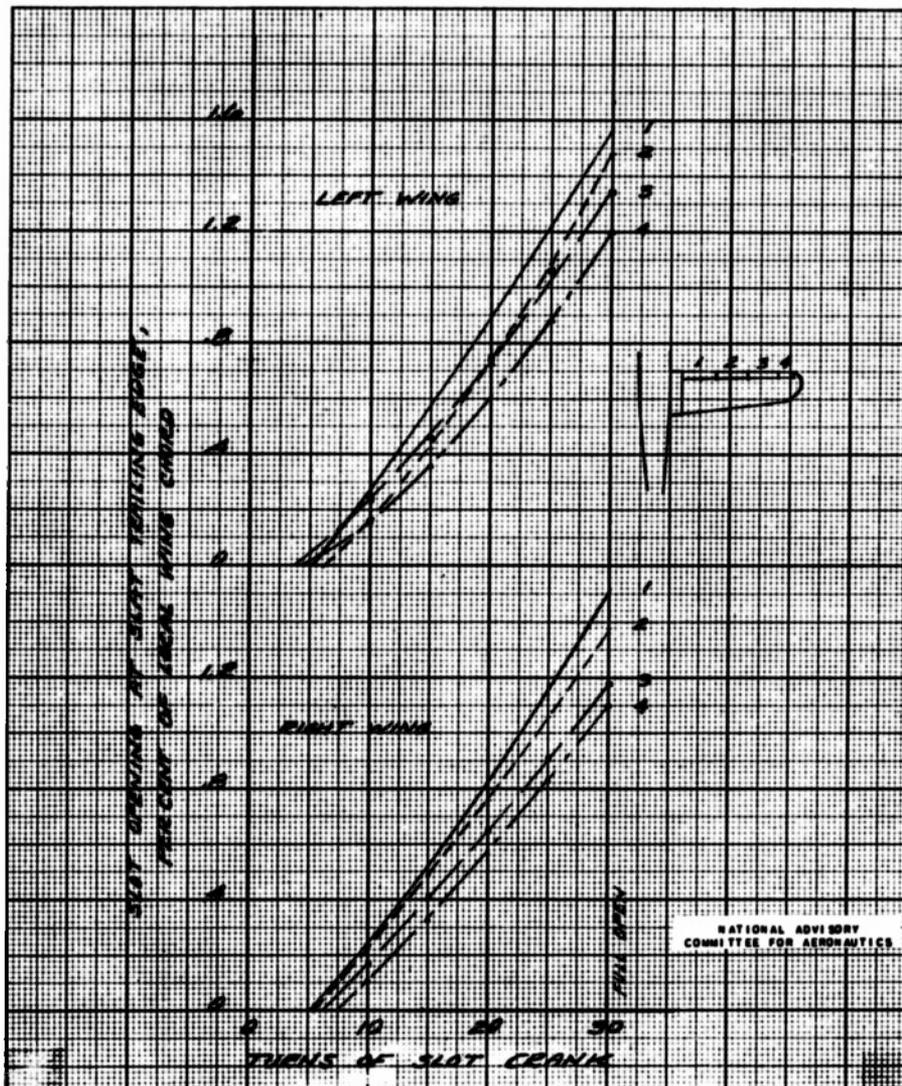
Figure 27.- Variation of slot opening with slot control crank position.

linkage changes were used in the present tests, the slot gap for the slot-open tests being that shown for 30 turns in figure 27. In flight, it was found that the loads on the slot caused it to open the equivalent of approximately three crank turns more than when unloaded. For this reason, about 27 turns were used to fully open the slots in flight.
