NATIONAL ADVISORY COMMITTEE FOR AERONAUTICS

WARTIME REPORT

By William N. Turner and Betty Adams

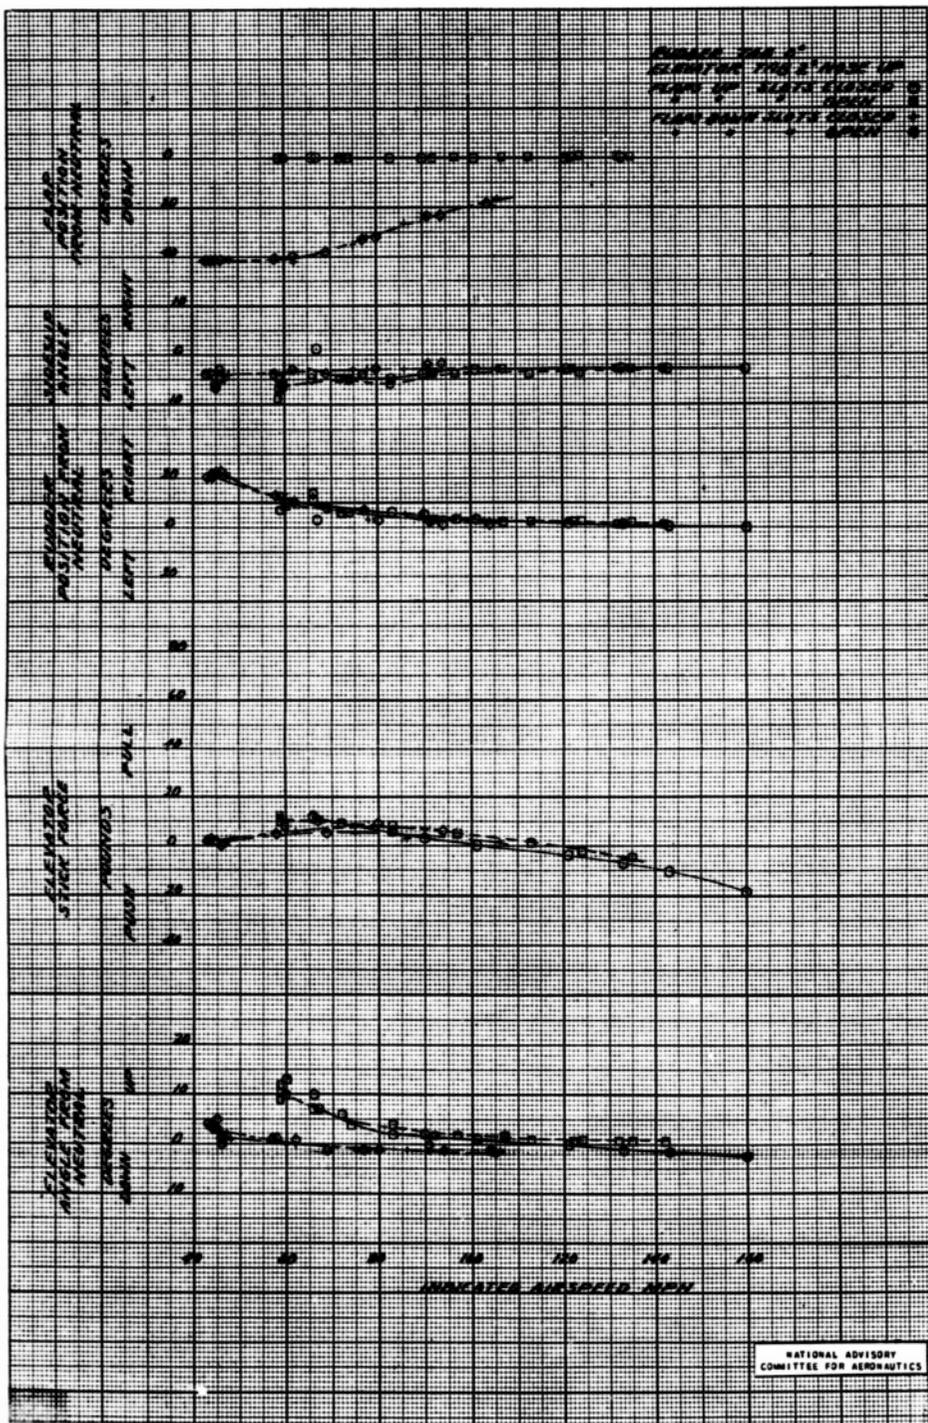
Figure 23.- Characteristics in steady straight flight with power for level flight. Test airplane with hoods closed, center of gravity at 26.3 percent M.A.C.

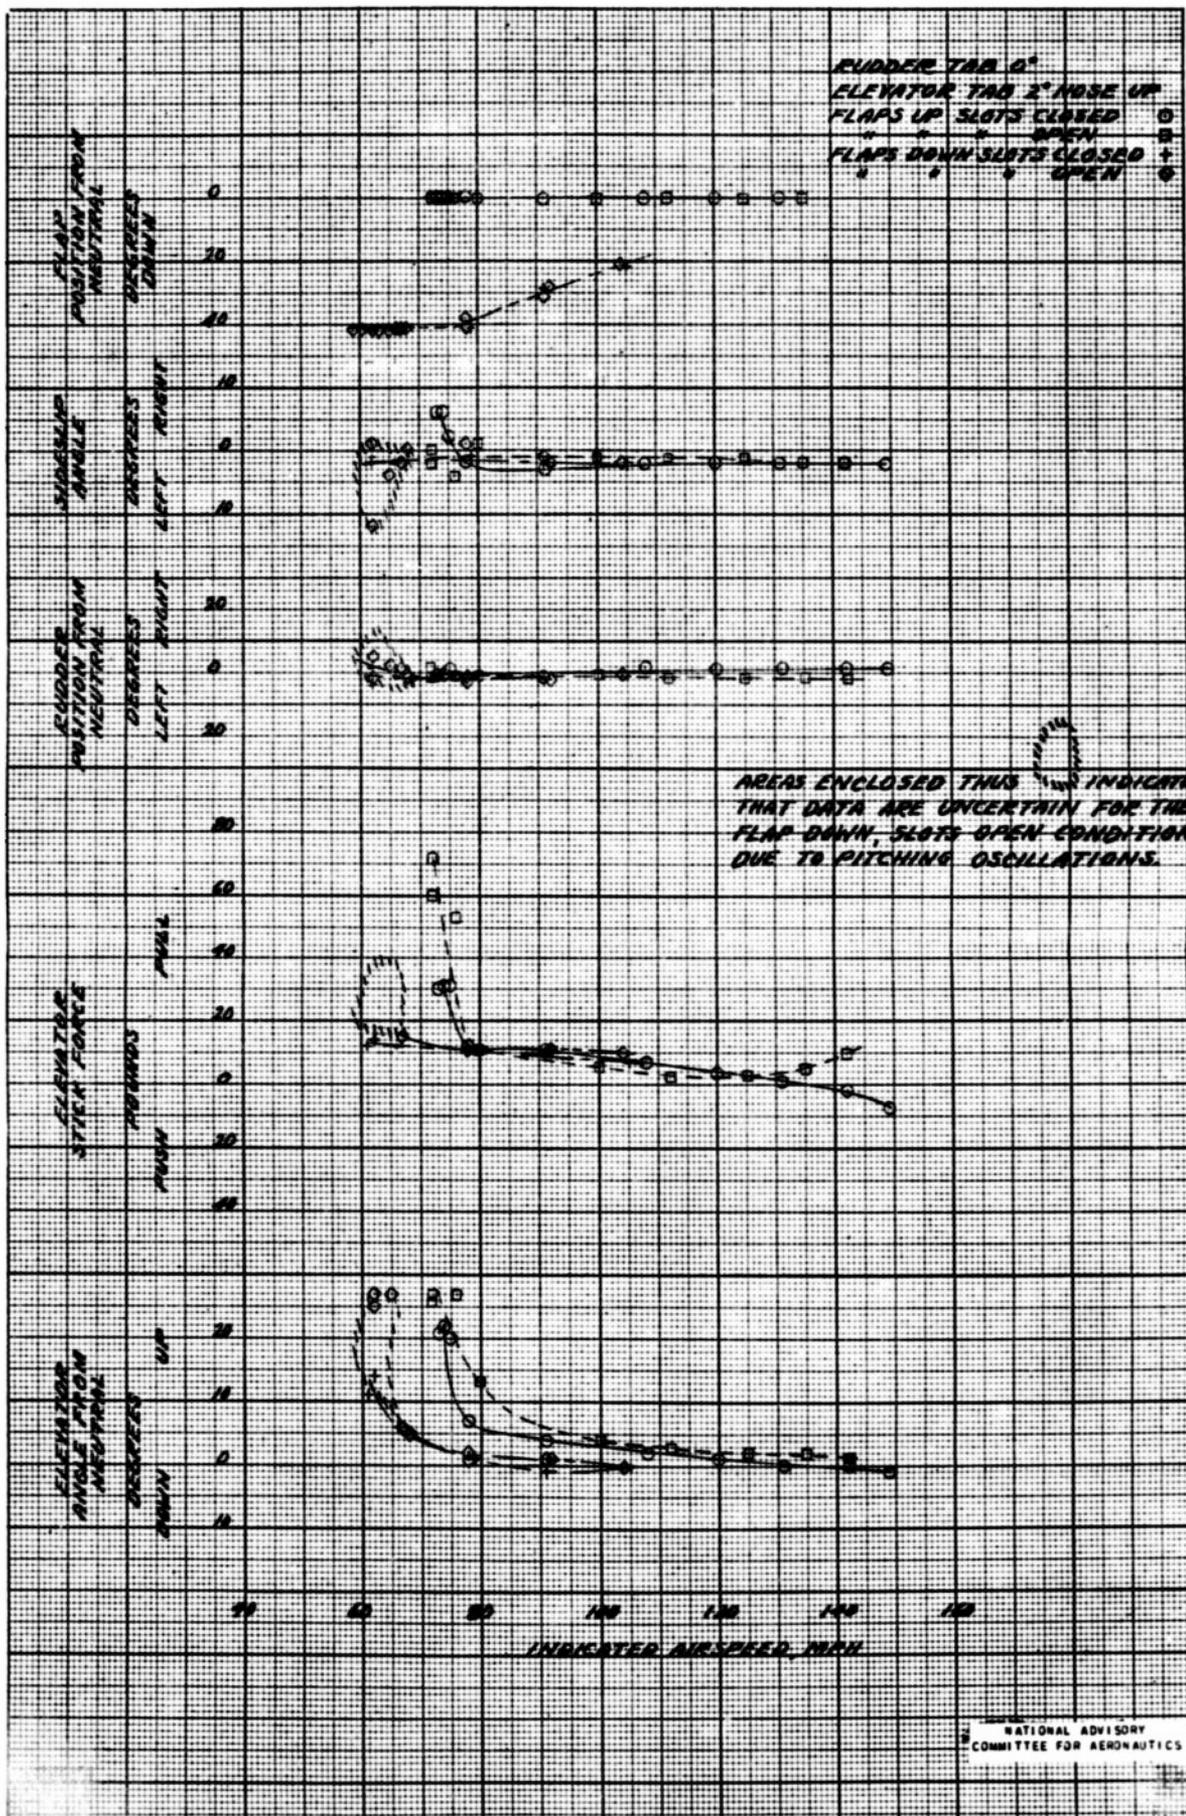
Figure 28.- Characteristics in steady straight flight with power off. Test airplane with hoods and cowl flaps closed, center of gravity at 26.3 percent M.A.C.

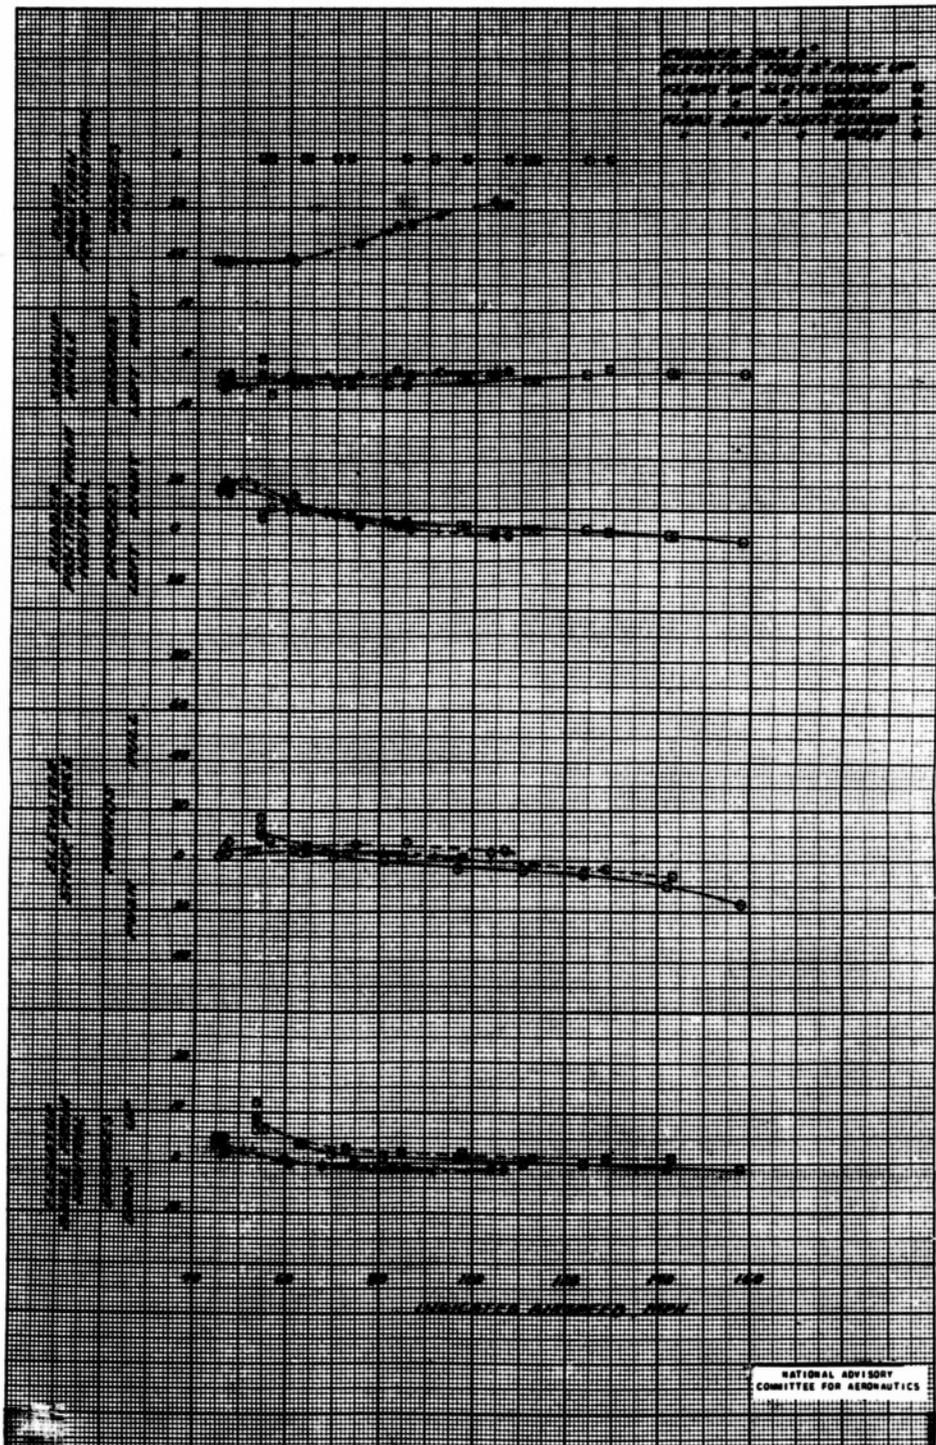
Figure 30.- Characteristics in steady straight flight with approximately 345 bhp at 2300 rpm. Test airplane with hoods closed and cowl flaps open, center of gravity at 26.3 percent M.A.C.

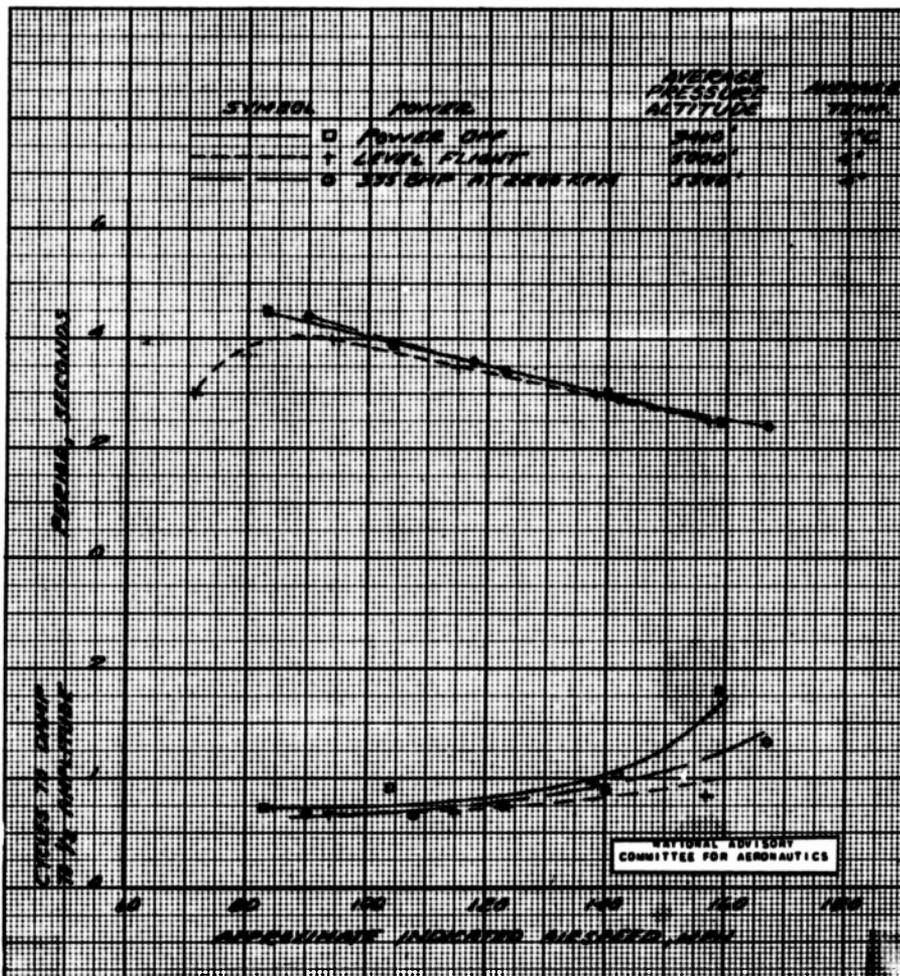
Figure 31.- Period and damping of the lateral oscillations. Test airplanes with flaps up and slots closed, center of gravity at 26.3 percent M.A.C.

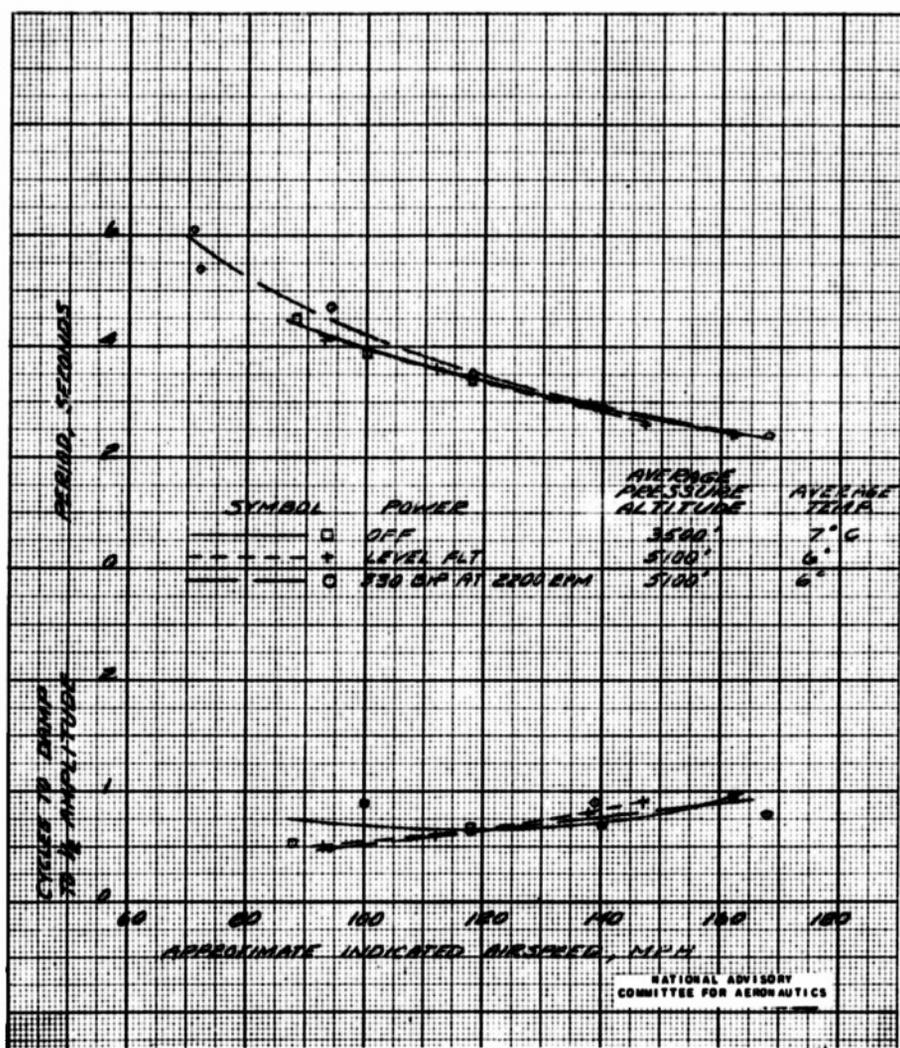
Figure 32.- Period and damping of the lateral oscillations. Test airplane with flaps up and slots open, center of gravity at 26.3 percent M.A.C.

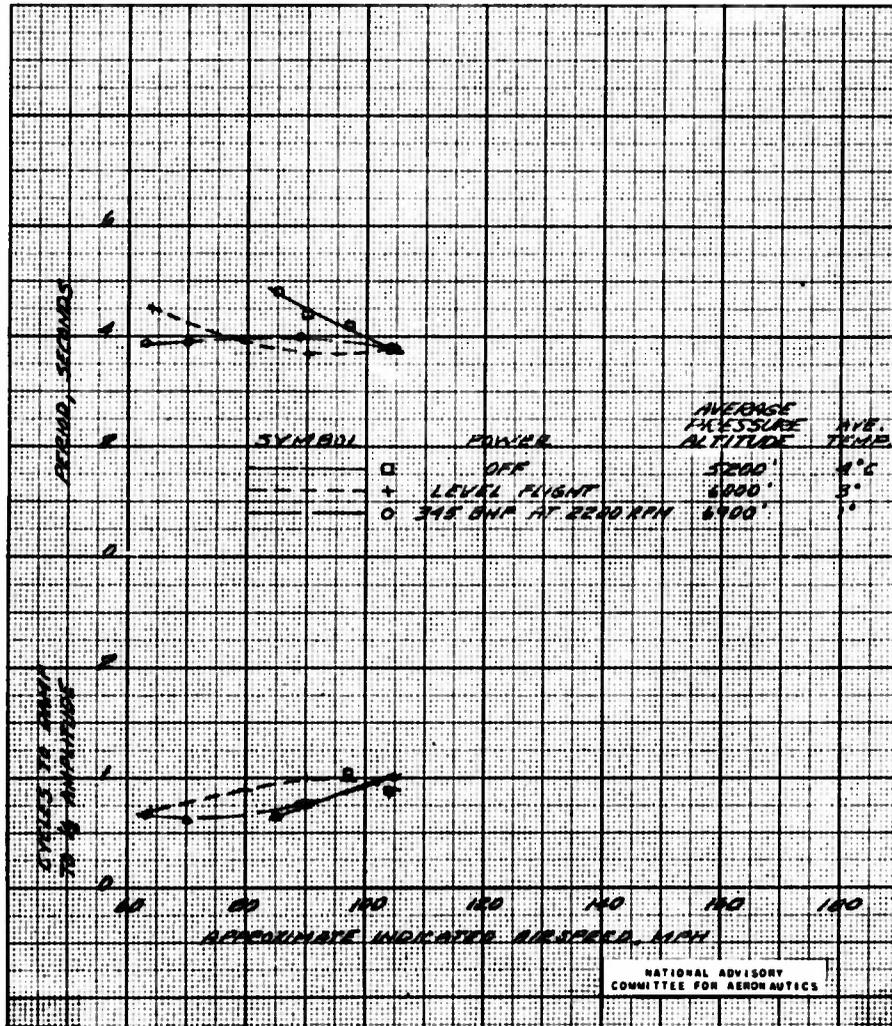
Figure 33.- Period and damping of the lateral oscillations. Test airplane with flaps set full down and slots closed, center of gravity at 26.3 percent M.A.C.

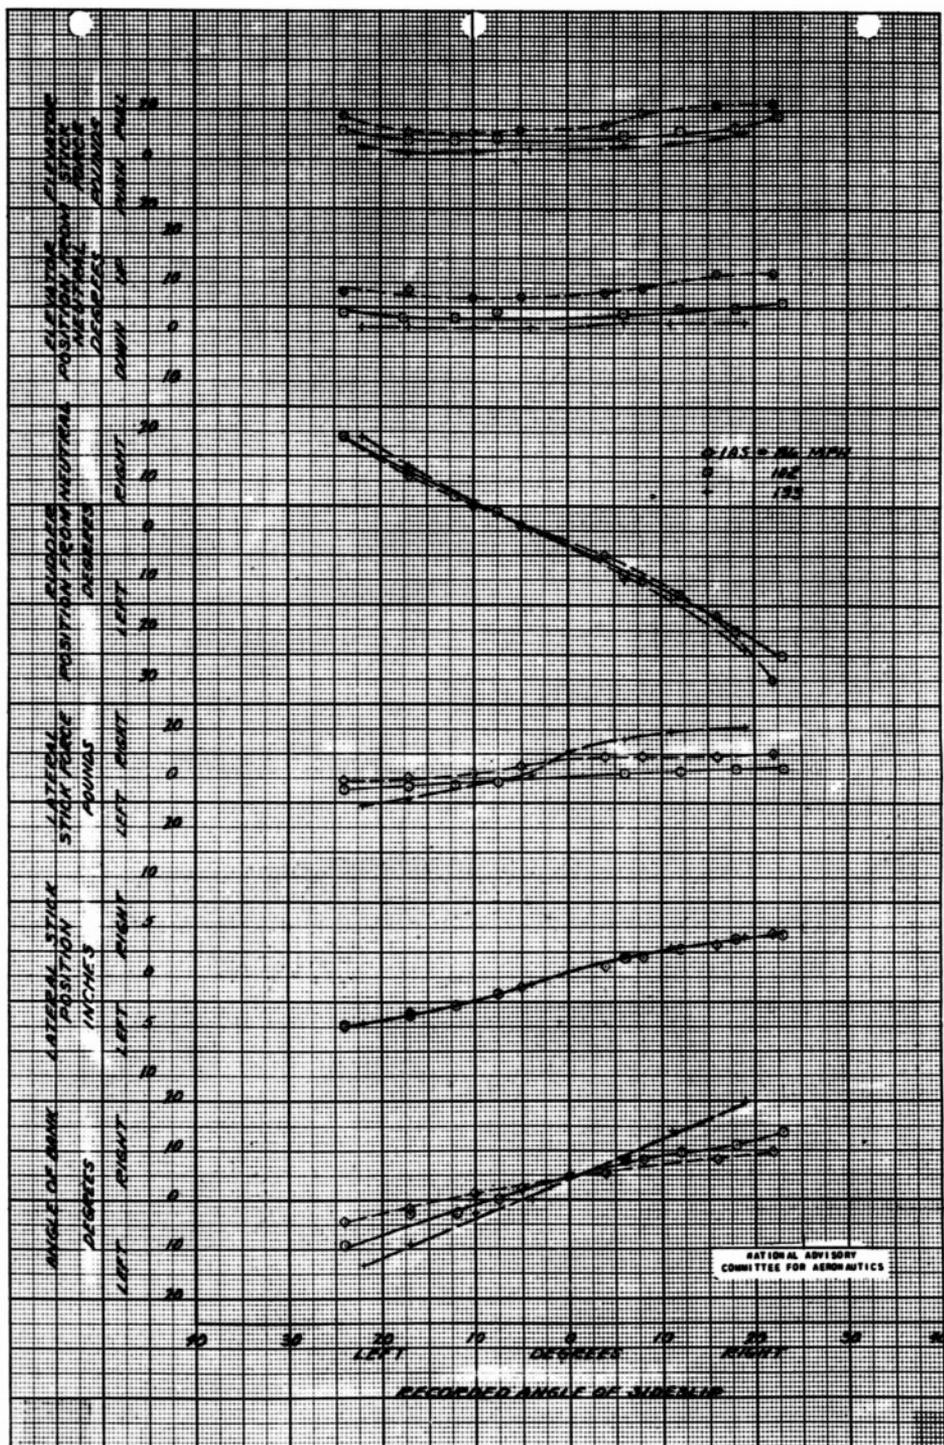
Figure 36.- Characteristics in steady sideslips. Power off, flaps up, slots open, hoods and cowl flaps closed, center of gravity at 26.5 percent M.A.C.

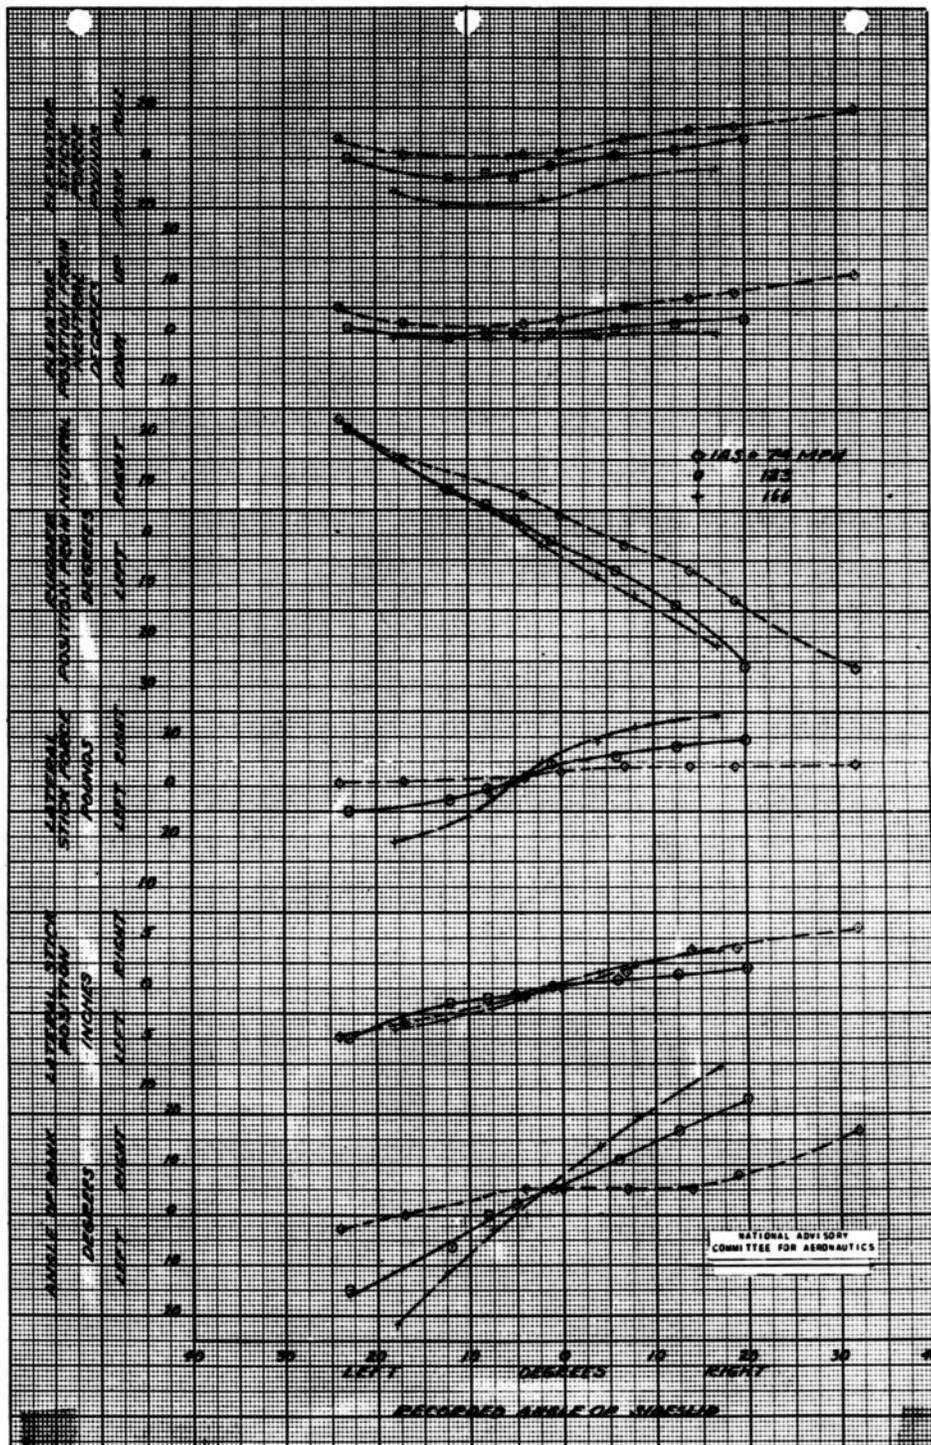
Figures 37.- Characteristics in steady sideslips. 340 bhp at 2300 rpm, flaps up, slots closed, hoods closed, cowl flaps open, center of gravity at 26.3 percent M.A.C.

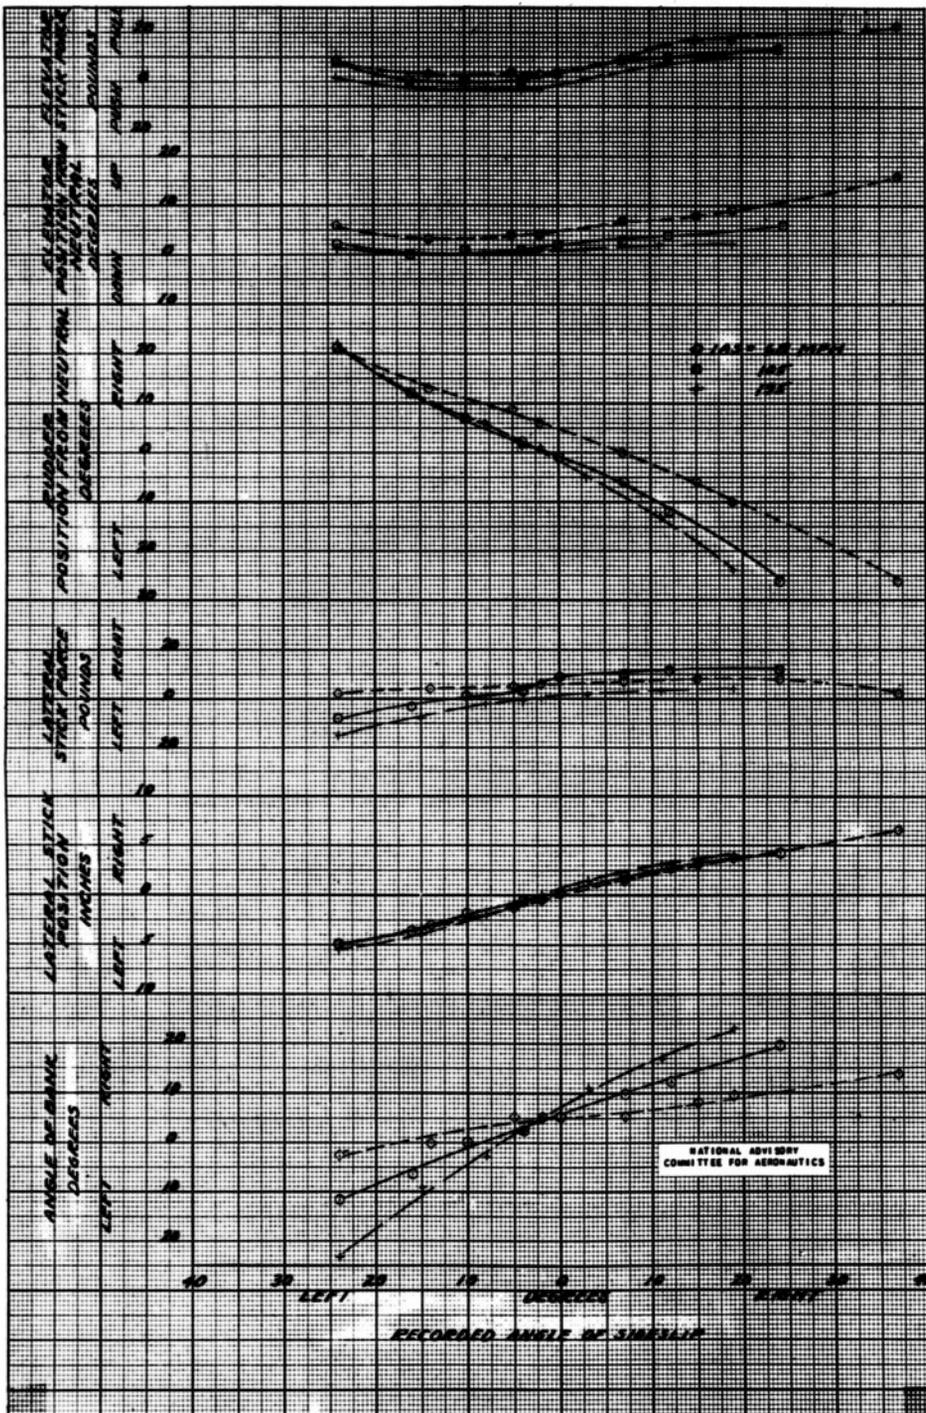
Figure 38.- Characteristics in steady sideslips. 340 bhp at 2300 rpm, flaps up, slots open, hoods closed, cowl flaps open, center of gravity at 26.3 percent M.A.C.

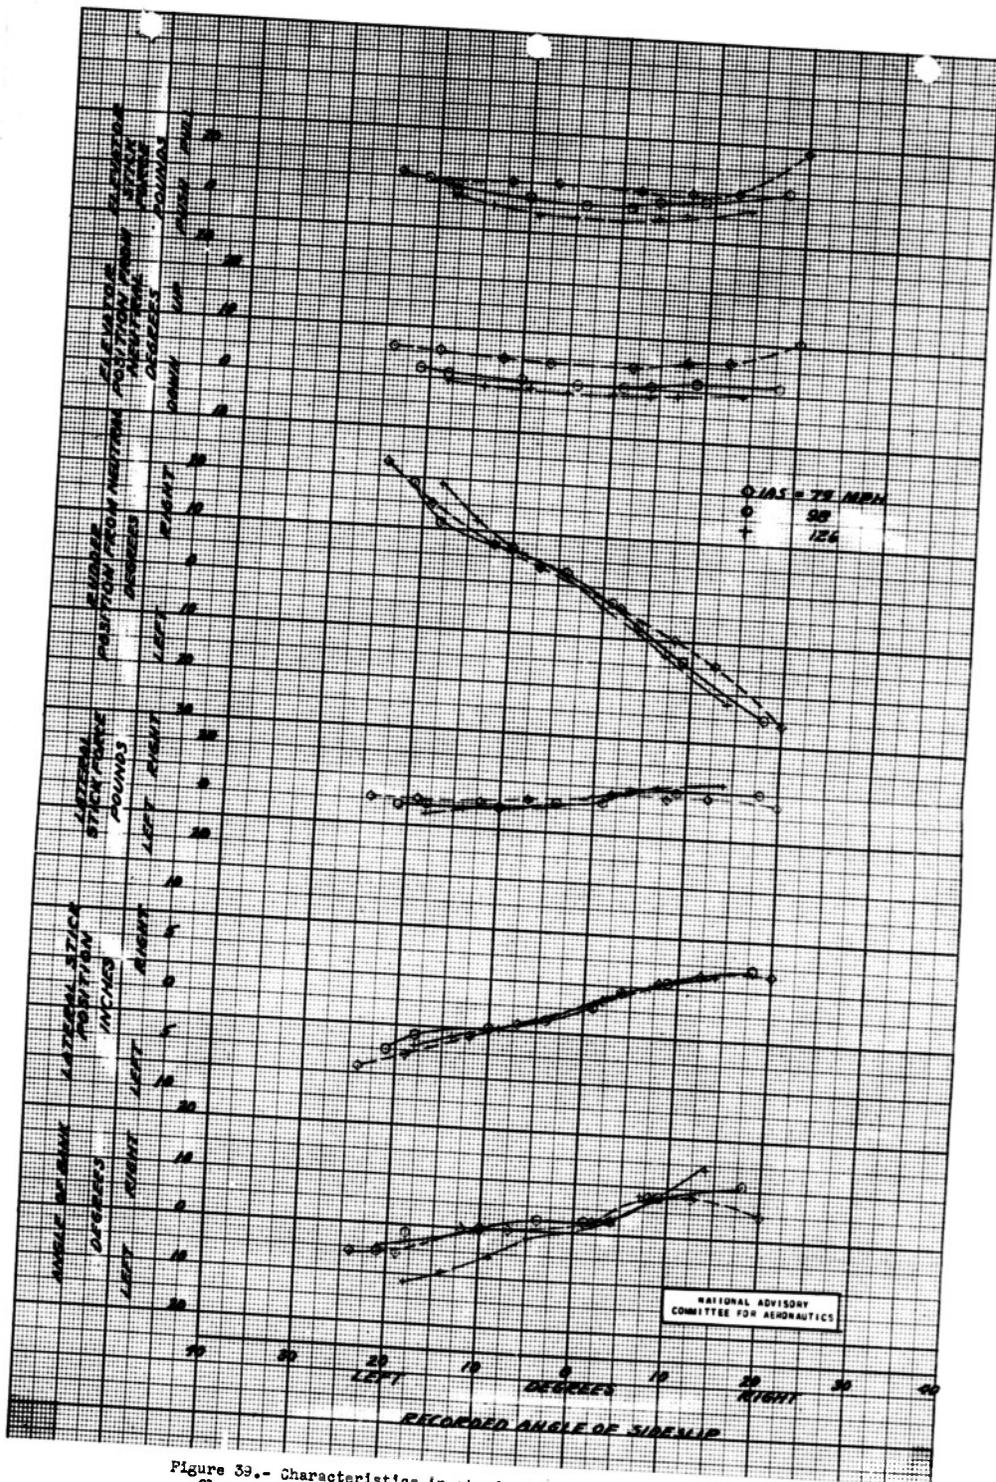
Figure 39.- Characteristics in steady sideslips. Power off, flaps set 1/3 down, slots closed, hoods closed, cowl flaps closed, center of gravity at 26.3 percent L.A.C.

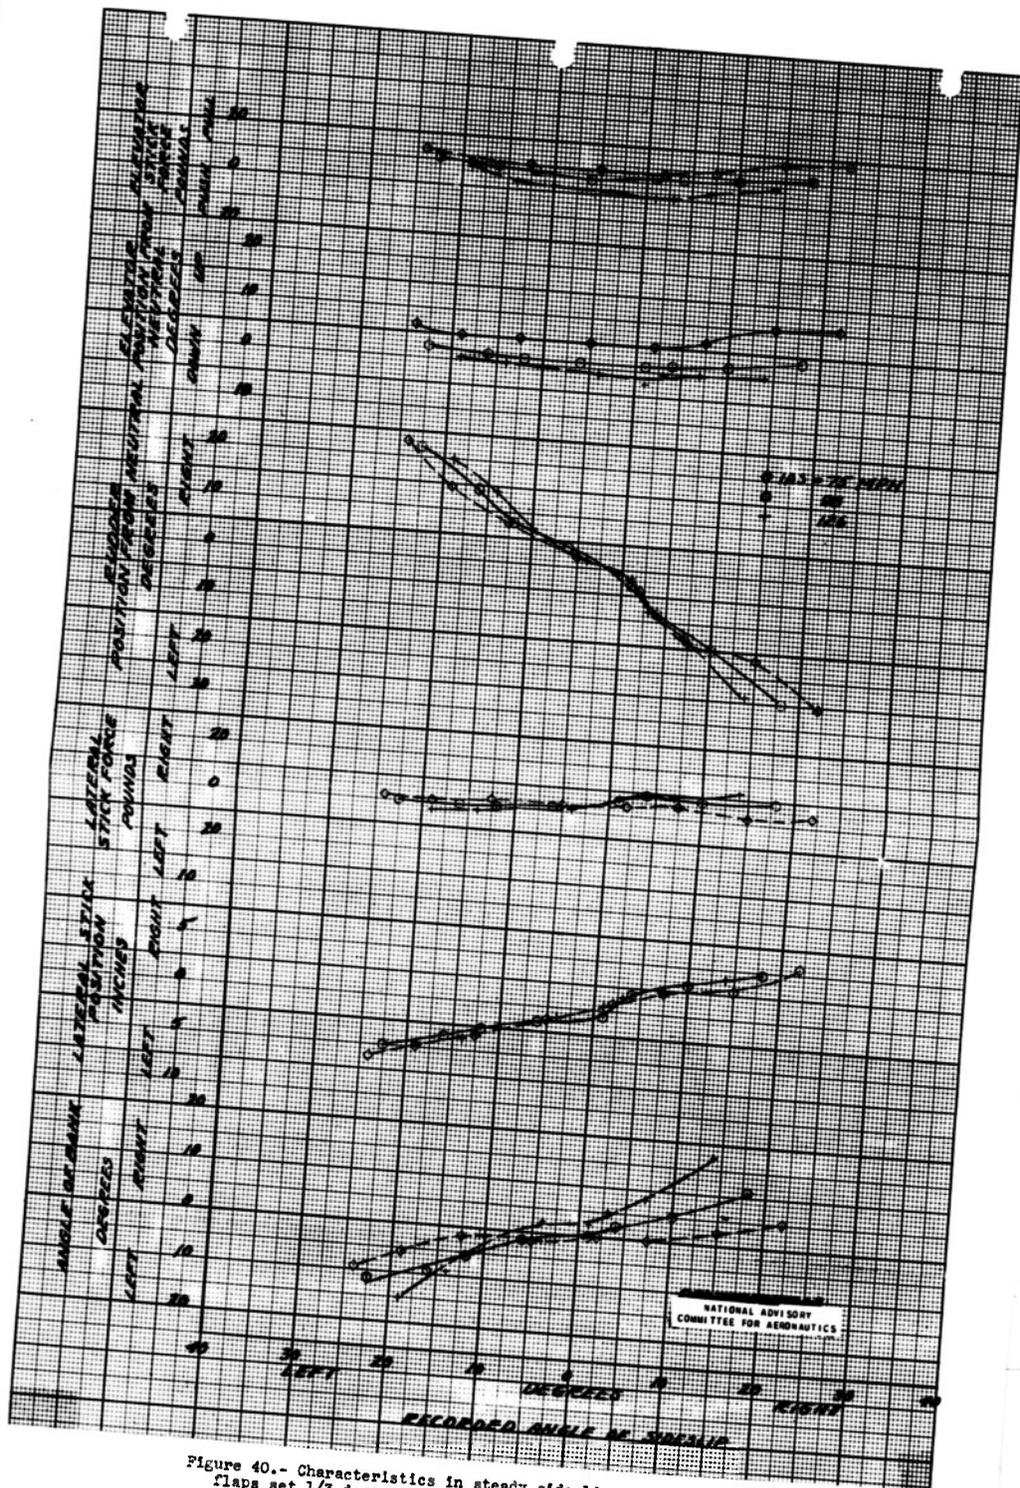
Figure 40.- Characteristics in steady sideslips. Power off, flaps set 1/3 down, slots open, hoods closed, cowl flaps closed, center of gravity at 26.3 percent M.A.C.

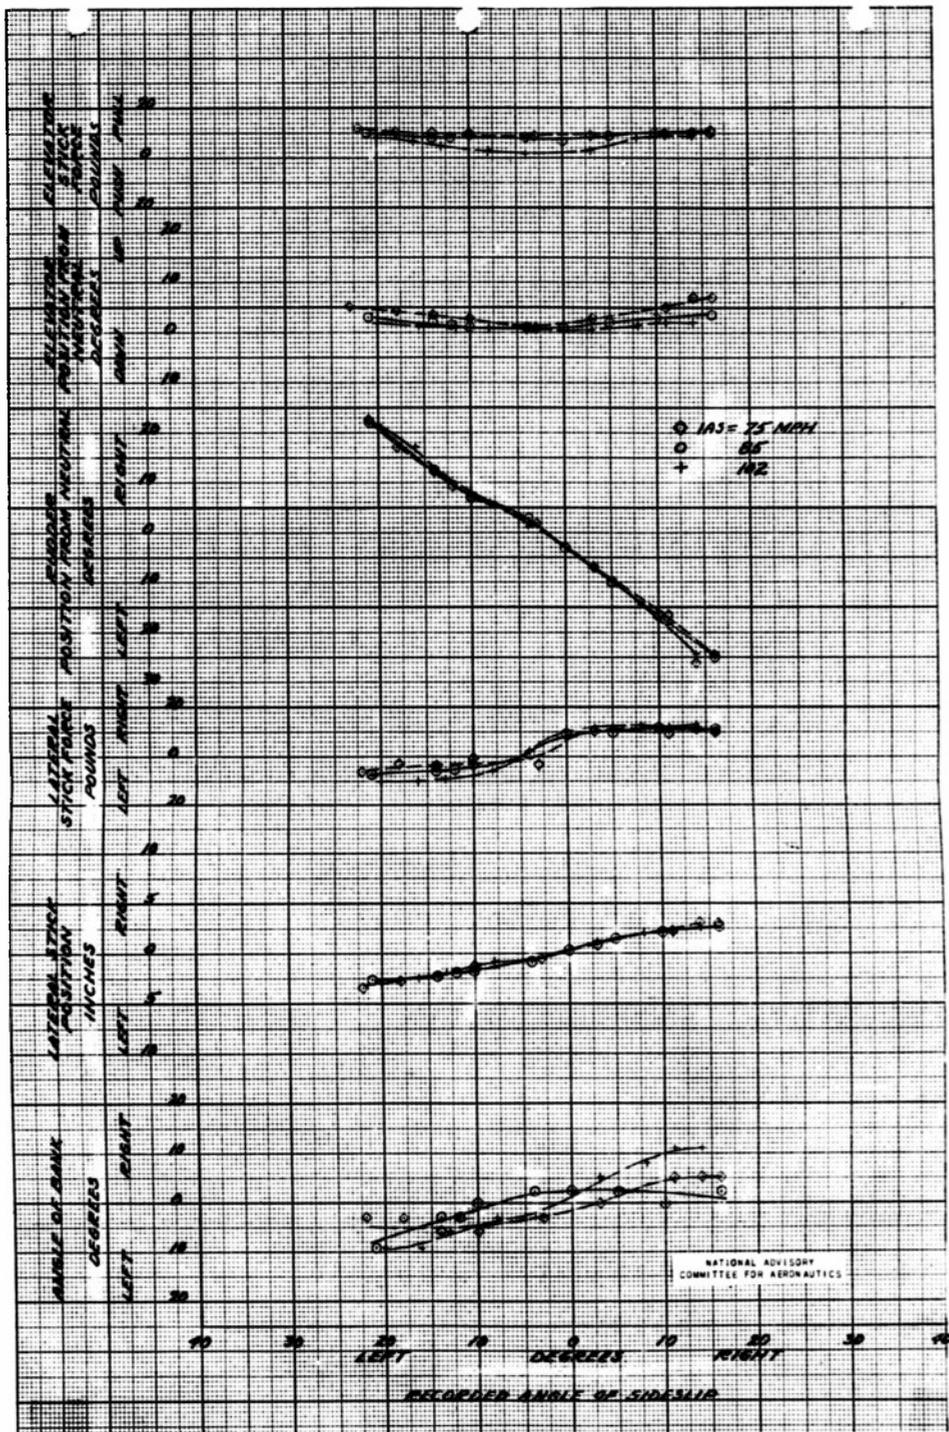
Figure 43.- Characteristics in steady sideslips. Power off, flaps set full down, slots closed, hoods closed, cowl flaps closed, center of gravity at 26.3 percent M.A.C.

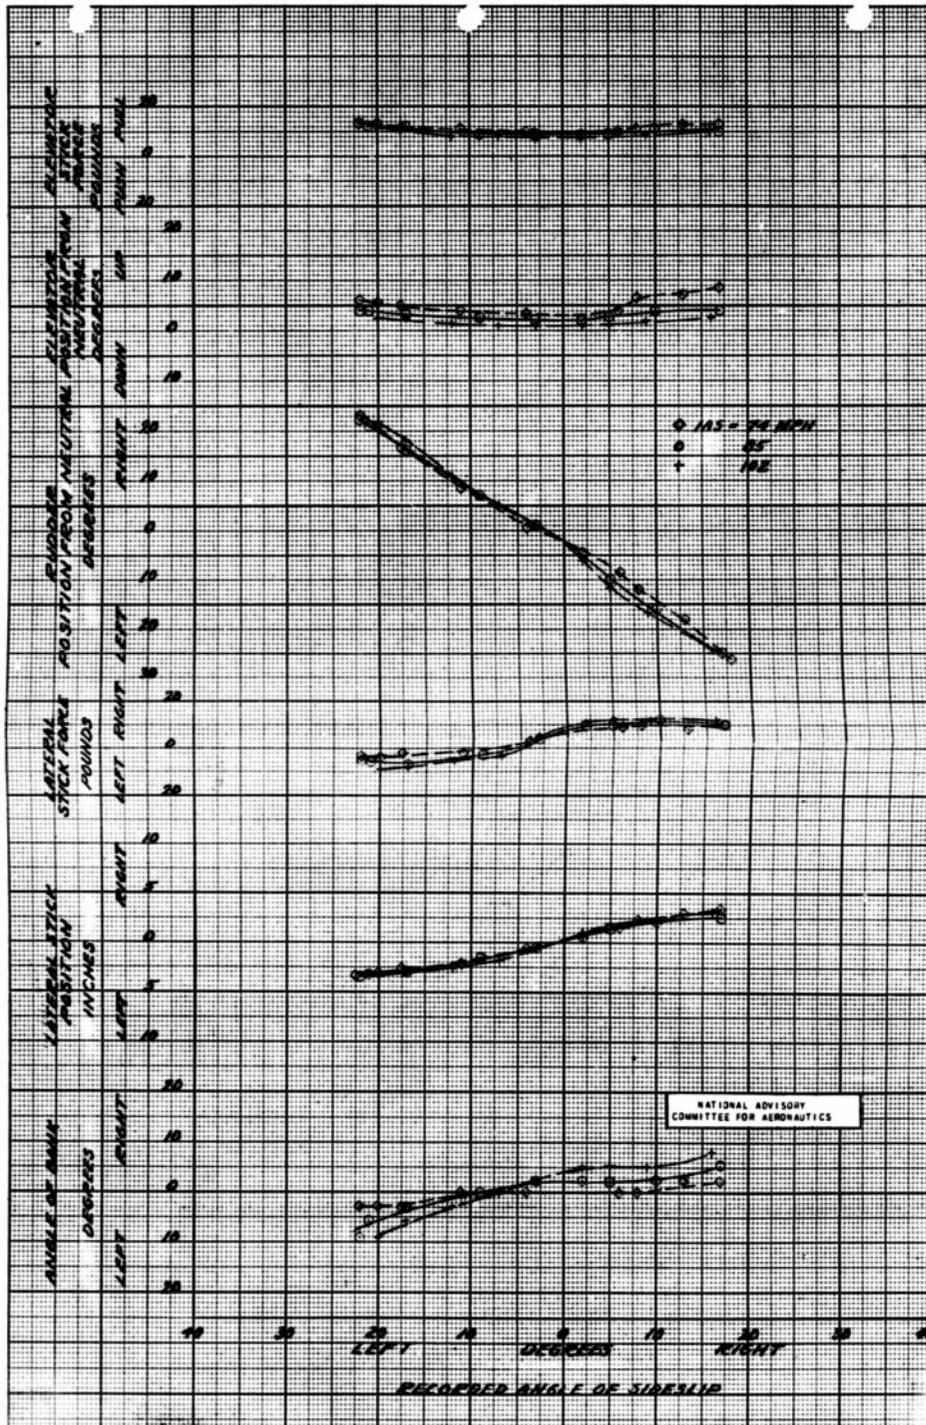
Figure 44.- Characteristics in steady sideslips. Power off, flaps set full down, slots open, hoods closed, cowl flaps closed, center of gravity at 26.3 percent M.A.C.

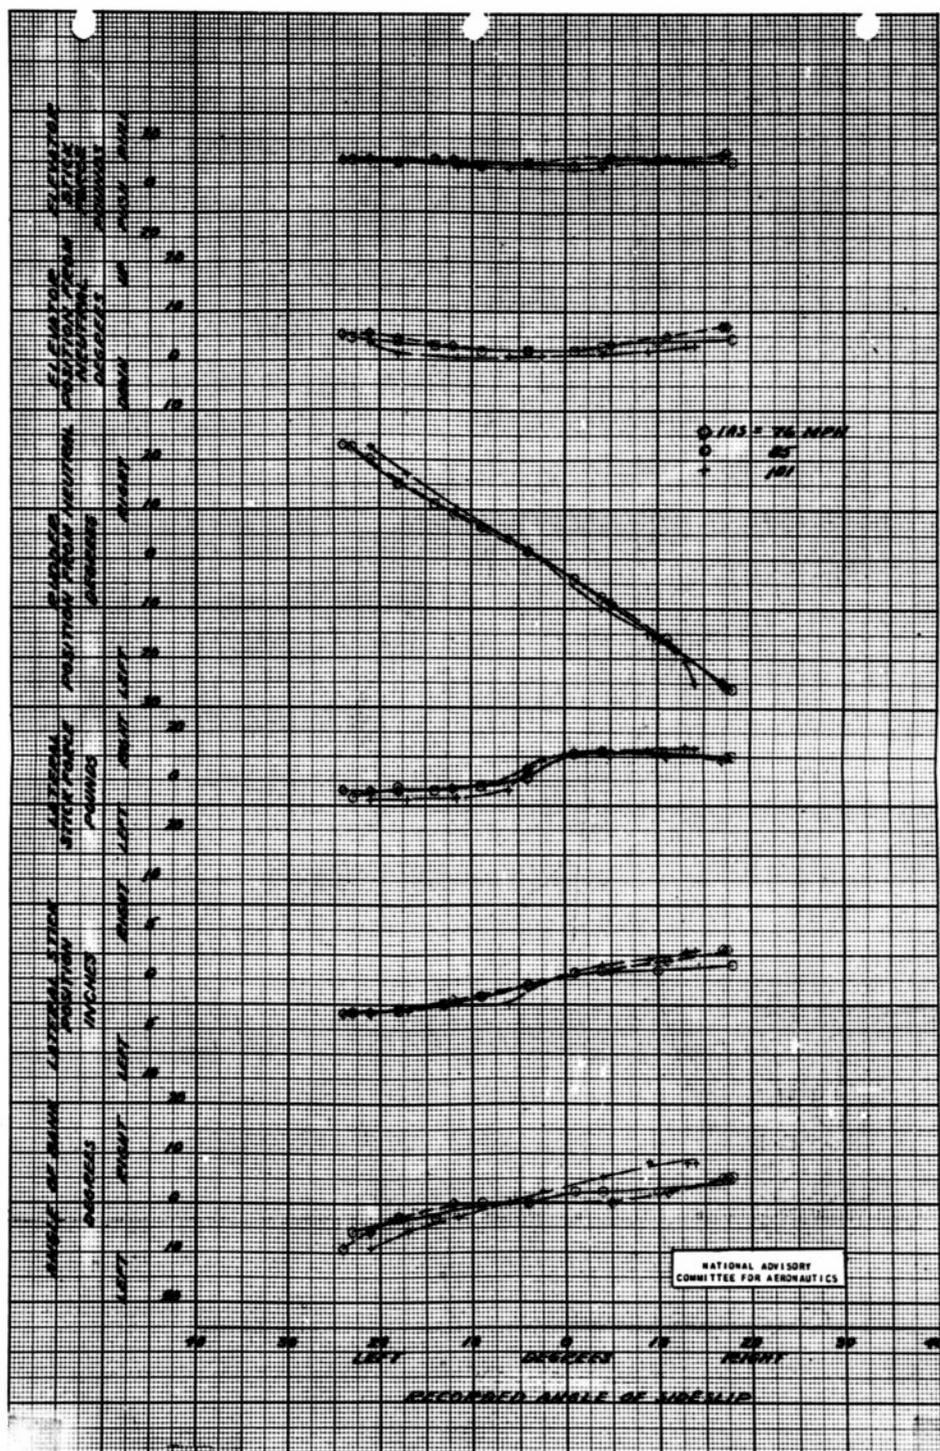
Figure 45.- Characteristics in steady sidslips. Power off, flaps set full down, slots open, hoods open, cowl flaps closed, center of gravity at 26.3 percent M.A.C.

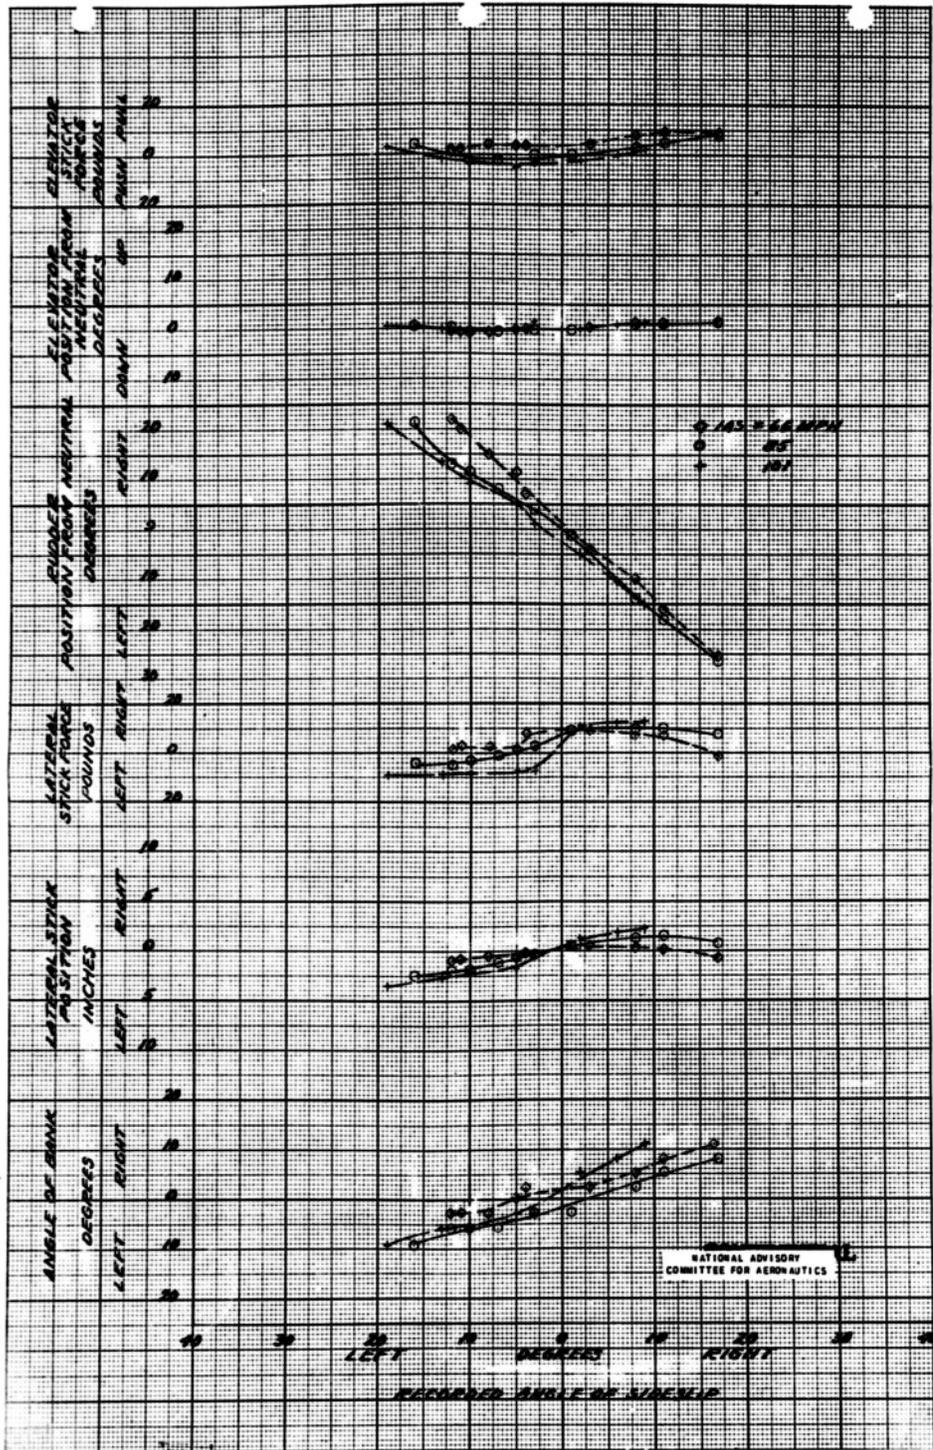
Figure 46.- Characteristics in steady sideslips. 340 bhp at 2300 rpm, flap set full down, slots closed, hoods closed, cowl flaps open, center of gravity at 26.3 percent M.A.C.

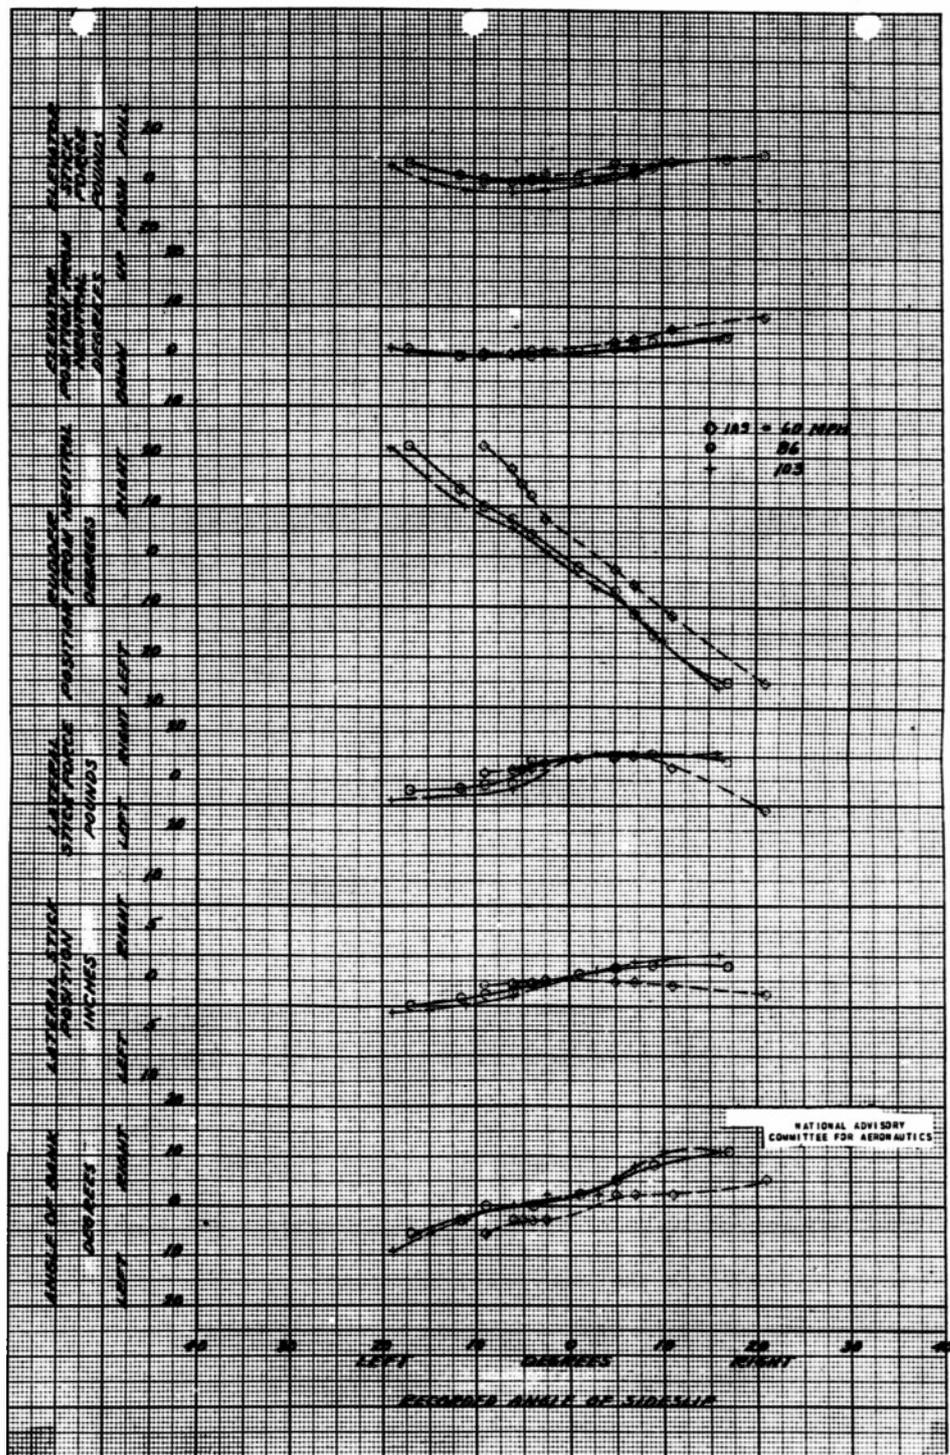
Figure 47.- Characteristics in steady sideslips. 340 bhp at 2500 rpm, flap set full down, slots open, hoods closed, cowl flaps open, center of gravity at 26.3 percent M.A.C.
