NATIONAL ADVISORY COMMITTEE FOR AERONAUTICS

WARTIME REPORT

By William N. Turner and Betty Adams

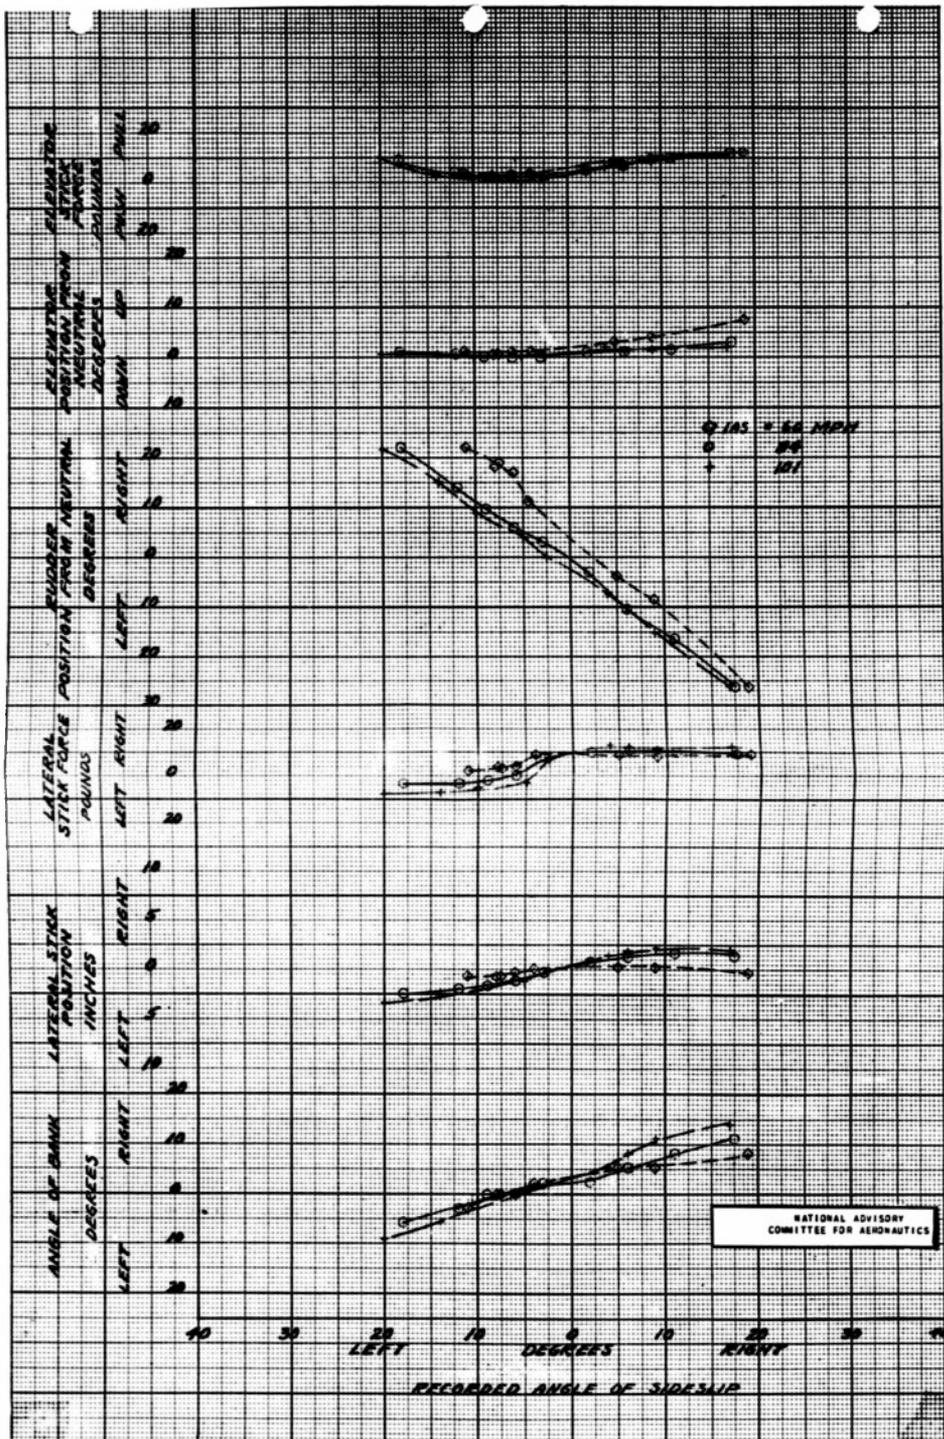
Figure 48.- Characteristics in steady sideslips. 340 bhp at 2300 rpm, flap set full down, slots open, hoods open, cowl flaps open, center of gravity at 26.3 percent M.A.C.

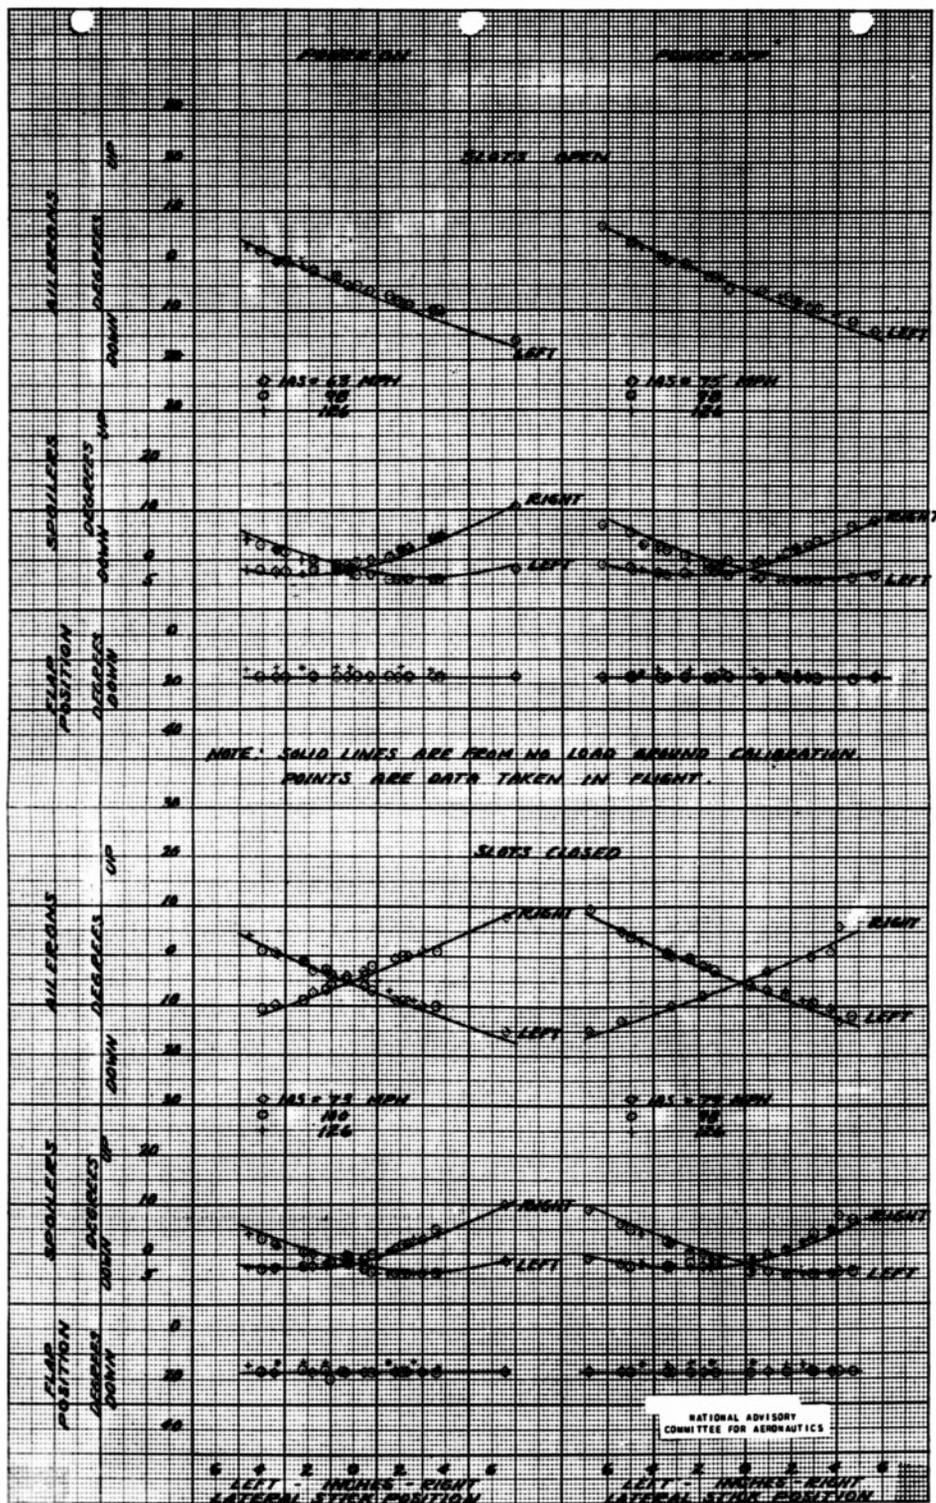
Figure 50.- Stretch in the lateral control system as measured in steady sideslipping flight. Test airplane with flaps set 1/3 down.

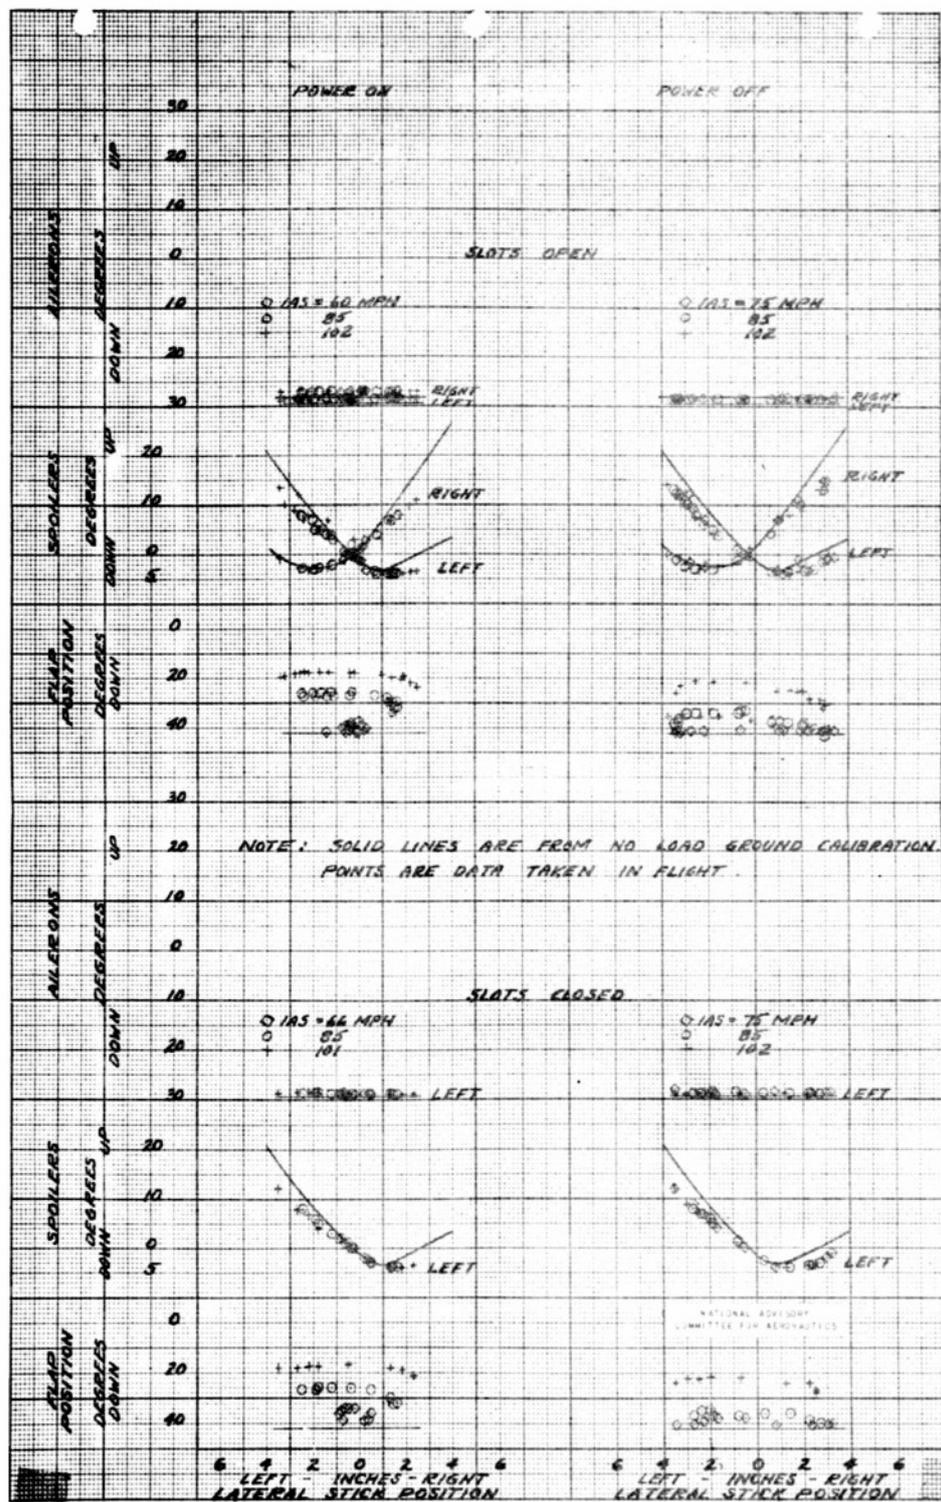
Figure 51.- Stretch in the lateral control system as measured in steady sideslipping flight. Test airplane with flaps set full down.

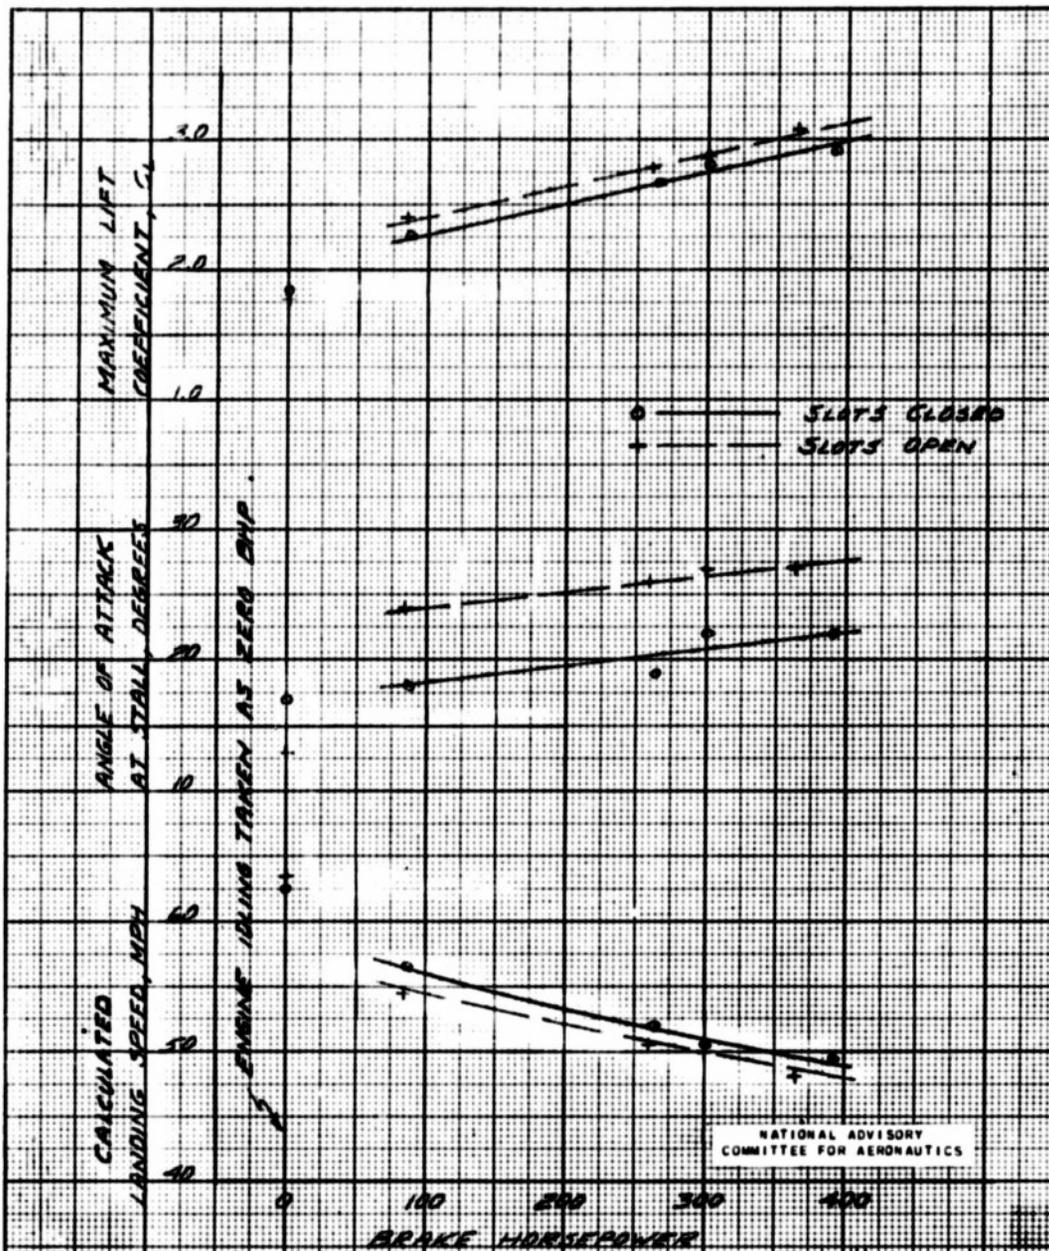
Figure 52.- Variation of maximum lift coefficient with power. Flaps full down, hoods open, cowl flaps open, center of gravity at 32.1 percent L.A.C.

Using the data shown in figure 52, the value of k for this airplane was found to be 1.0, thus showing agreement with the conclusions of reference 3.

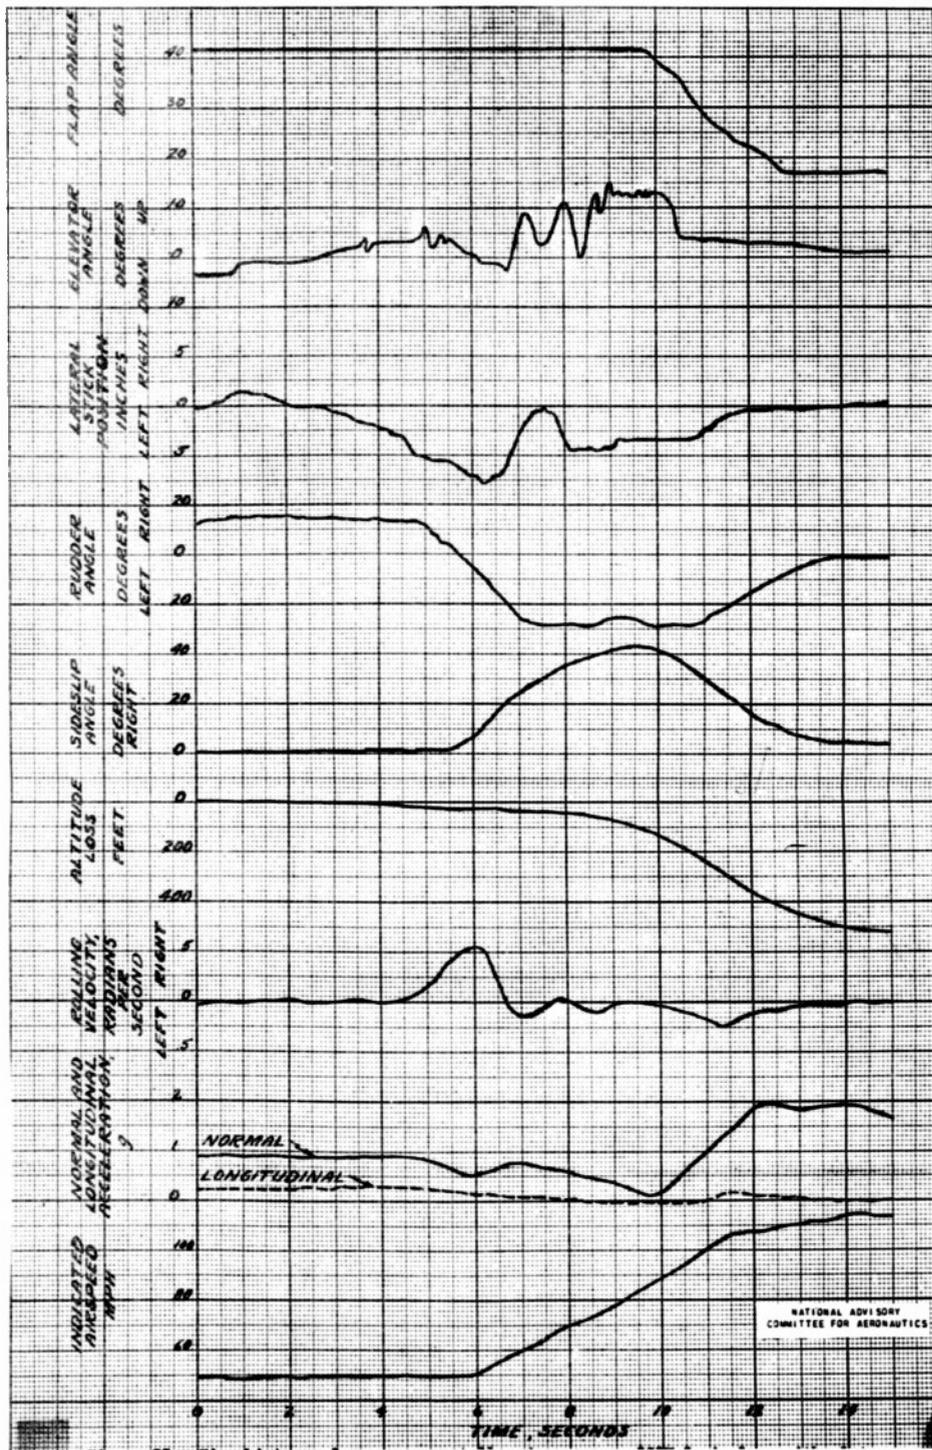
Figure 53.- Time history of a power-on stall and recovery, test airplane with slot extensions and wing-root fillets. Flaps full down, slots open, hoods open, cowl flaps closed, 300 bhp at 2200 rpm, center of gravity at 22.5 percent M.A.C.

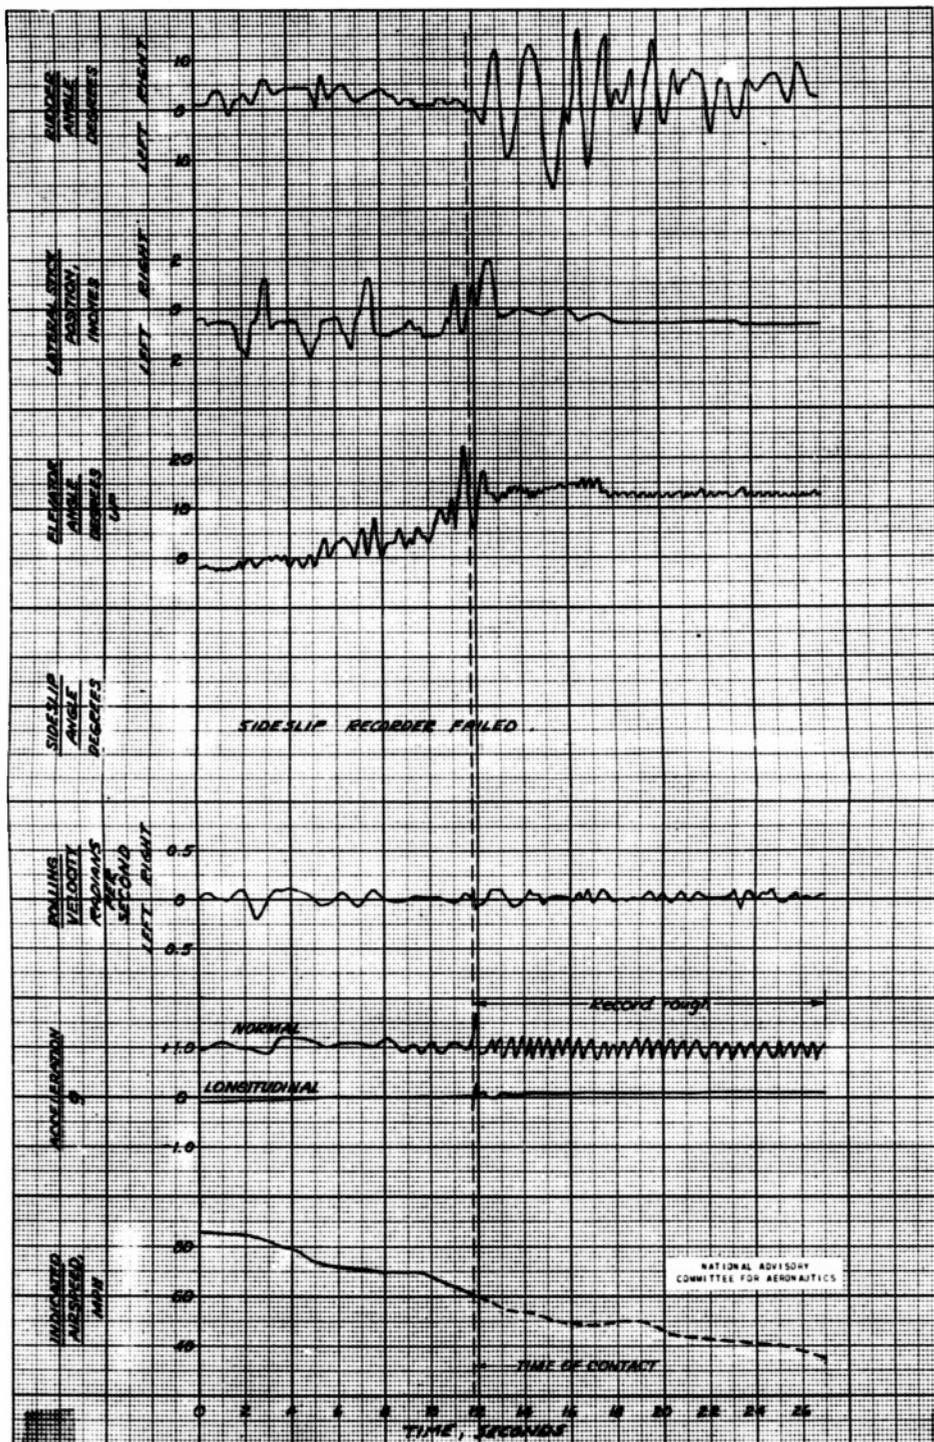
Figure 54.- Time history of a three-point, power-off landing, with flaps full down, slots, hoods, and cowl flaps open. Test airplane with Maxwell slot extensions and smooth walkway.

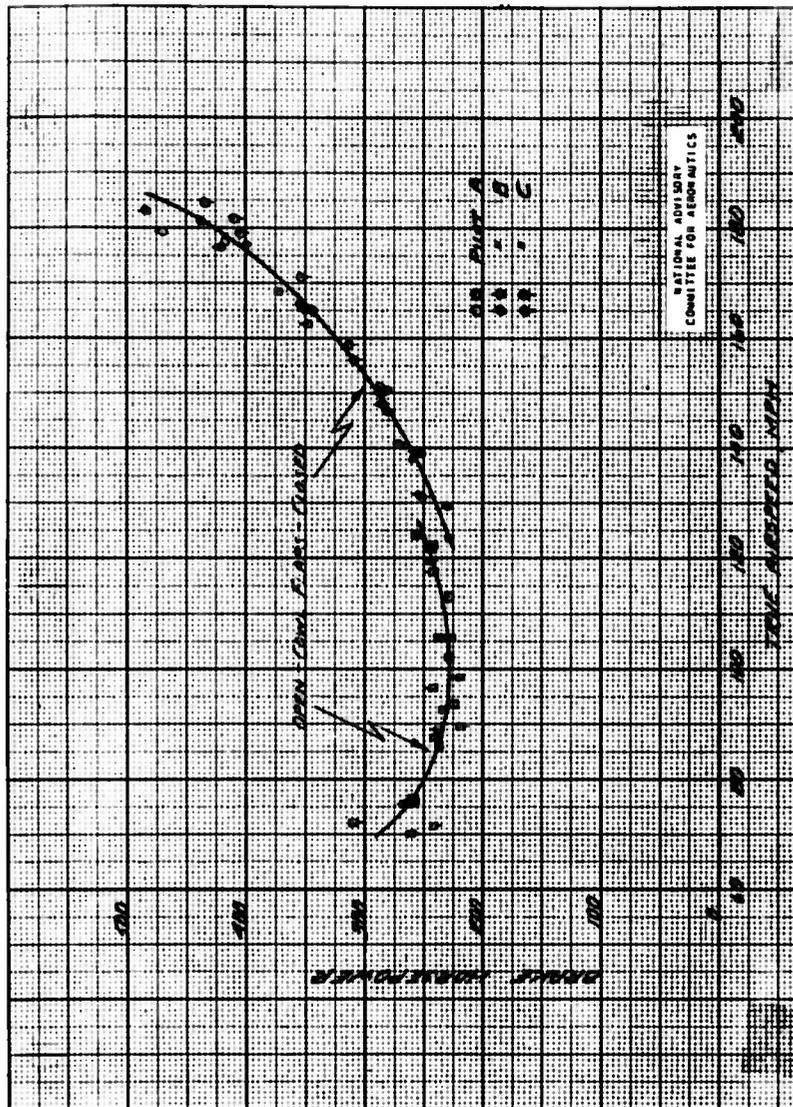
Figure 55.- Power required for level flight at 5500 feet density altitude and 4500 pounds weight. Test airplane with flaps up, slots closed, hoods closed.

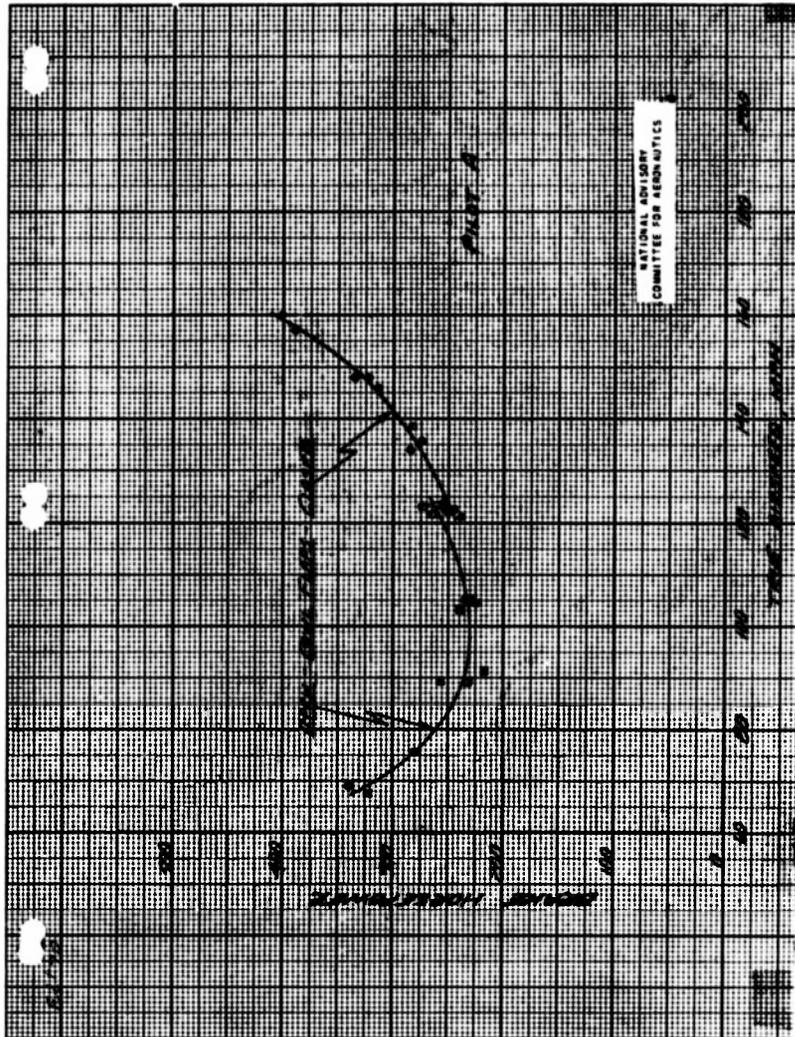
Figure 56.- Power required for level flight at 5500 feet density altitude and 4800 pounds weight. Test airplane with flaps up, slots open, hoods closed.

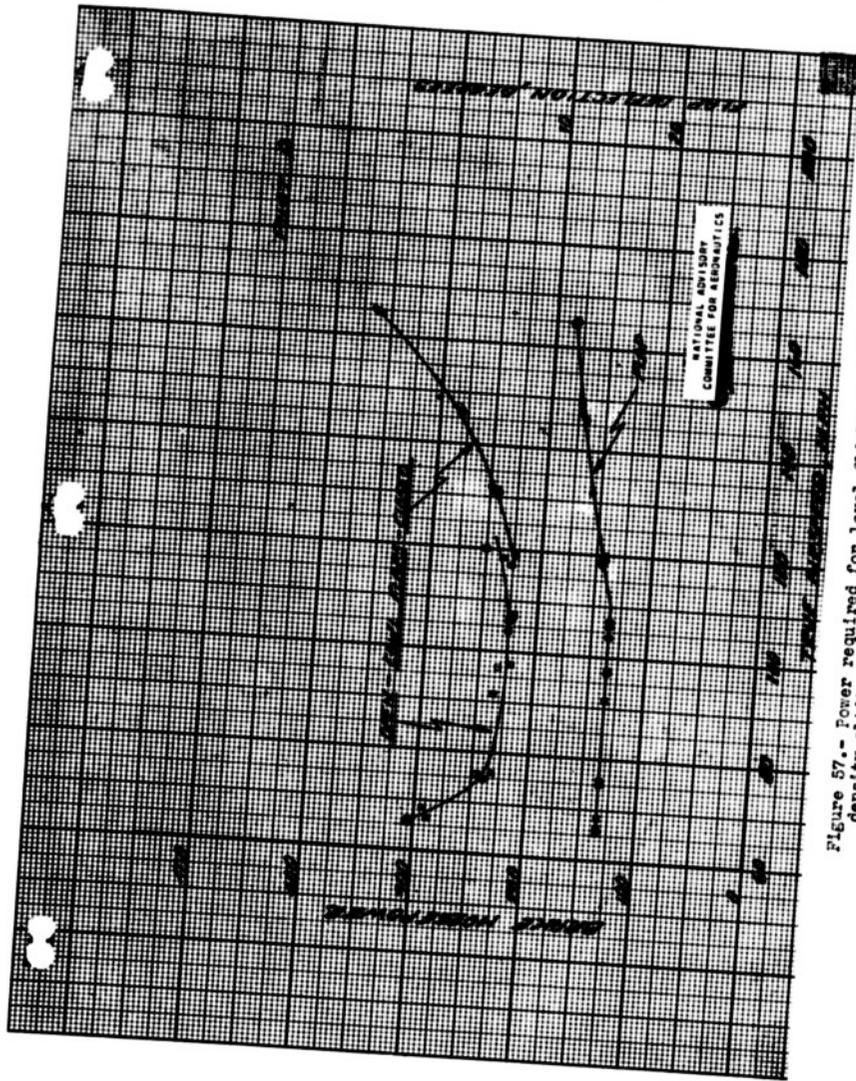
Figure 57.- Power required for level flight at 5500 feet density altitude and 4800 pounds weight. Test airplane with flaps set for 16.50 deflector, slots closed, hoods closed.

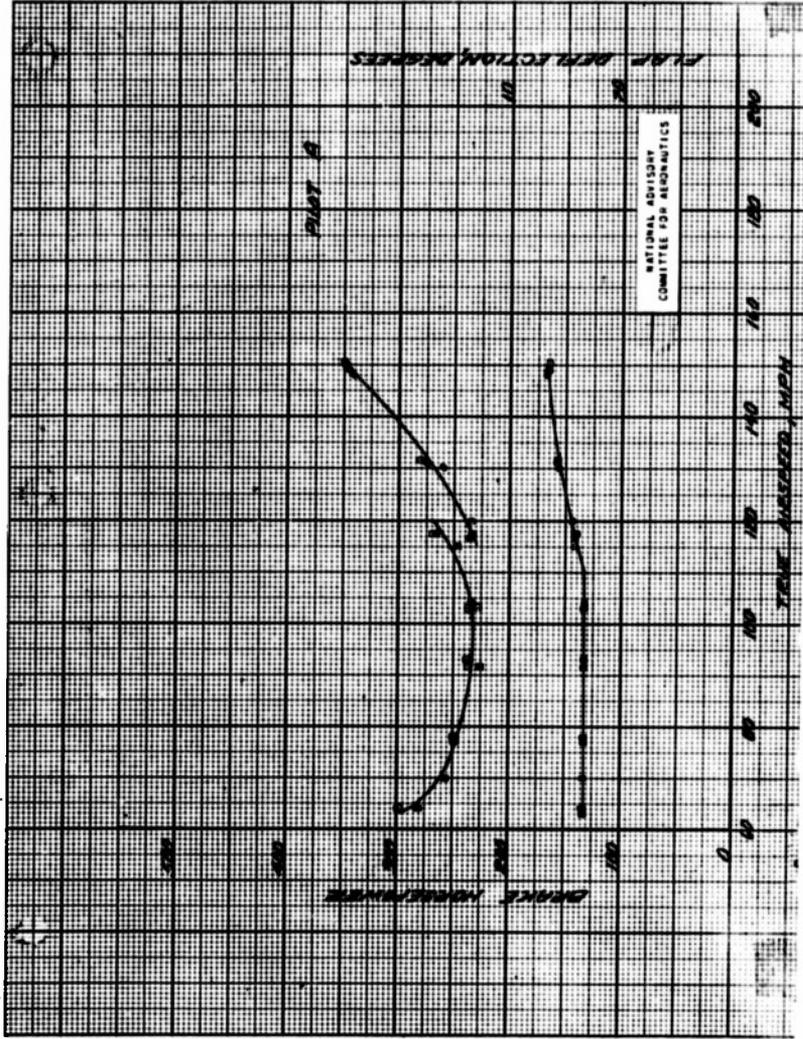
Figure 52.- Power required for level flight at 5500 feet density altitude and 4500 pounds weight. Test airplane with flap set for 16.75 deflection, slots open, hoods closed.
