*Waca  
Navy  
airpl*

NATIONAL ADVISORY COMMITTEE FOR AERONAUTICS

MEMORANDUM REPORT

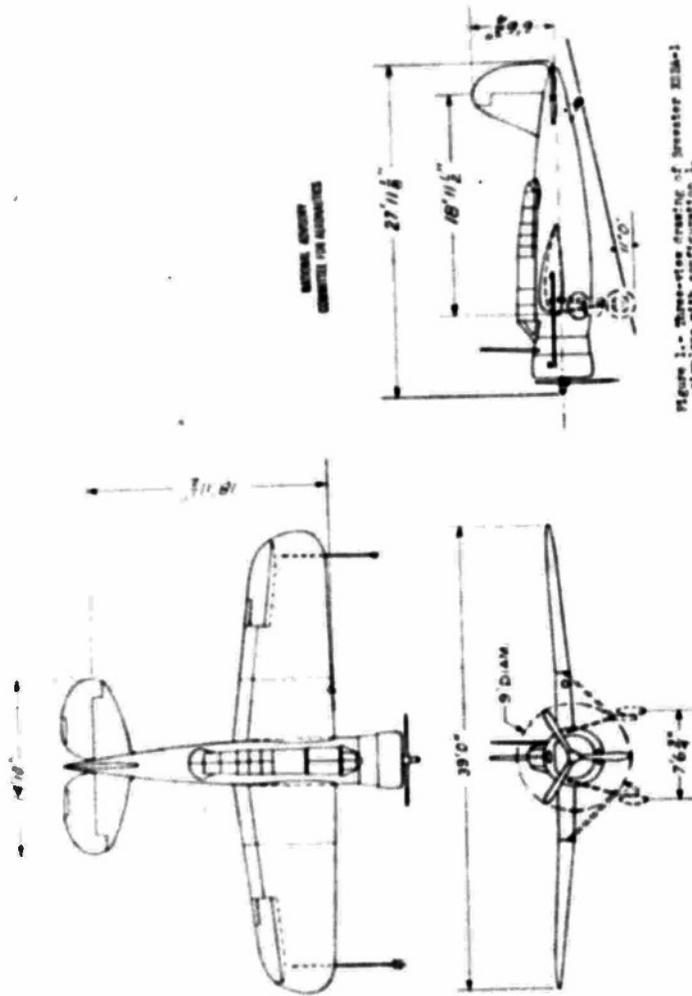
Figure 1.- Perspective drawing of Inceptor 2134a-1 airplane with configuration 1.

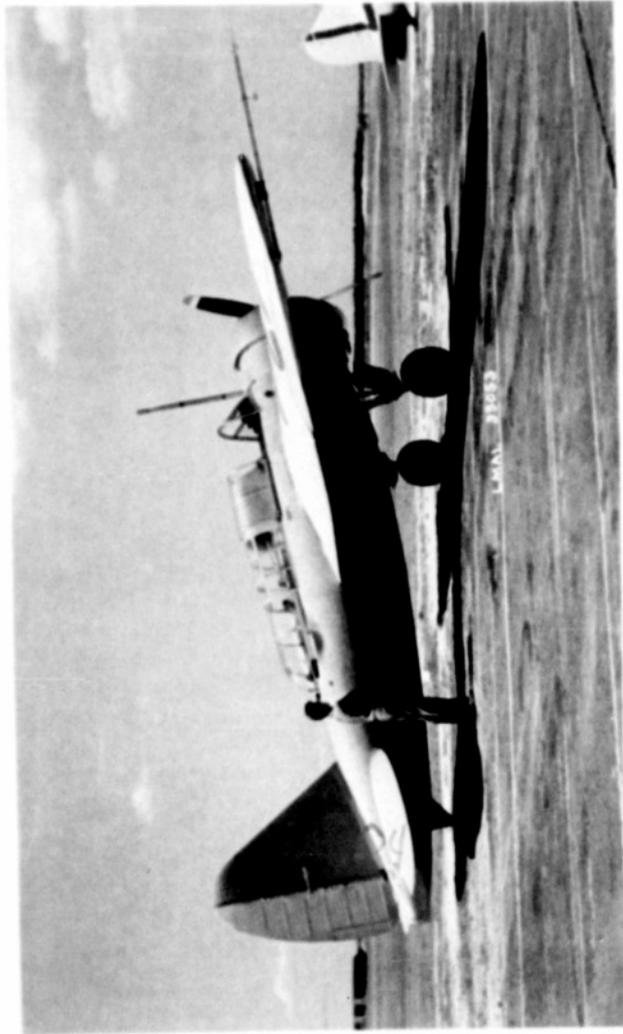
Figure 2.- Side view of Brewster XSB-1 with tail configuration 3.

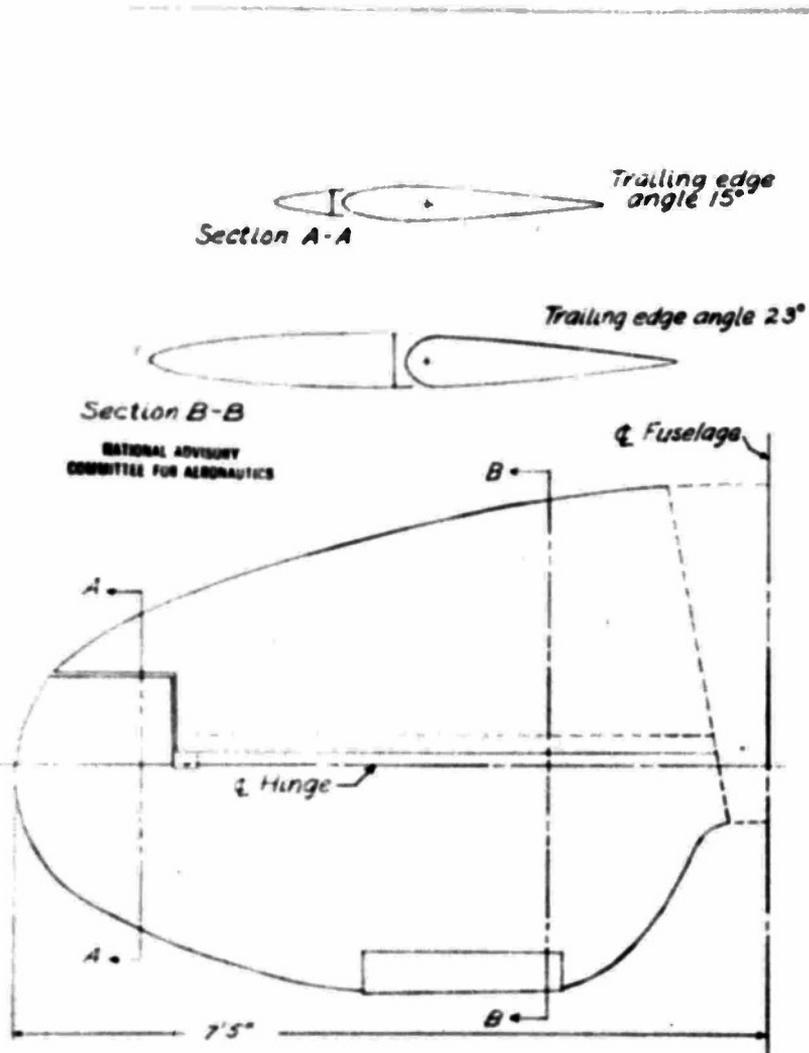
Figure 1.- Horizontal tail configuration number one. Brewster B38A-1 airplane.

1. As is shown in figures 3, 5, and 7, the elevator trimming tabs on the three tail configurations were of the same area. The power of the tab on tail 3 in pounds of stick force per degree of tab deflection, shown in figure 24, was about one-third that of the tabs on tails 1 and 2. With a deflection range of 11° the elevator trimming tab on tail 3 was inadequate in the landing condition. For every 3.5° of tab deflection on tail 3, 1° of elevator deflection in the opposite direction was required to trim the airplane at a given speed.

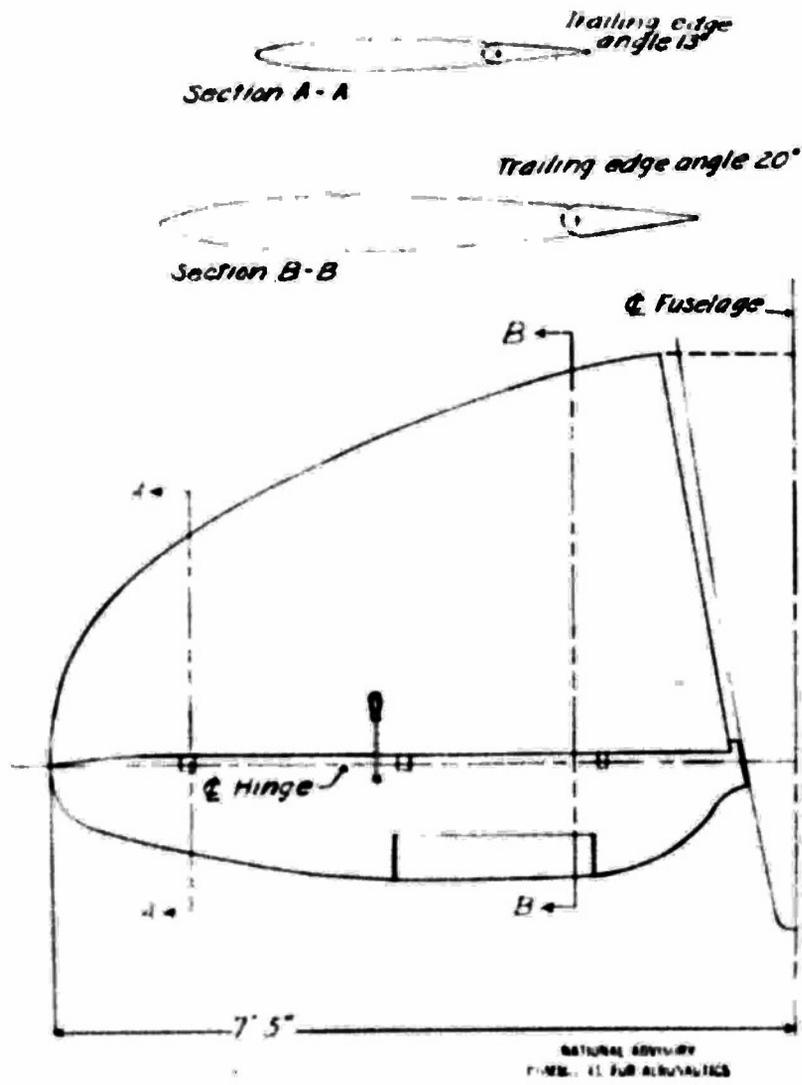
Figure 7.- Horizontal tail configuration of Brewster B339-1 airplane.

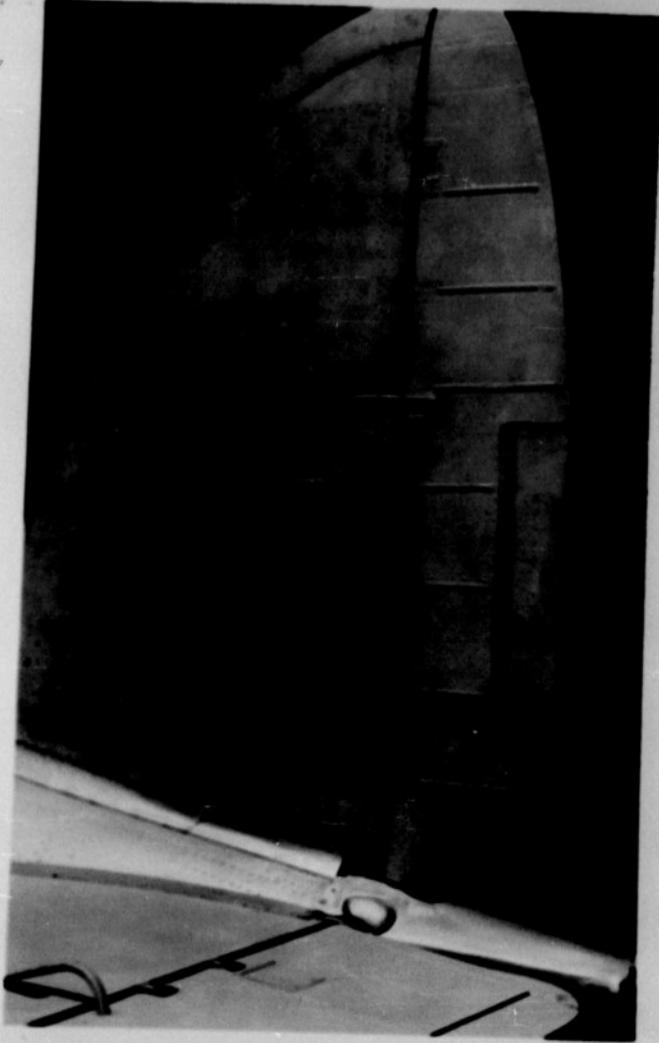
Figure 10.- Close-up of the horizontal tail of configuration 3:  
XSDA-1 airplane.

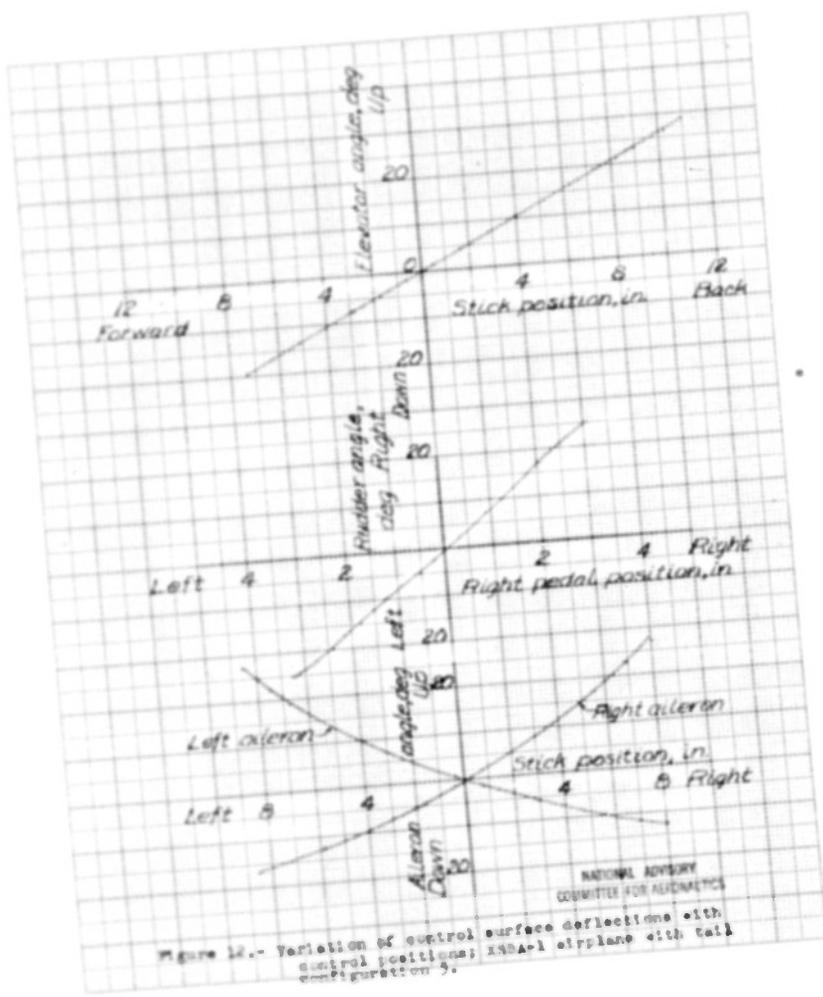
Figure 12.- Variation of control surface deflections with control positions; XA4A-1 airplane with tail configuration 3.

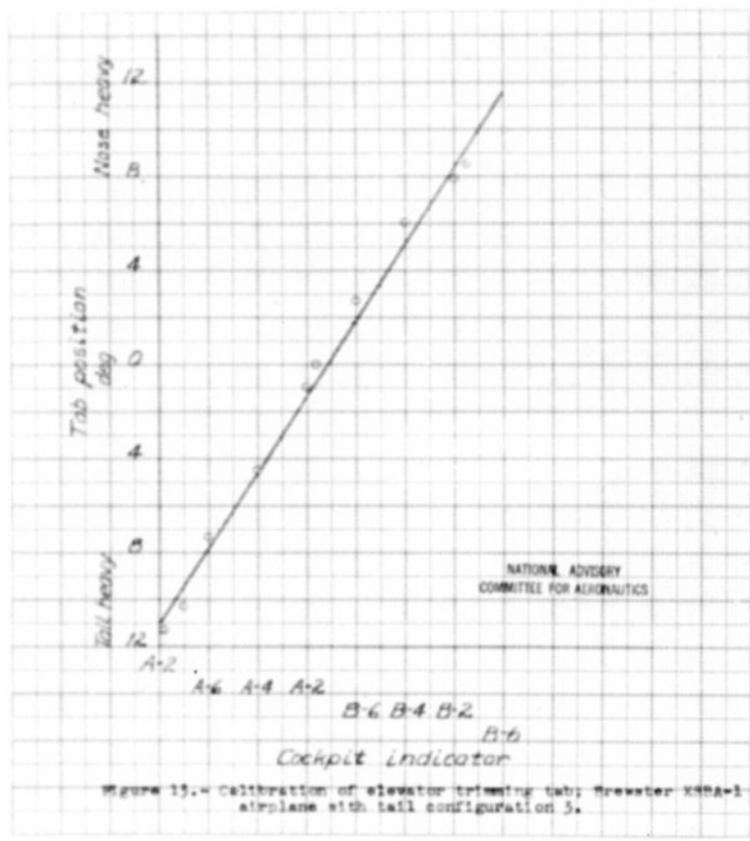
Figure 13.- Calibration of elevator trimming tab; Brewster XFB-1 airplane with tail configuration 3.

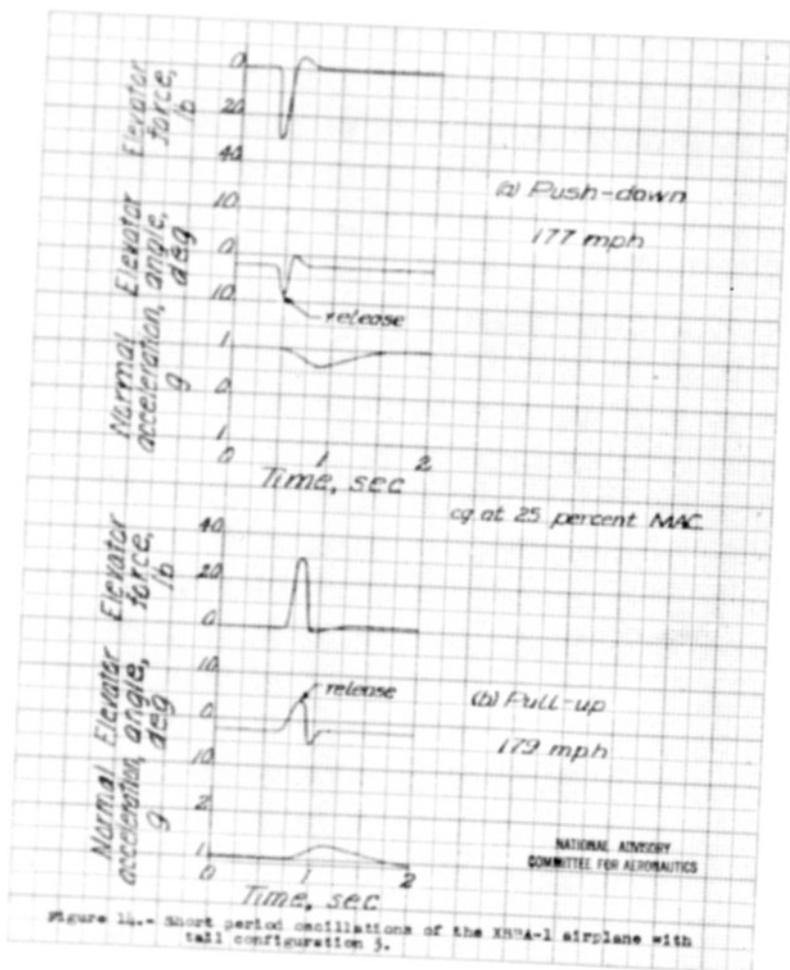
Figure 14.- Short period oscillations of the XNDA-1 airplane with tail configuration 3.

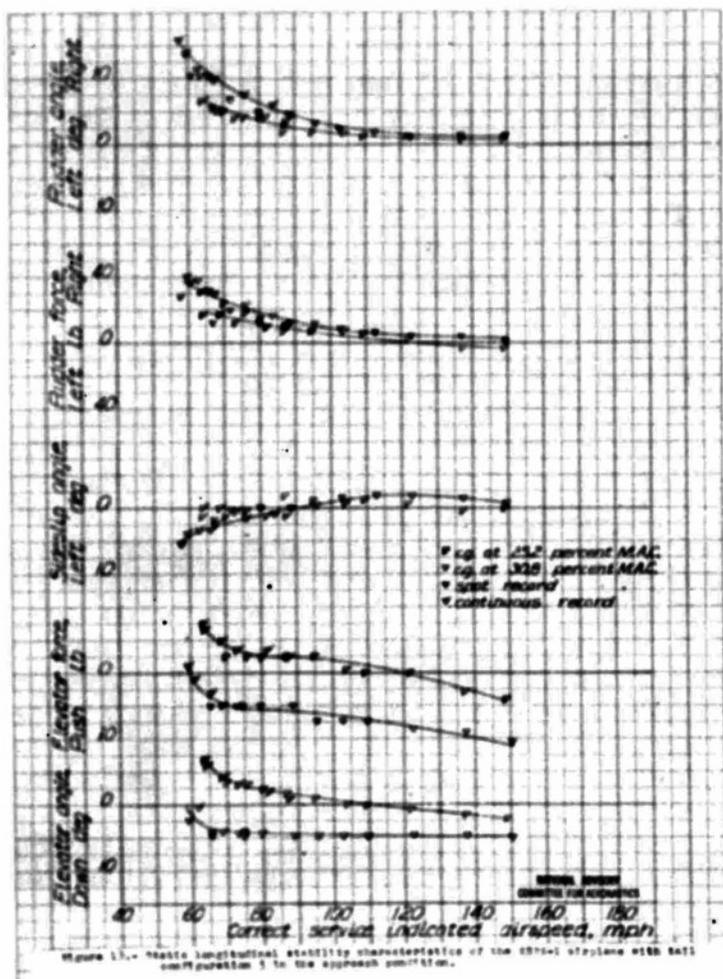
Figure 13. Static longitudinal stability characteristics of the Bristol airplane with ball configuration 5 in the approach position.

the speed range, the stick-fixed static stability had decreased but was still at least slightly positive for all-flight conditions. This is illustrated by the curves of elevator position against airspeed in figures 15 through 20.

2(a). The curves of elevator control force against indicated airspeed in figures 15 through 20 show the degree of stick-free static stability of the XSBA-1 airplane with tail configuration 3 with the trimming tabs undeflected. The force curves for the two center-of-gravity positions are parallel as would be expected with the same trimming-tab setting. With the center of gravity at 25 percent of the mean aerodynamic chord the airplane was stable, stick free, in all conditions except wave-off for any trim speed within the speed range for that flight condition. This statement is based on the calculated elevator force curves for various trim speeds which can be found using the power of the elevator trimming tab as given by figure 24.

3. The amount of rudder deflection required to trim the airplane for level flight in various conditions is shown in figures 15 through 20. Considerably more rudder deflection was required with the narrow-chord rudder of tail 3 than with rudders 1 and 2. The pilot stated that in some runs he "ran out of rudder" near the stall in the wave-off condition with tail configuration 3 but did not consider the rudder control inadequate on this account. In these instances the correct rudder deflection was almost  $20^\circ$  compared with about  $10^\circ$  required with rudders 1 and 2. Because of differences in the gas loading in the wing tanks, there may have been differences in the lateral position of the center of gravity which would have affected the amount of rudder deflection required for trim. Inasmuch as no records were kept of the lateral loading conditions, the effects of this variable on the rudder deflection were not determined. Subsequent flight tests have shown that a lateral center-of-gravity shift of a few inches produces a large effect on the amount of rudder deflection required for trim near the stall.

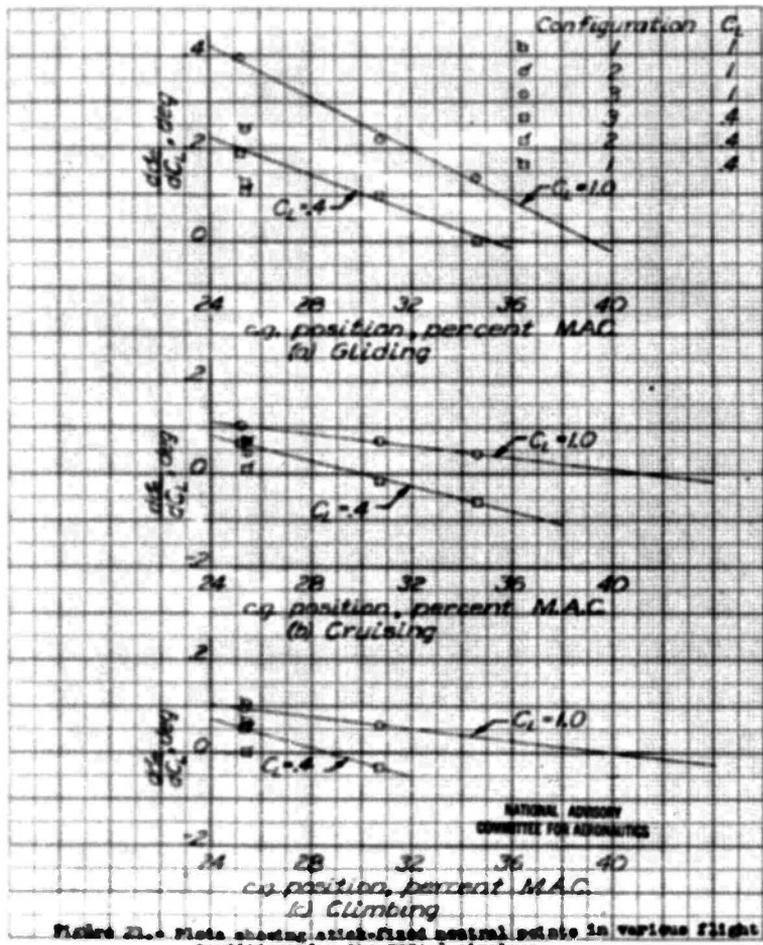
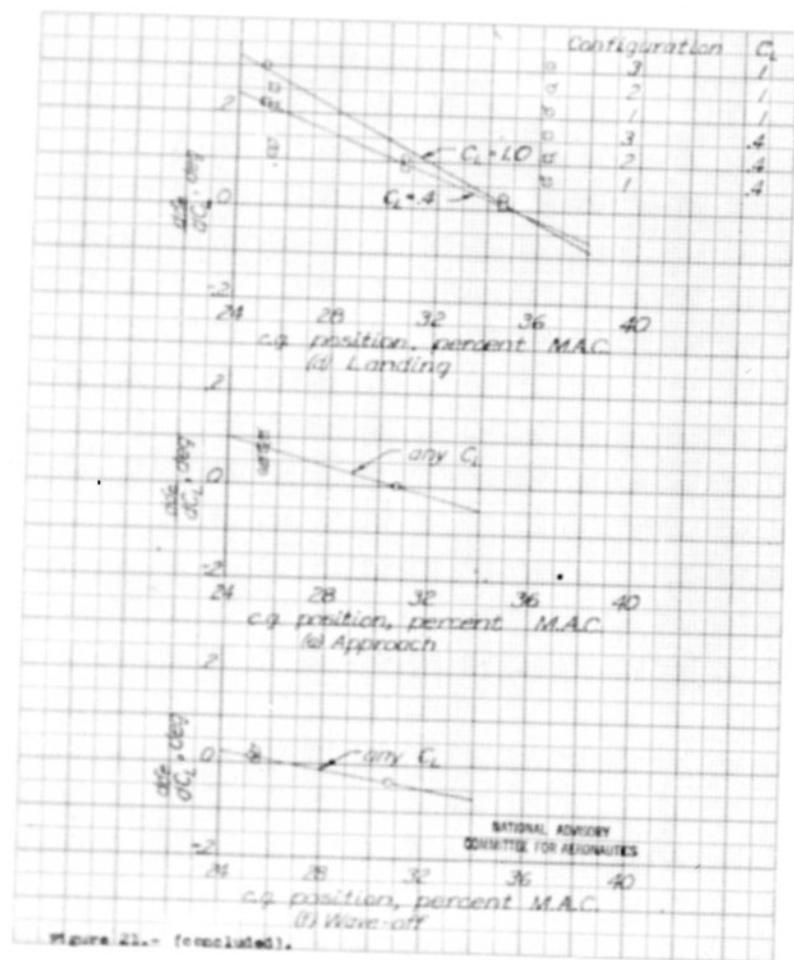
Figure 21.- Plots showing stick-fixed neutral points in various flight conditions for the XSB-1 airplane.

Figure 21. - Plots showing stick-fixed neutral points in various flight conditions for the X38A-1 airplane.

1(b). The stick-fixed neutral points have been determined for the airplane with tail 3 at lift coefficients of 0.4 and 1.0 from flight tests at three center-of-gravity positions. Figure 21 contains the plots of  $d\delta_e/dC_L$  against center-of-gravity position, where  $\delta_e$  is elevator position and  $C_L$  is airplane lift coefficient, from which the stick-fixed neutral points were determined. Figure 22, a plot of  $\delta_e$  against  $C_L$ , illustrates for one condition, landing, the intermediate step between the plots of elevator deflection against airspeed and the plots of  $d\delta_e/dC_L$  against center-of-gravity position.

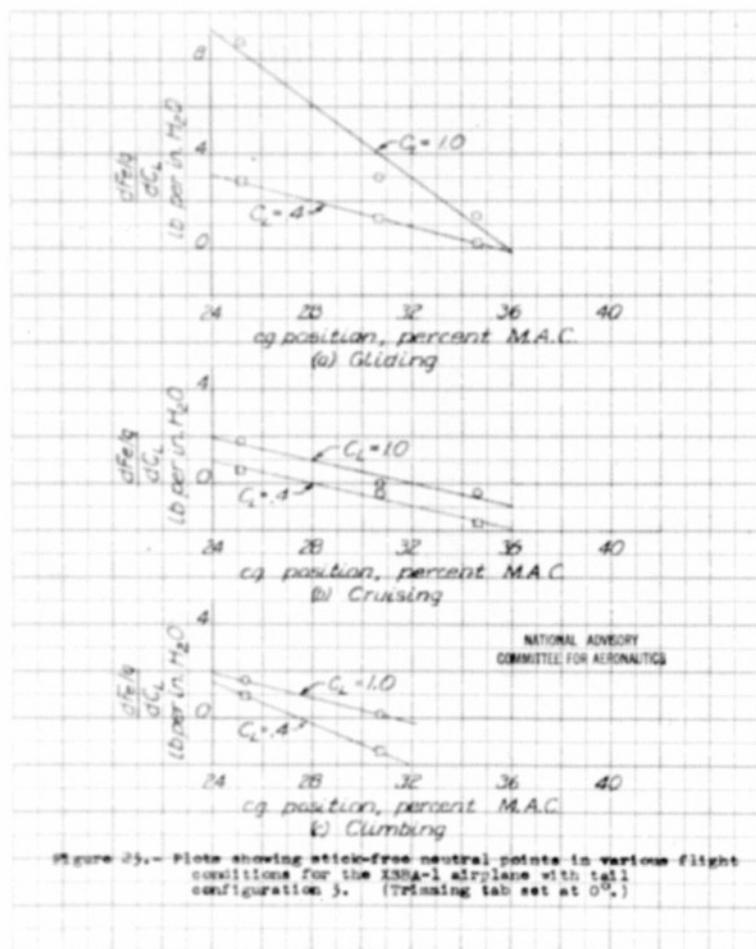
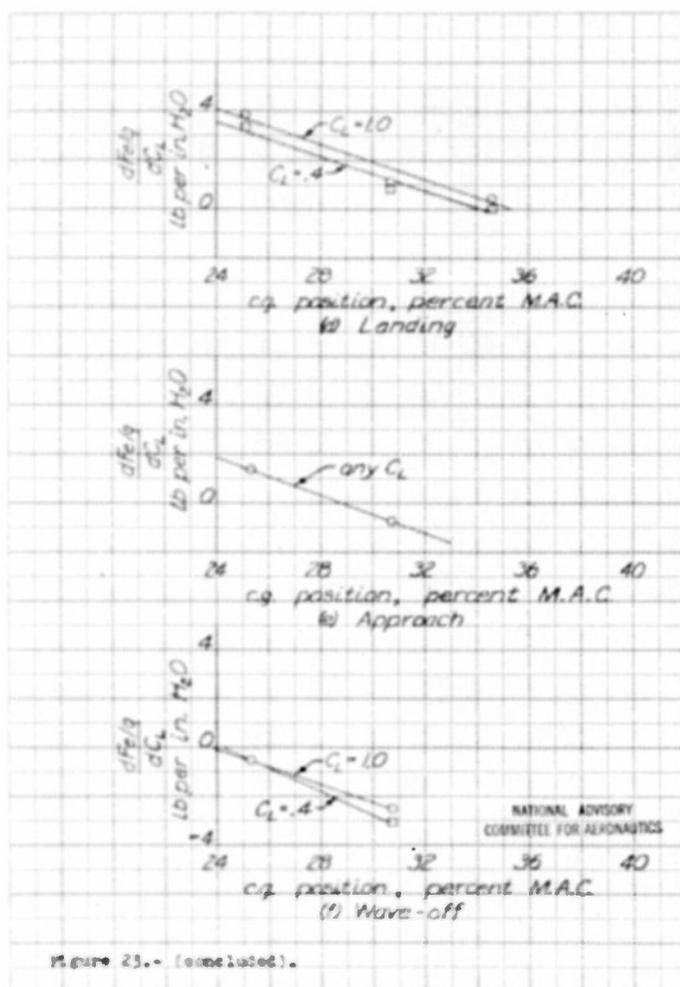
Figure 23.- Plots showing stick-free neutral points in various flight conditions for the XSB-1 airplane with tail configuration 3. (Trimming tab set at 0°.)

Figure 23.— Plots showing stick-free neutral points in various flight conditions for the XSB-1 airplane with tail configuration 3. (Trimming tab set at 0°.)

2(b). The stick-free neutral points have been determined at lift coefficients of 0.4 and 1.0 for the airplane with tail configuration 3 from flight tests at three center-of-gravity positions. Figure 23 contains plots of the variation of  $P/q_c$  with  $C_L$  against center-of-gravity position, where  $P$  is elevator control force and  $q_c$  is impact pressure, from which the neutral points are determined. The intermediate step, a plot of  $P/q_c$  against  $C_L$ , is again illustrated for one condition by figure 22.

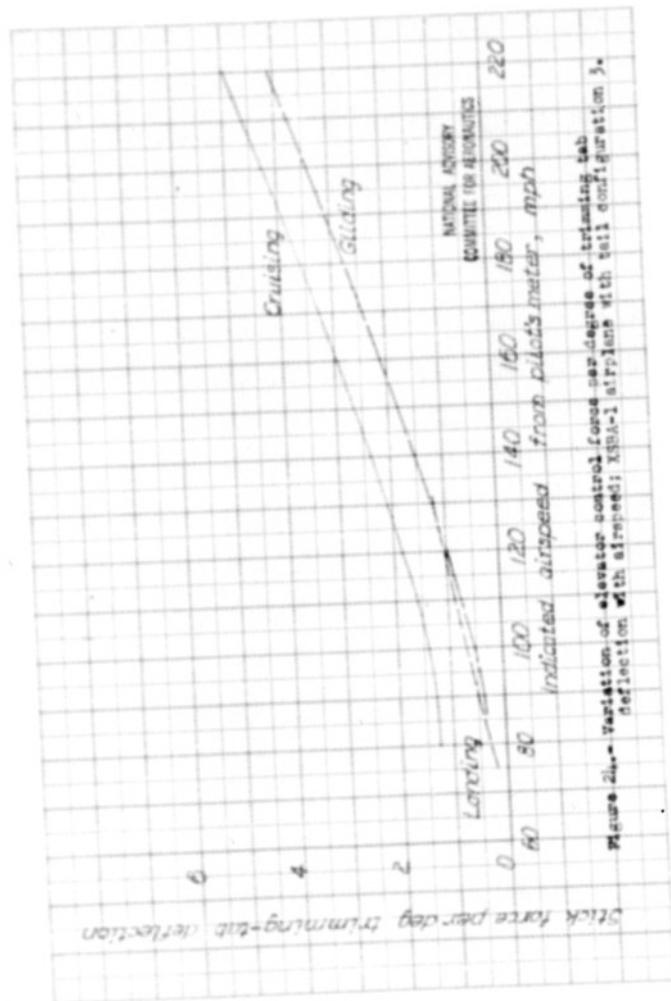
Figure 24.-- Variation of elevator control force per degree of trimming tab deflection with airspeed: XSPA-1 airplane with tail configuration 3.

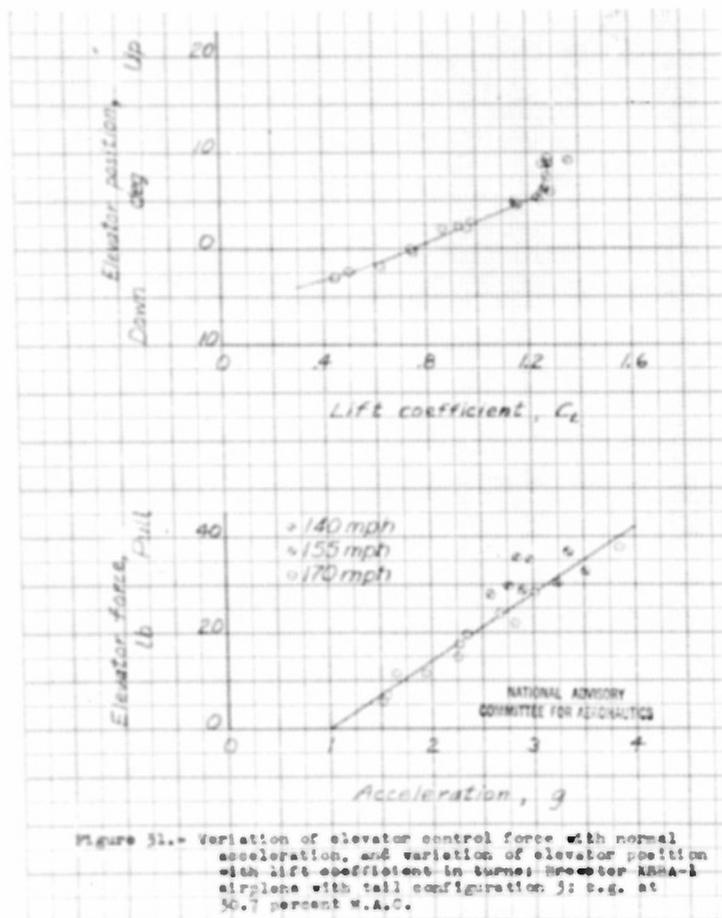
Figure 51.- Variation of elevator control force with normal acceleration, and variation of elevator position with lift coefficient in turns; Proctor ABMA-1 airplane with tail configuration 3; e.g. at 50.7 percent W.A.C.

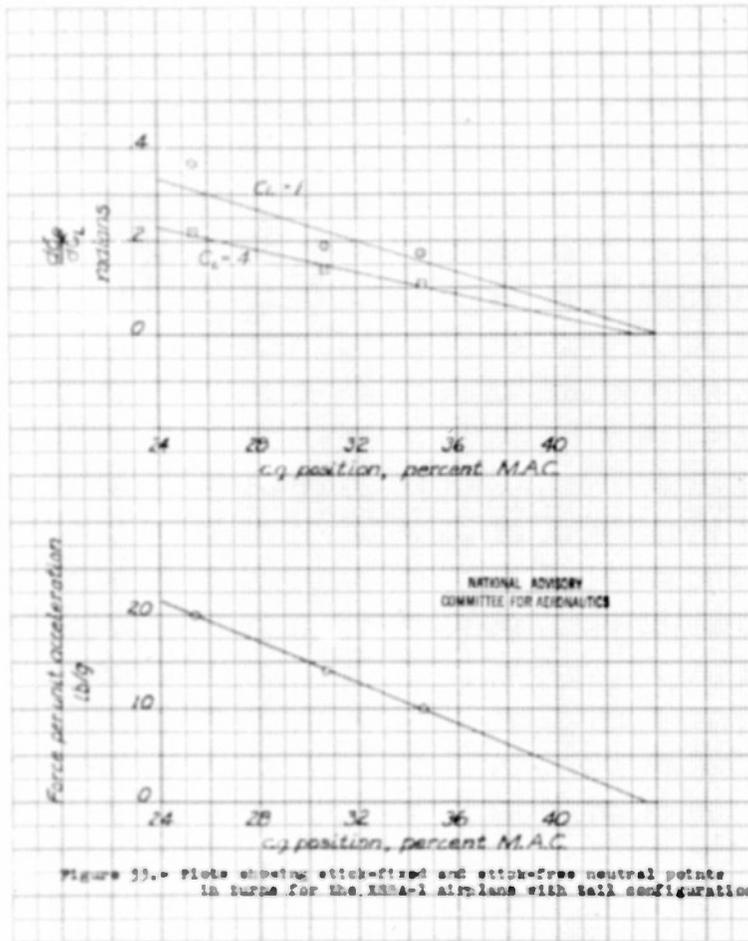
Figure 39.— Plots showing stick-fixed and stick-free neutral points in terms of percent M.A.C. for the XSB-1 airplane with tail configuration 1.

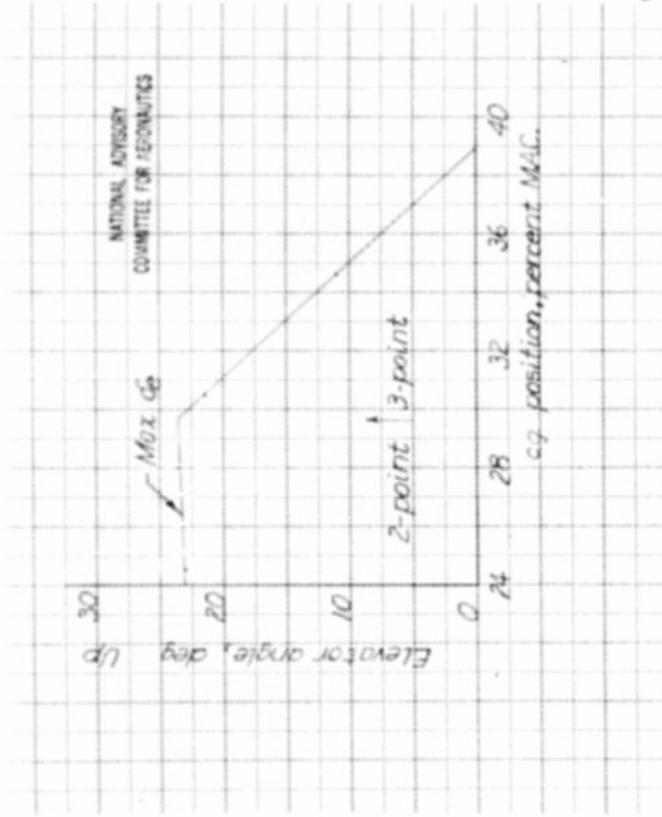
Figure 34.- Elevator deflection required to land XSPA-1 airplane with tail configuration 3 (power off, flaps down).

aerodynamic chord the elevator did not have sufficient power to stall the airplane in the landing condition either at altitude or during an actual landing, as shown by figures 22 and 34. With the wider chord surfaces of tails 1 and 2 the elevator angles required for trim were well within the available range for all flight conditions.

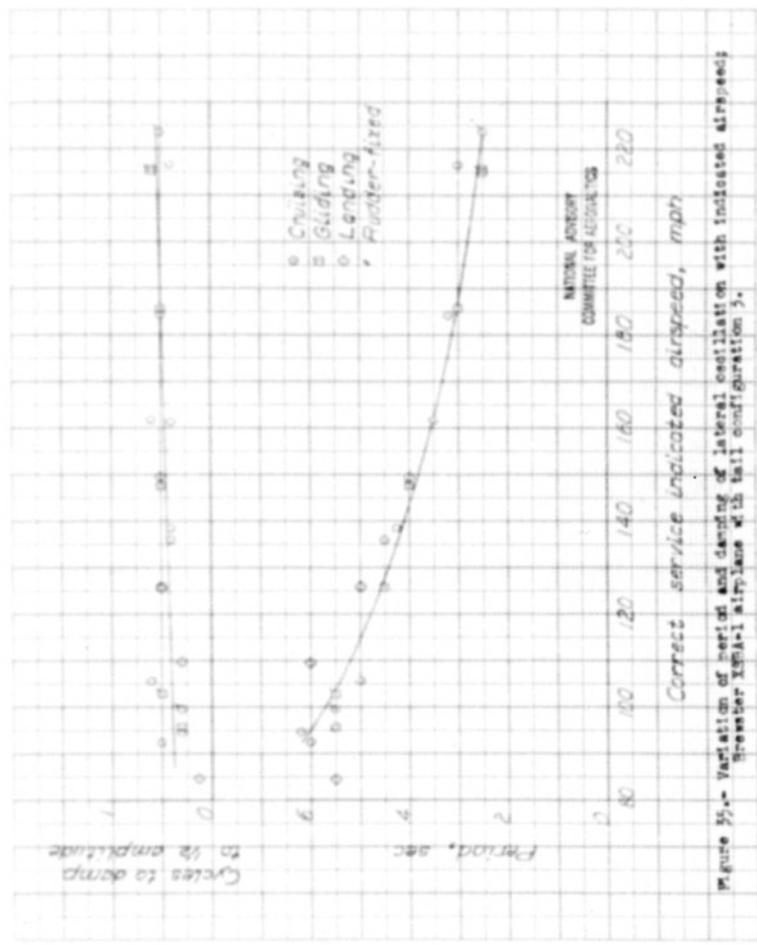
Figure 55.- Variation of period and damping of lateral oscillation with indicated airspeed; Bessner Light airplane with tail configuration 3.

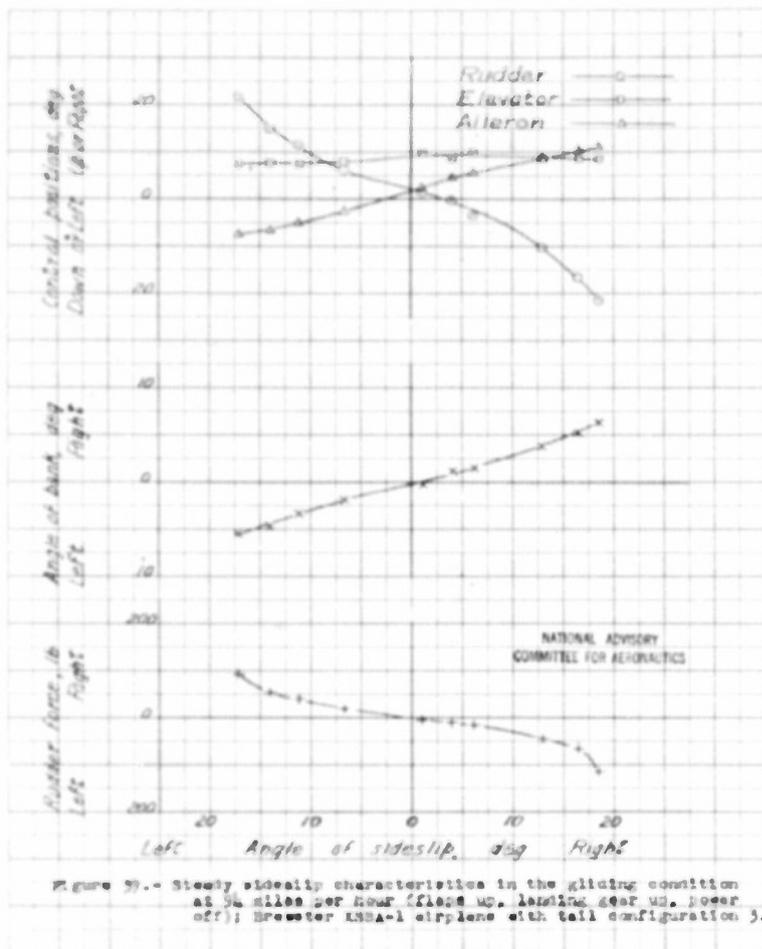
Figure 29.- Steady sideslip characteristics in the gliding condition at 50 miles per hour (flaps up, landing gear up, power off); Brewster BNA-1 airplane with tail configuration 3.

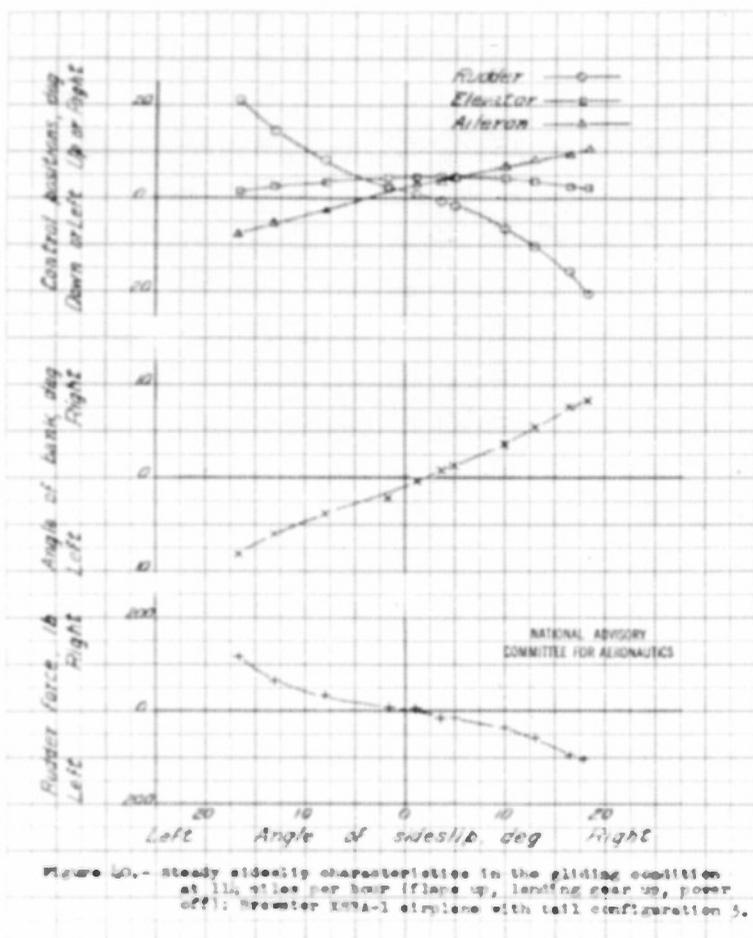
Figure 40.- Steady sideslip characteristics in the gliding condition at 114 miles per hour (flaps up, landing gear up, power off); Brewster XSBA-1 airplane with tail configuration 3.

Figure 40.- Steady sideslip characteristics in the gliding condition at 114 miles per hour (flaps up, landing gear up, power off); Brewster B39A-1 airplane with tail configuration 3.

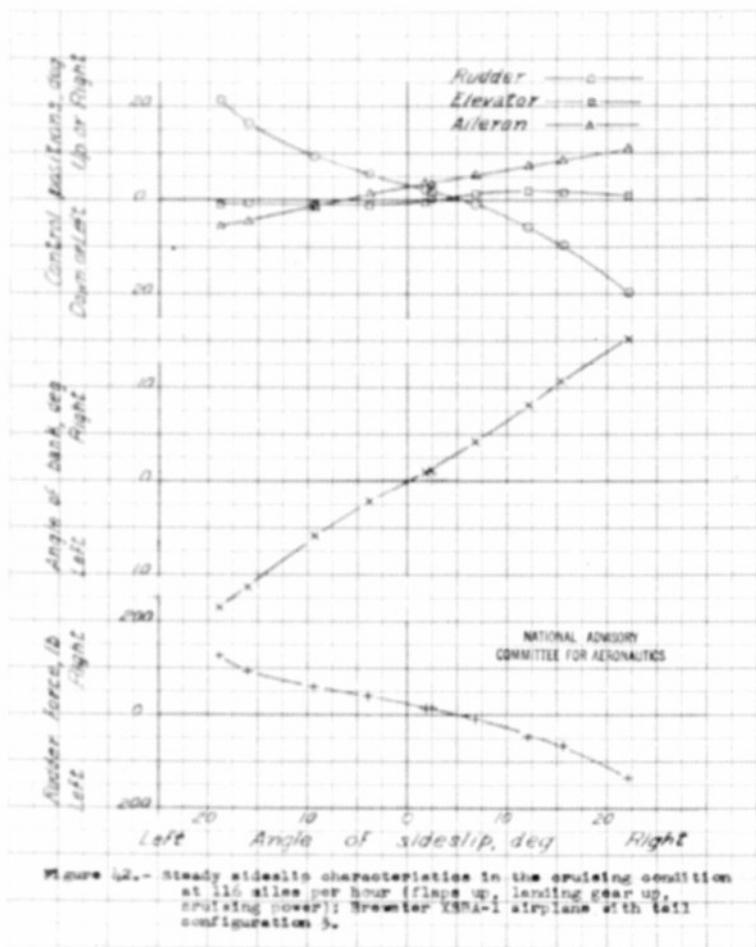
Figure 42.- Steady sideslip characteristics in the cruising condition at 116 miles per hour (flaps up, landing gear up, cruising power); Brewster XSBA-1 airplane with tail configuration 3.

Figure 42.- Steady sideslip characteristics in the cruising condition at 115 miles per hour (flaps up; landing gear up, cruising power); Brewster XNA-1 airplane with tail configuration 5.

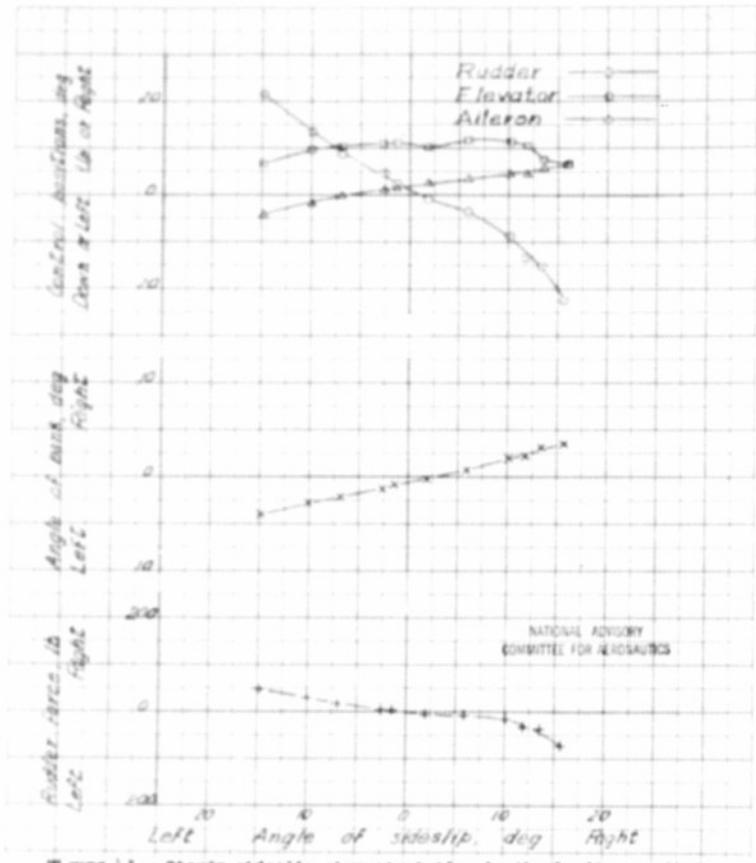
Figure 43.- Steady sideslip characteristics in the landing condition at 83 miles per hour (flaps down, landing gear down, power off); Brewster XSBA-1 airplane with tail configuration 3.

Figure 43.- Steady sideslip characteristics in the landing condition at 55 miles per hour (flaps down, landing gear down, power off); Brewster BNA-2 airplane with tail configuration 3.

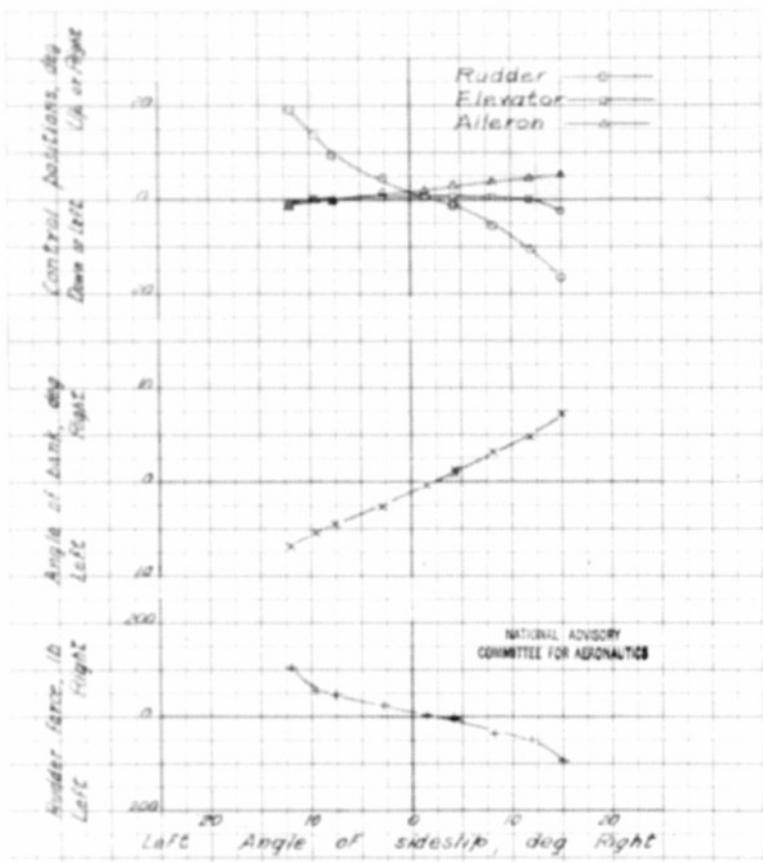
Figure 44.- Steady sideslip characteristics in the landing condition at 112 miles per hour (flaps down, landing gear down, power off); Brewster XSBA-1 airplane with tail configuration 3.

Figure 44.- Steady sidslip characteristics in the landing condition at 112 miles per hour (flaps down, landing gear down, power off); Brewster XSB-1 airplane with tail configuration 3.

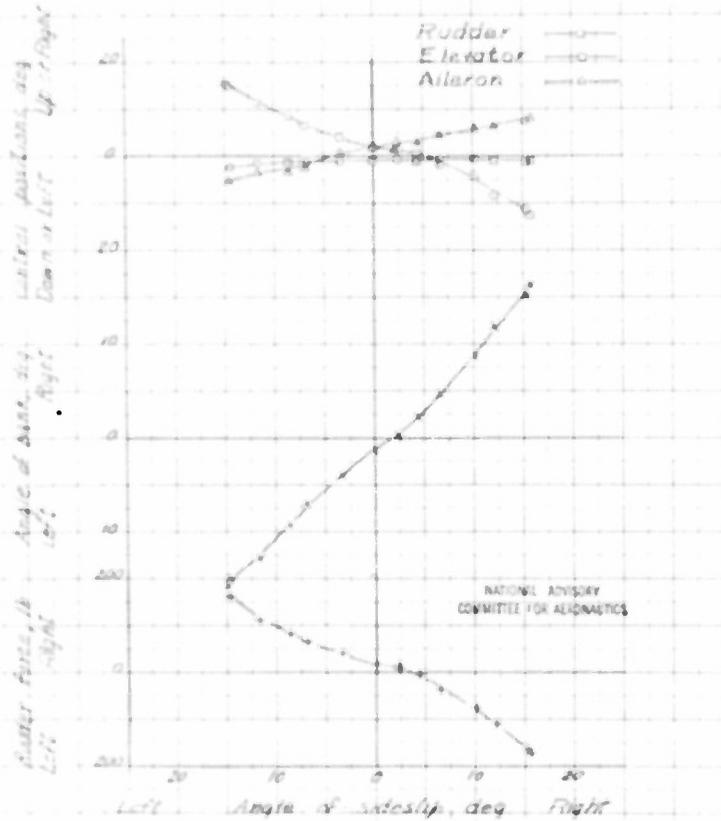
Figure 45.- Steady sideslip characteristics in the level flight condition at 157 miles per hour (flaps up, landing gear up, power on); Brewster XSBA-1 airplane with tail configuration 3.

Figure 45. - Steady sideslip characteristics in the level flight condition at 157 miles per hour (flaps up, landing gear up, power on); Brewster XSB-1 airplane with tail configuration 3.

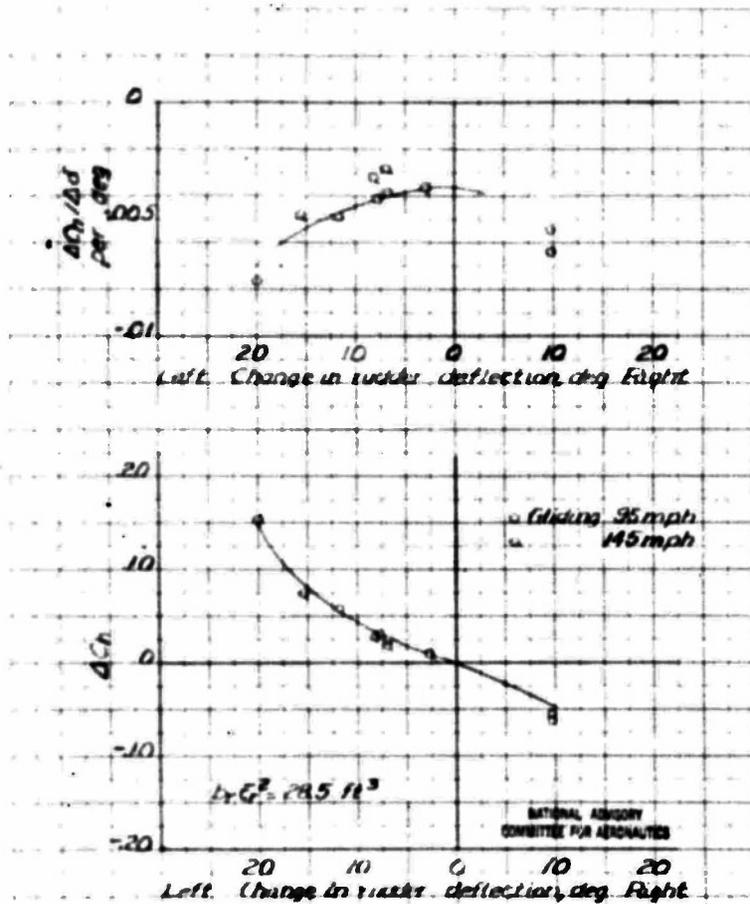
Figure 54.- Plots of  $\Delta C_n / \Delta \delta$  and  $\Delta C_n$  for constant  $\alpha$  against change of rudder deflection during rudder kicks; XSB-1 airplane with tail configuration 1.

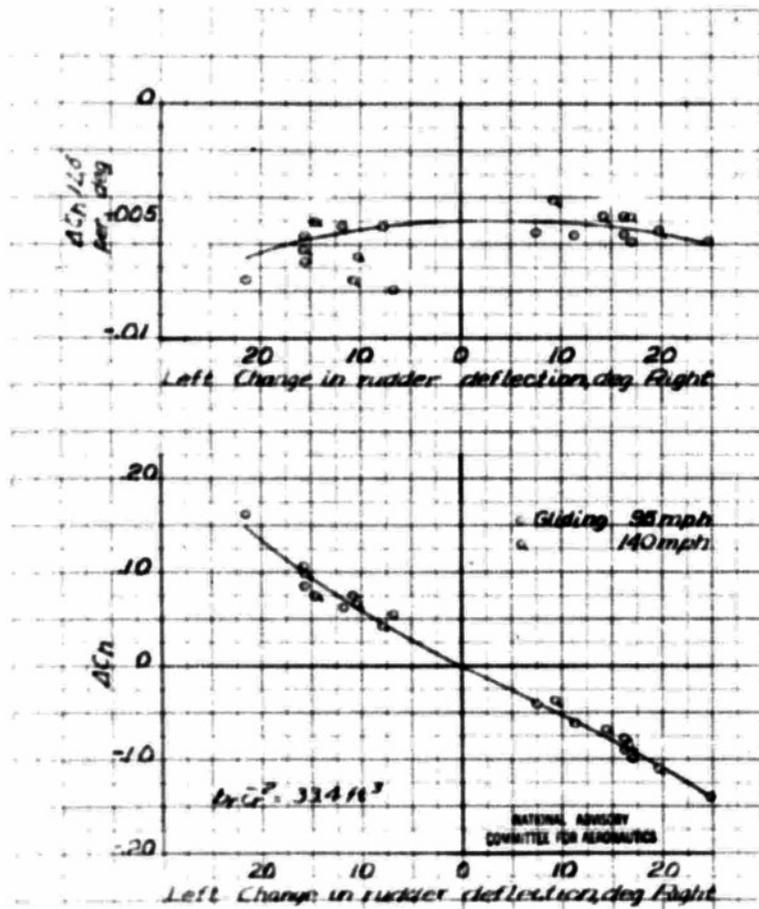
Figure 55.- Plots of  $\Delta C_n / \Delta \delta$  and  $\Delta C_n$  for constant  $\alpha$  against change of rudder deflection during rudder kicks; KSB-1 airplane with tail configuration 2.

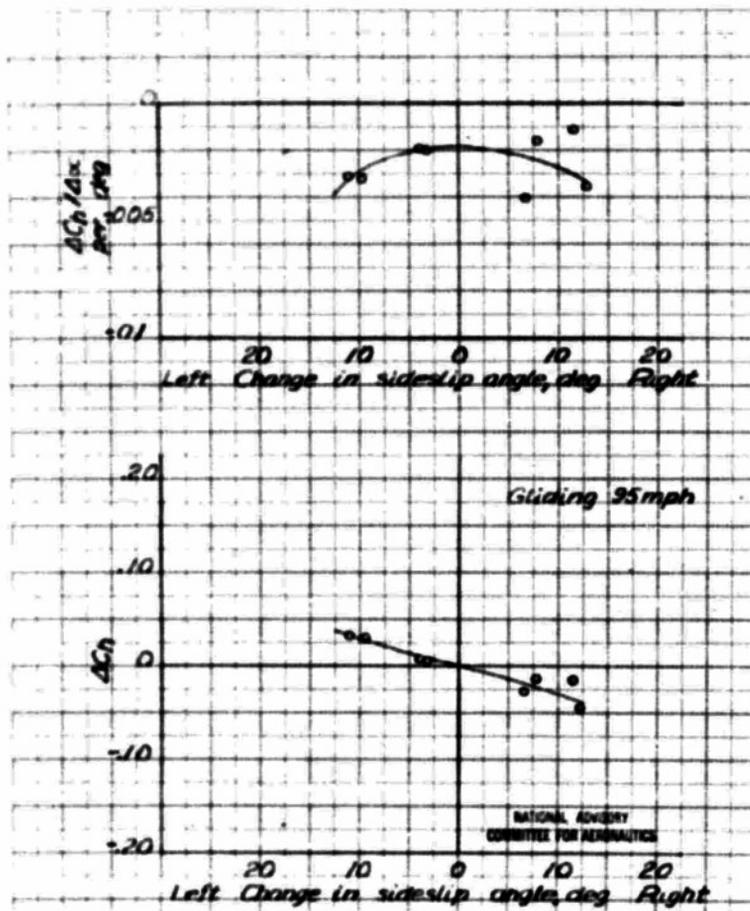
**Figure 56.-** Plots of  $\Delta C_h/\Delta \alpha$  and  $\Delta C_h$  against change of sideslip angle during rudder kicks; XSBA-1 airplane with tail configuration 3.

Figure 56.- Plots of  $\Delta C_n / \Delta \alpha$  and  $\Delta C_n$  against change of sideslip angle during rudder kicks; X5RA-1 airplane with tail configuration 5.
