No. 1224

FLIGHT TESTS OF A DOUBLE-HINGED HORIZONTAL TAIL SURFACE WITH REFERENCE
TO LONGITUDINAL-STABILITY AND -CONTROL CHARACTERISTICS

By Carl M. Hanson and Seth B. Anderson

Ames Aeronautical Laboratory
Moffett Field, Calif.

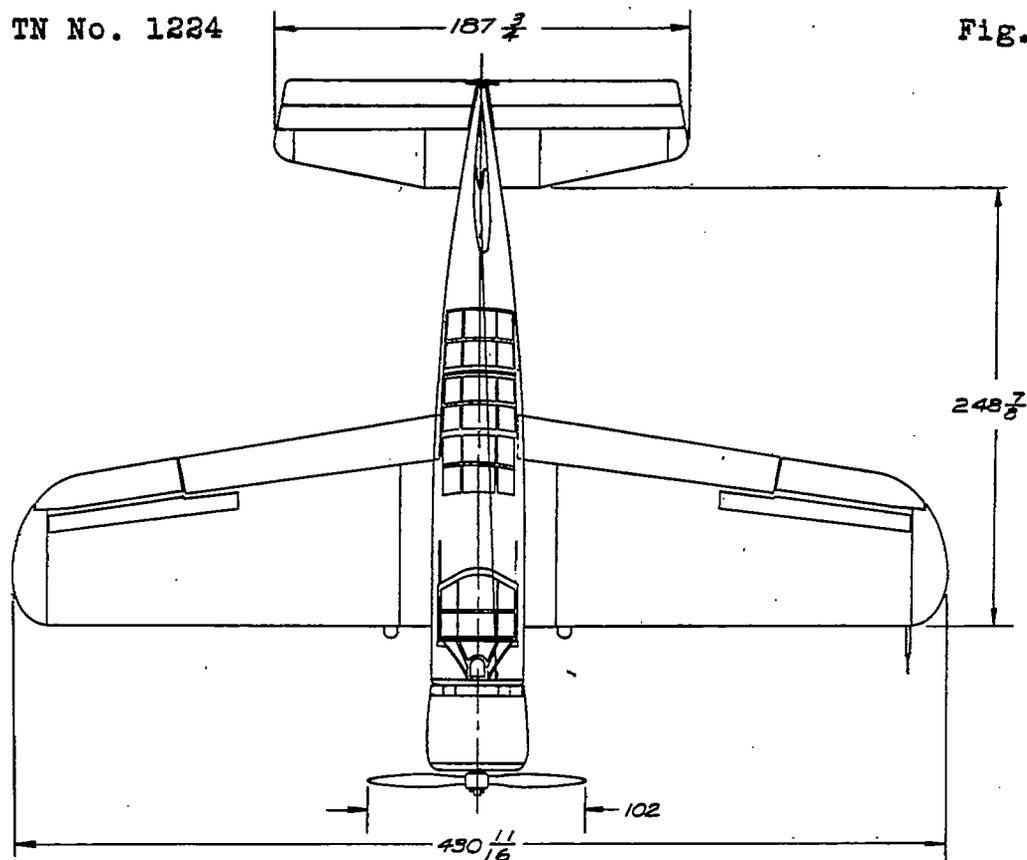
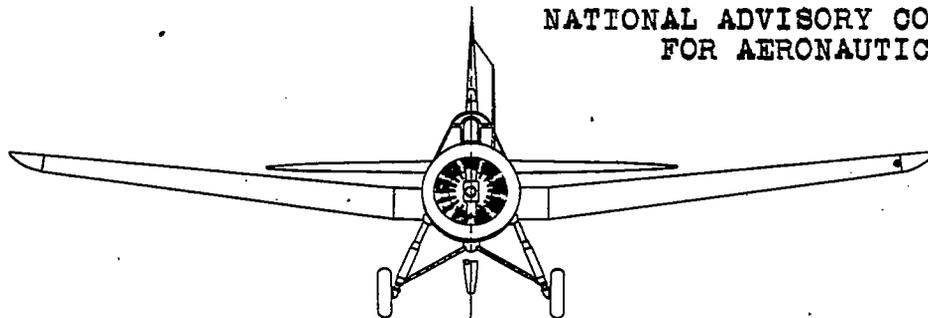
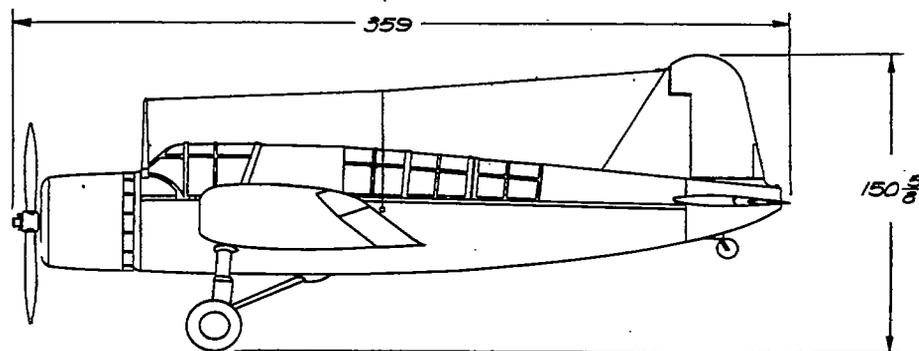
Figure 1.- Three-view drawing of the test airplane equipped with a double-hinged horizontal tail.

A three-view drawing of the airplane is shown in figure 1. A photograph of the airplane instrumented for flight tests is given in figure 2, and figure 3 is a photograph showing various positions of the horizontal control surface. To eliminate any tendency of the separate halves of the elevator to assume different angles (because of play inherent in the actuating mechanism), the two portions of the elevator were connected rigidly together by a strip at the elevator trailing edge. The mechanics of the elevator system were such that the range of elevator deflection (relative to the trimmer) was independent of the trimmer setting. Friction in the elevator control system was less than one-half pound, as measured when the control was moved slowly through the neutral position with no load on the surfaces. The variation of elevator angle with stick position as measured on the ground with no load applied to the surfaces is shown in figure 4. The trimmer drive mechanism was hand-operated from the cockpit through a cable-chain system. The mechanical advantage was such that 1.0 turn of the control handle (on a 5-inch arm) was required to change the trimmer angle 1°. Plan and section views of the horizontal tail are shown in figures 5 and 6, respectively.

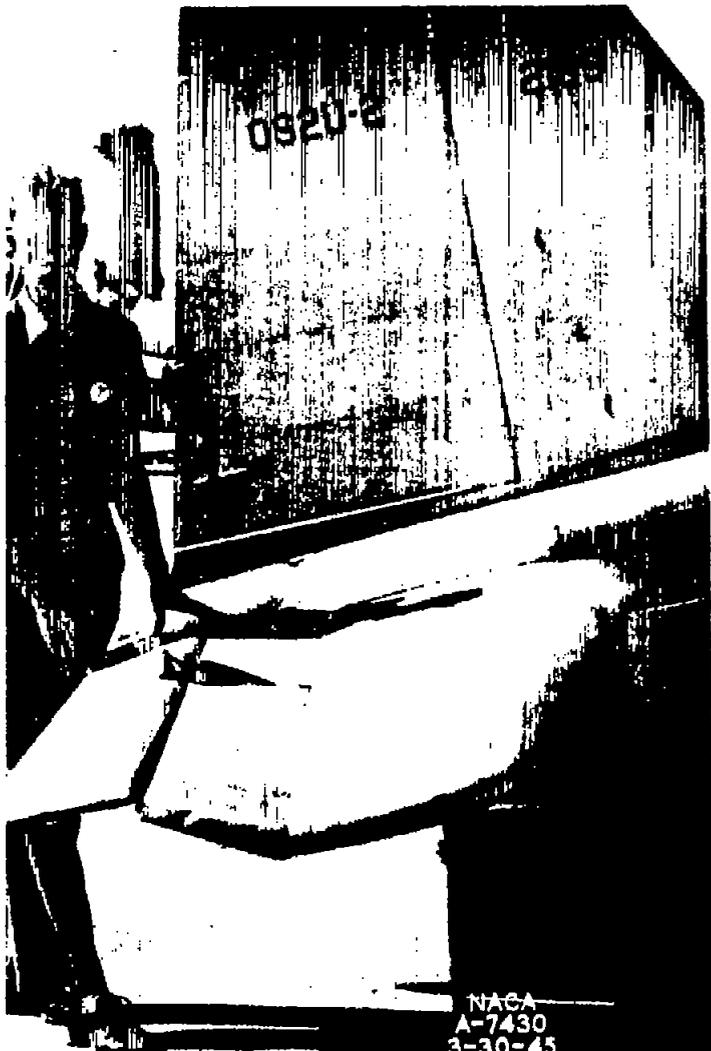
(a) Trimmer full down, elevator full up. (b) Trimmer full down, elevator full down.

Figure 3.- Side view of the double-hinged horizontal-tail surface, trimmer and elevator deflected.

(c) Trimmer full up, elevator full down. (d) Trimmer full up, elevator full up.
Figure 3.- Concluded.

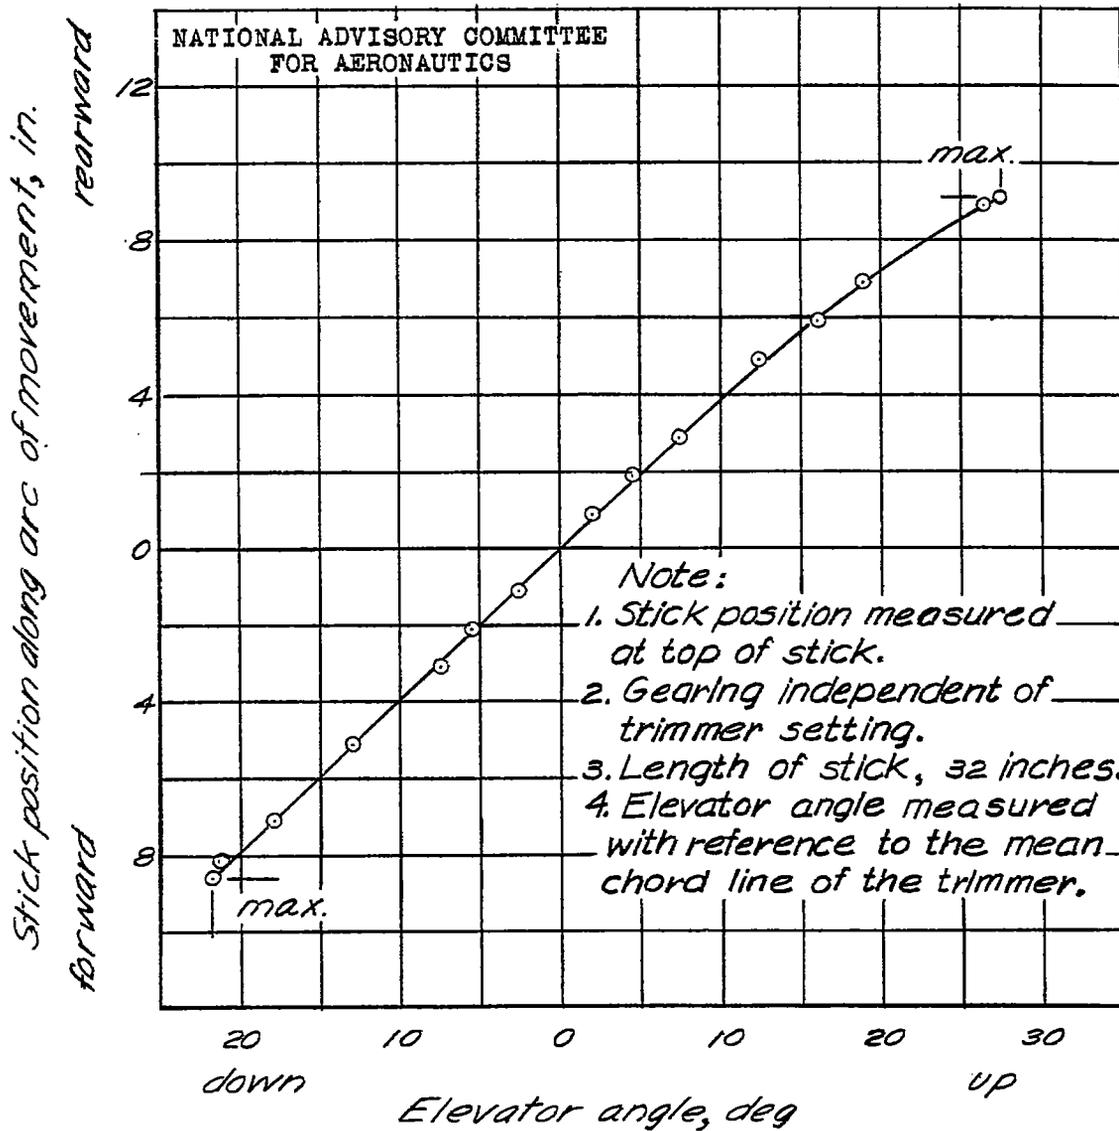
Figure 4 - Variation of stick position with elevator angle as measured on the ground with no load on the surfaces.

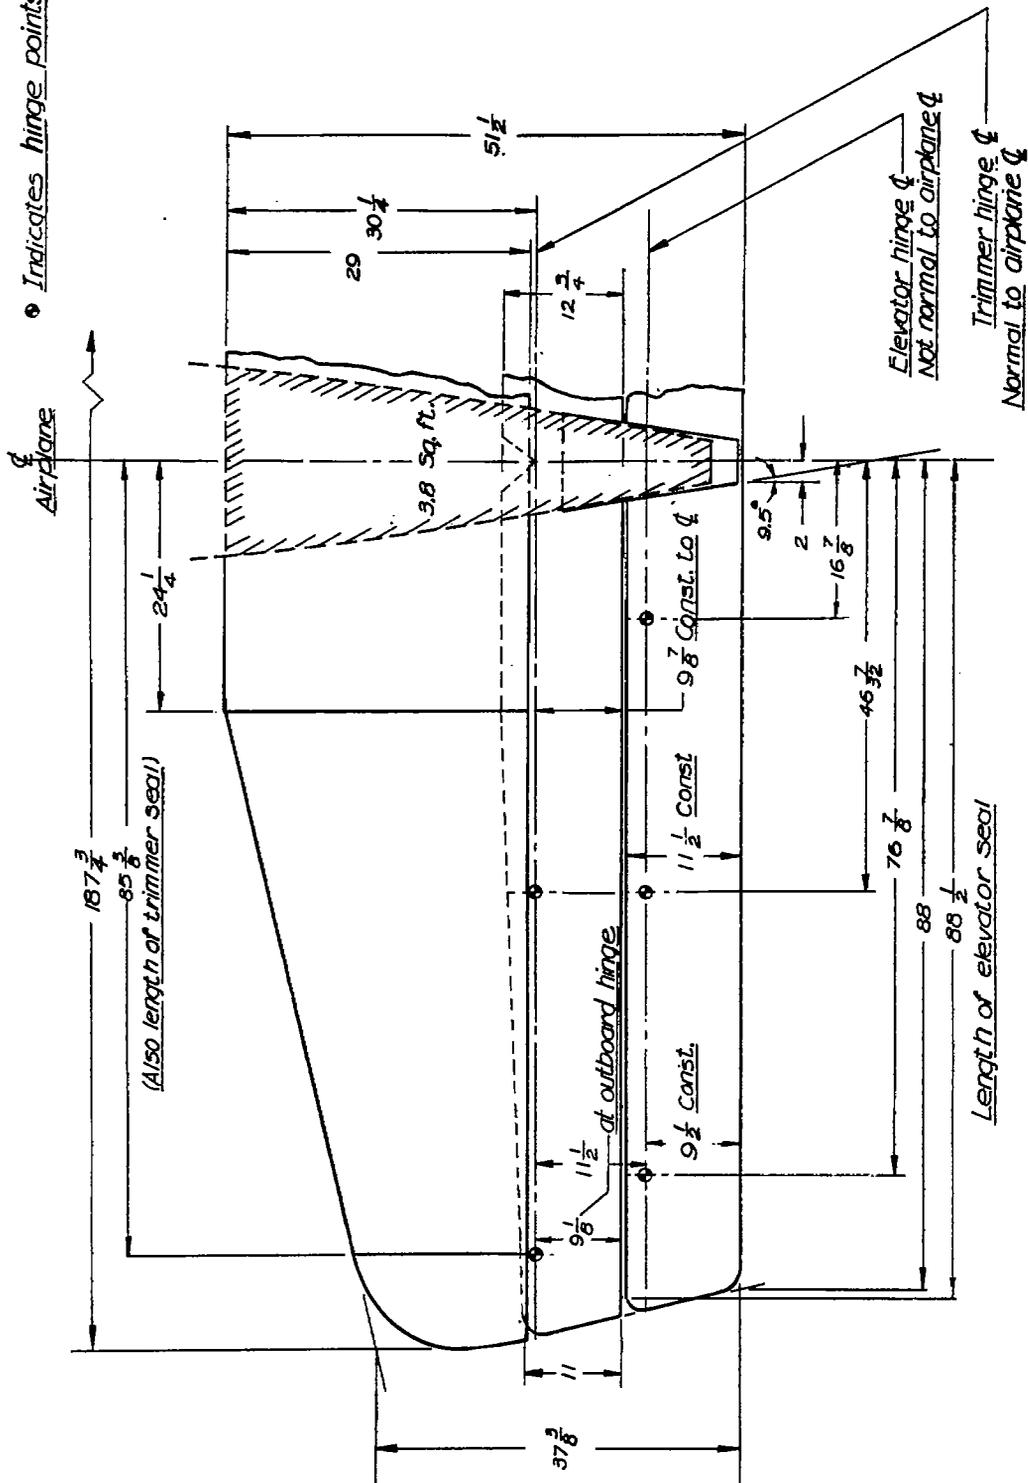
Figure 5.-Plan form of double-hinged horizontal tail.

1. The Vought Special airfoil used approximates an NACA 0013 airfoil.
2. Full-span seals were employed except for trimmer hinge cut-outs.
3. Approximately true to scale.

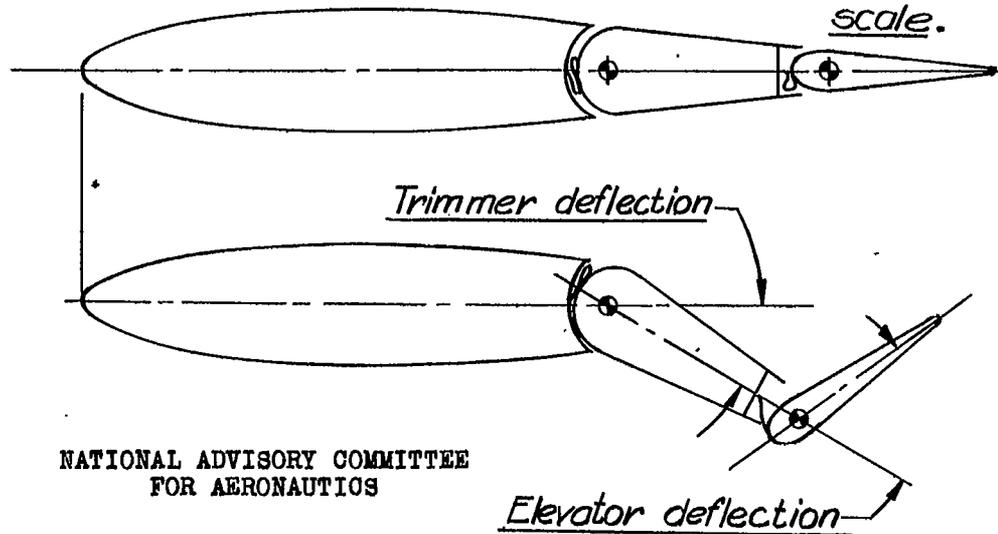
Figure 6.- Cross section of the double-hinged horizontal tail.

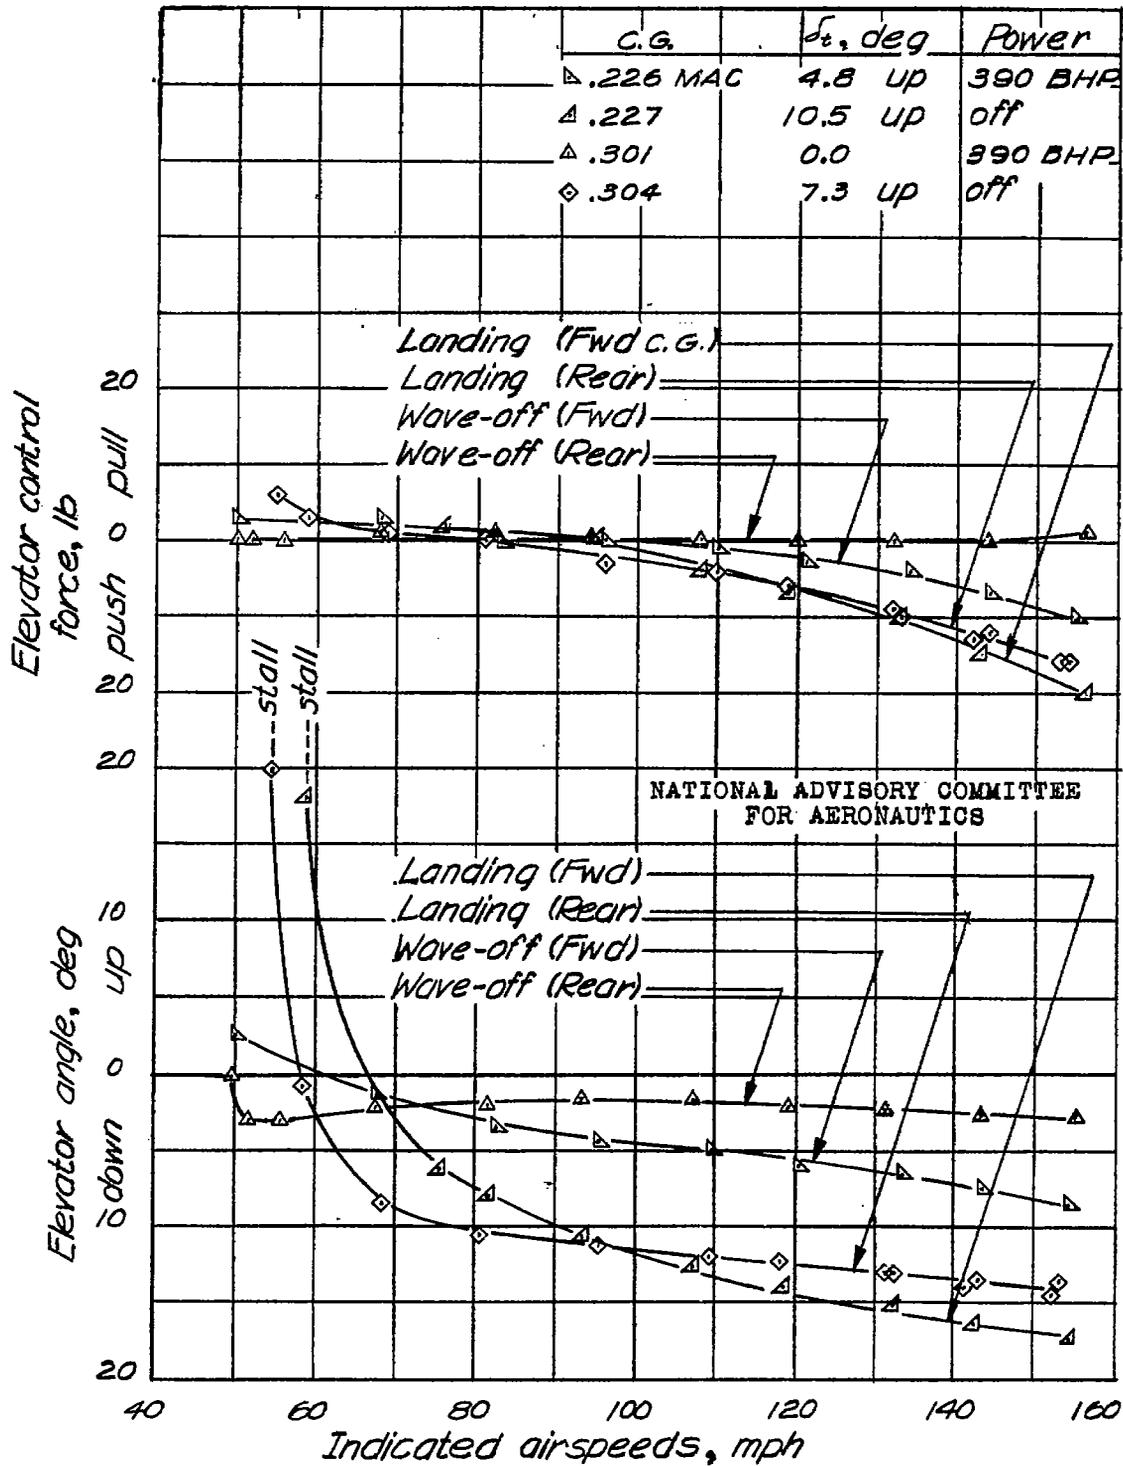
Figure 7.-Static longitudinal-stability characteristics.
Flaps down.

The results of the tests to determine the dynamic and static longitudinal-stability characteristics are presented in table I and in figures 7 and 8, respectively. The elevator control characteristics are presented in figure 9 for landings and in figure 10 for maneuvering flight. Trim changes due to variation of flaps and power are shown in table II. Figures 11 and 12 present data showing the trimming characteristics of the

Examination of the data presented in figures 7 to 12 and in tables I and II shows that the longitudinal handling characteristics of the airplane were satisfactory except for the dynamic longitudinal-stability characteristics (initiated by abruptly deflecting and releasing the elevator control) and a large forward movement of the stick (stick walking) when trimming to low speeds (flaps down, forward center of gravity).

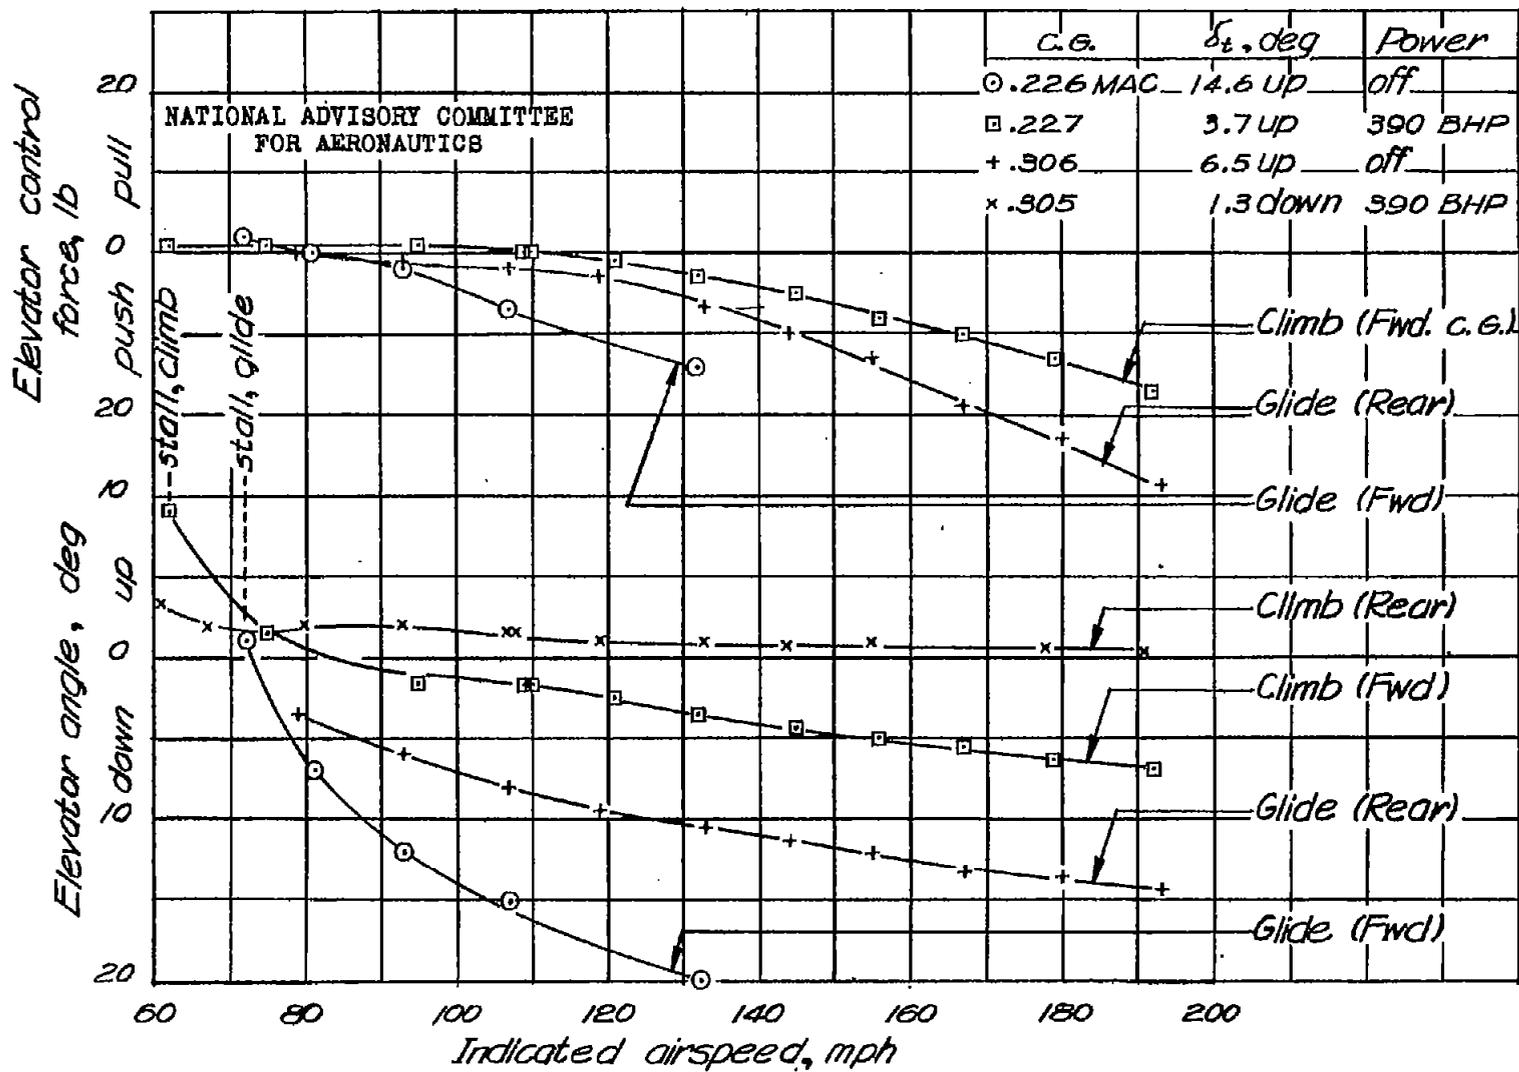
Figure 8.-Static longitudinal-stability characteristics. Flaps up.

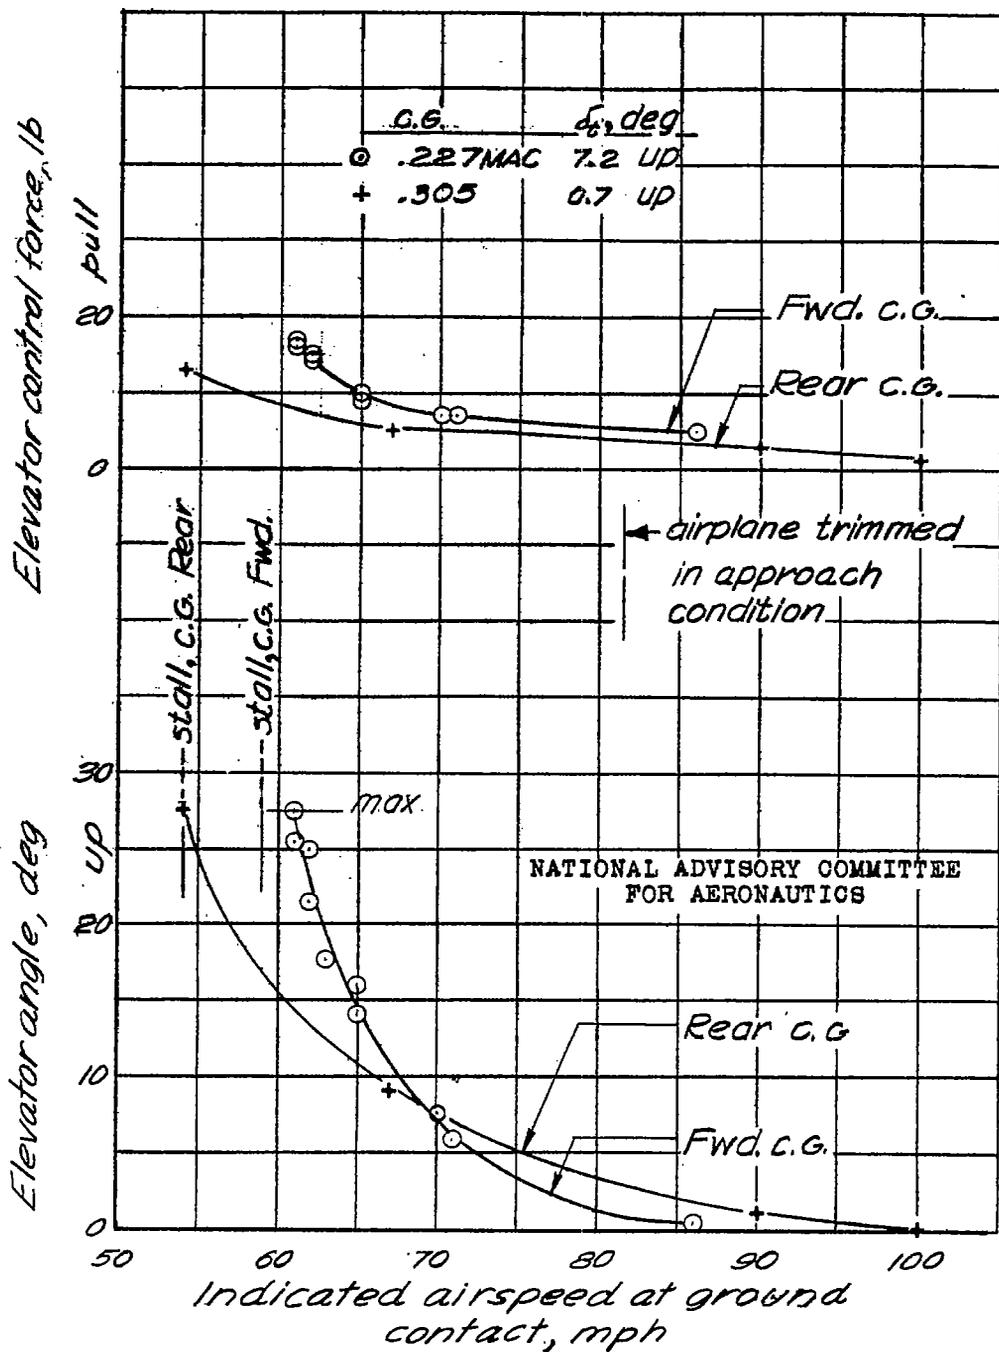
Figure 9.-Elevator angle and force required for various ground contact speeds. Flaps down, power off.

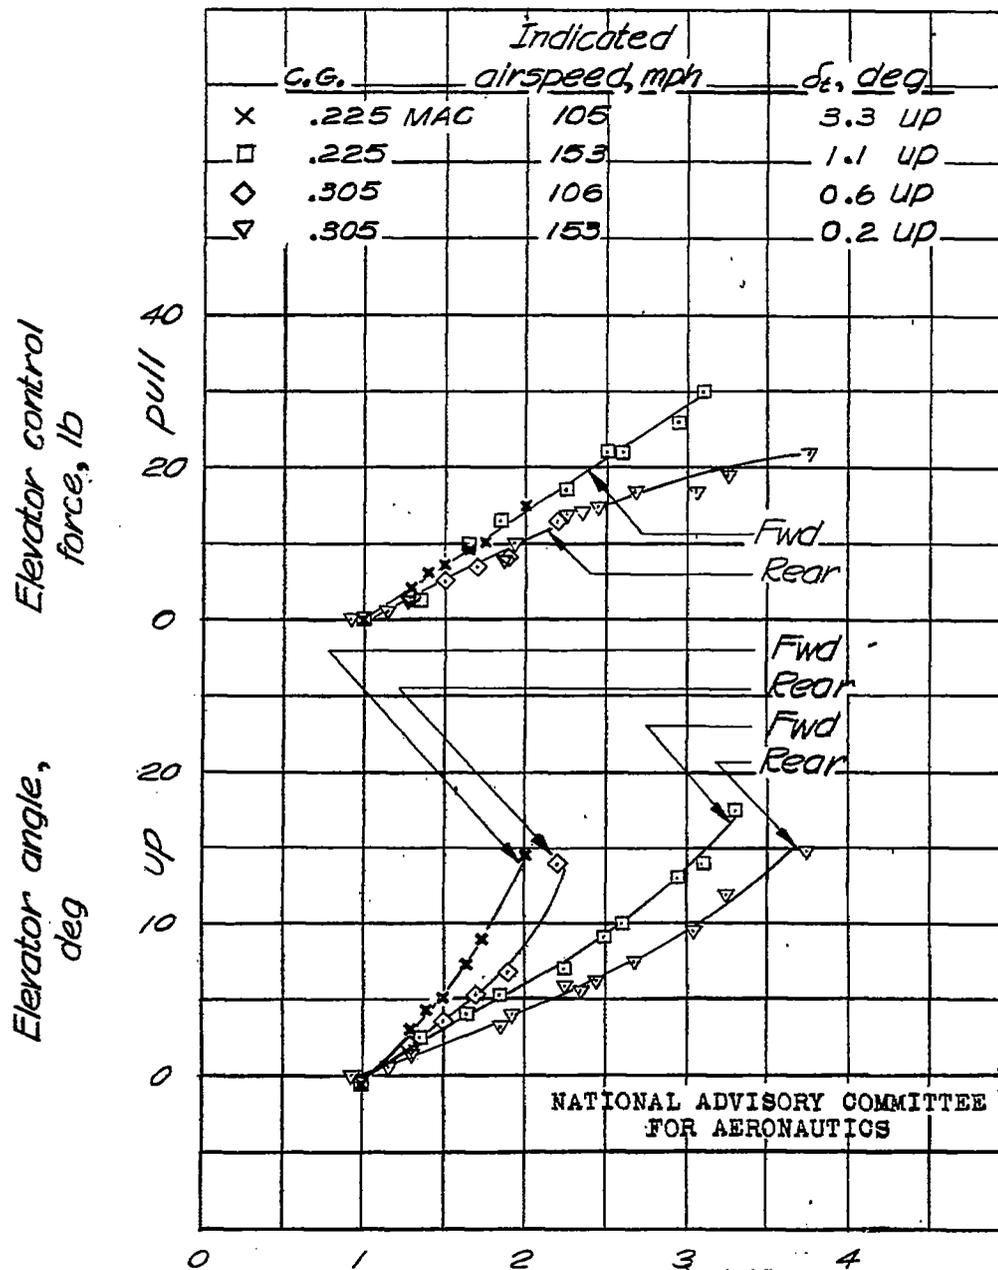
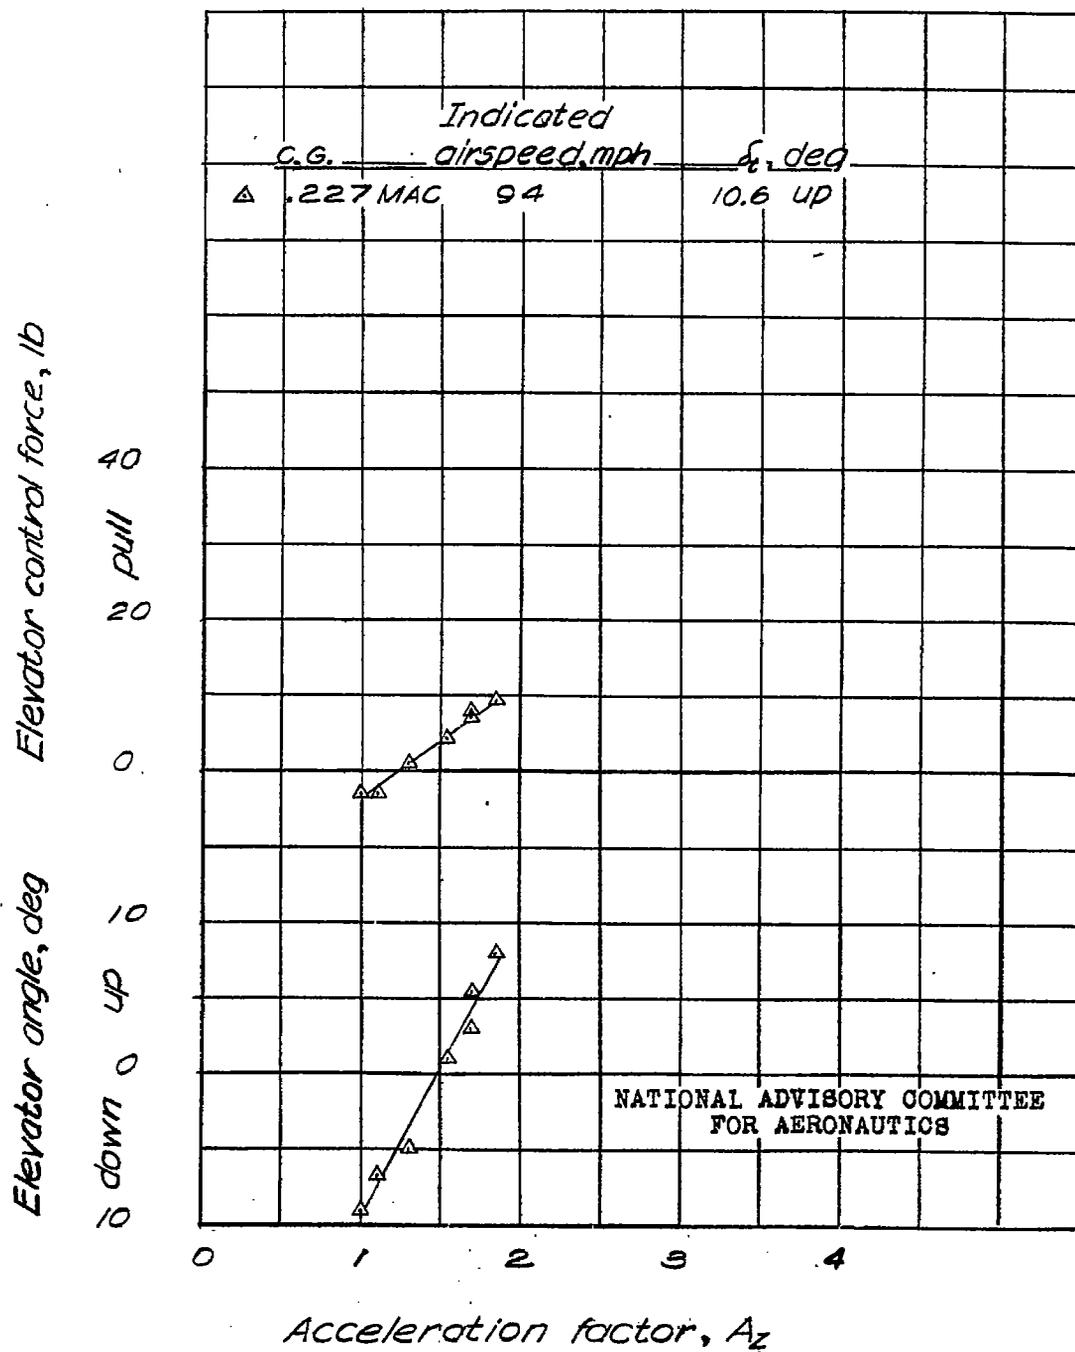
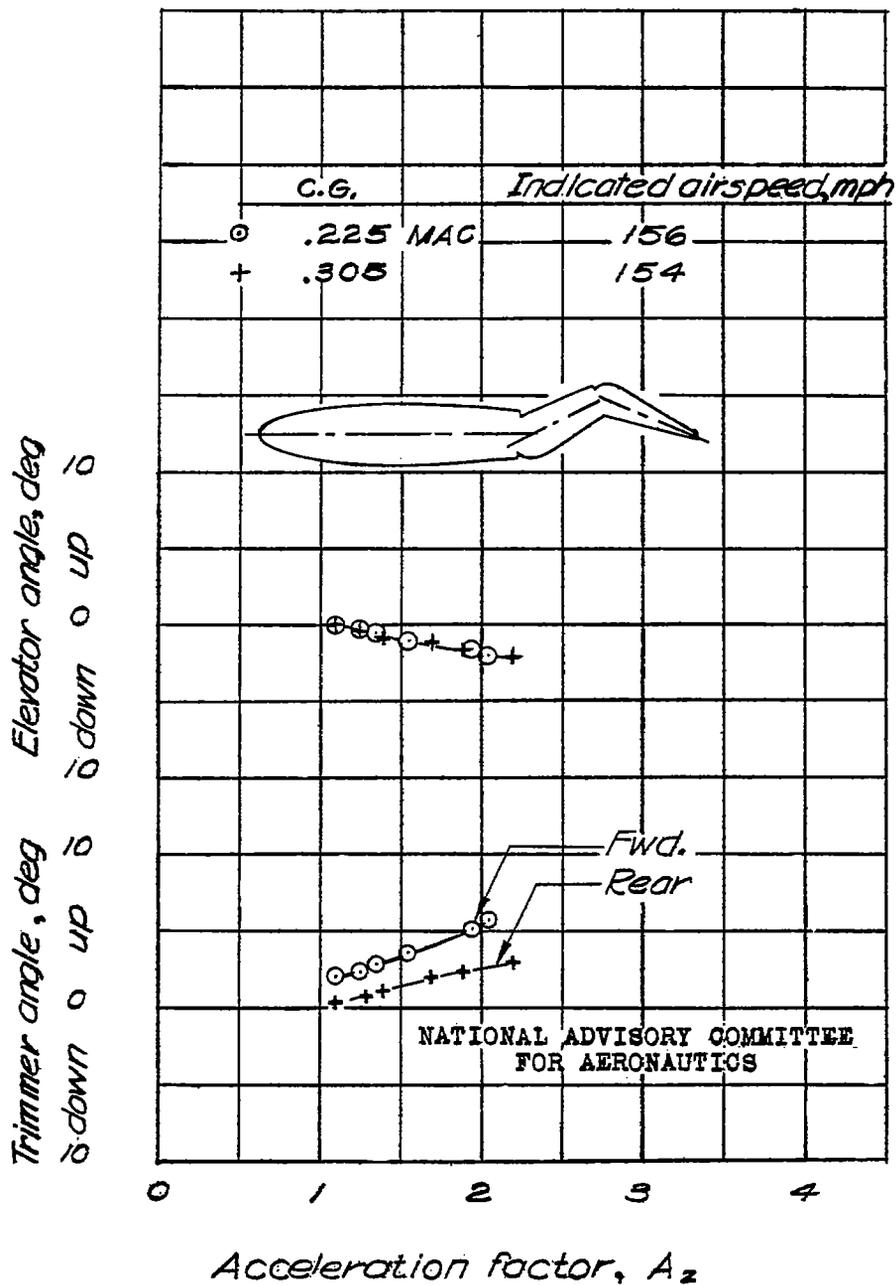
(a) Flaps up, normal rated power
 Figure 10.-Longitudinal control in steady turning flight.

(b) Flaps down, power off
 Figure 10.- continued.

(c) Flaps up, normal rated power, using trimmer for control (stick force equal to zero)
 Figure 10.-concluded

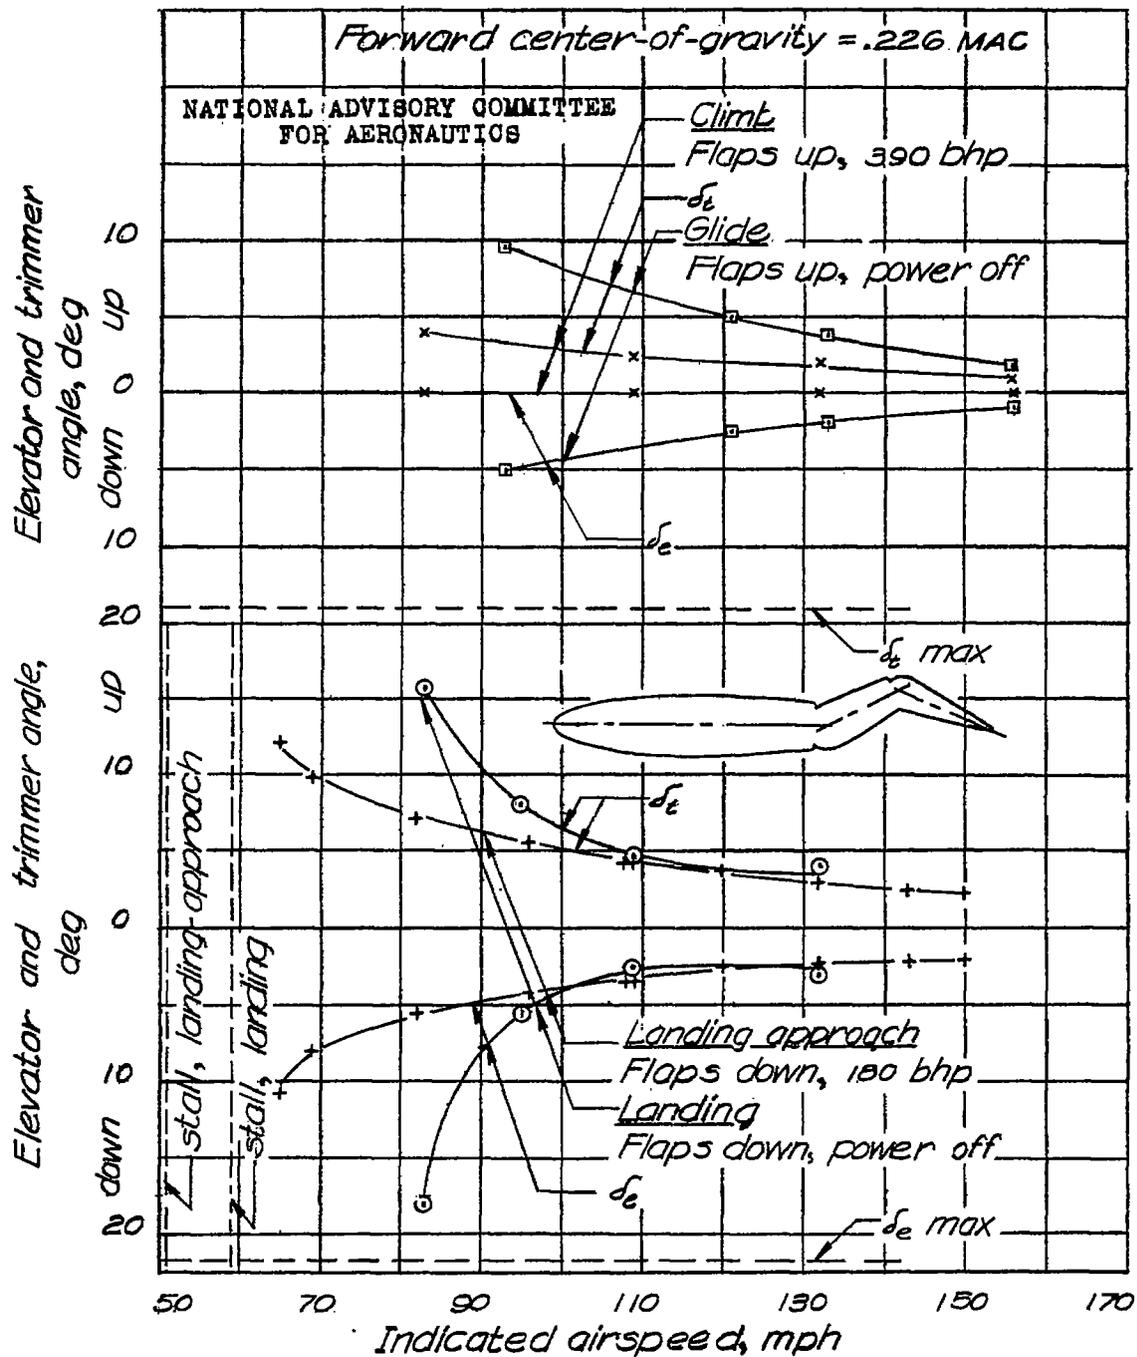
Figure 11.-Elevator and trimmer angles required to trim for various airspeeds. Center of gravity forward. Control force equal to zero.

The problem of adjusting the elevator floating characteristics as the airplane is trimmed to decreasing airspeeds in the landing and landing-approach conditions of flight (figs. 11 and 12) is basic for this type of longitudinal control.¹ Not only did the pilots object to the forward movement of the stick because of the possibility of loss of control in a wave-off or inability to recover from a stall, but the minimum trim speed in the landing condition was limited by the elevator travel.

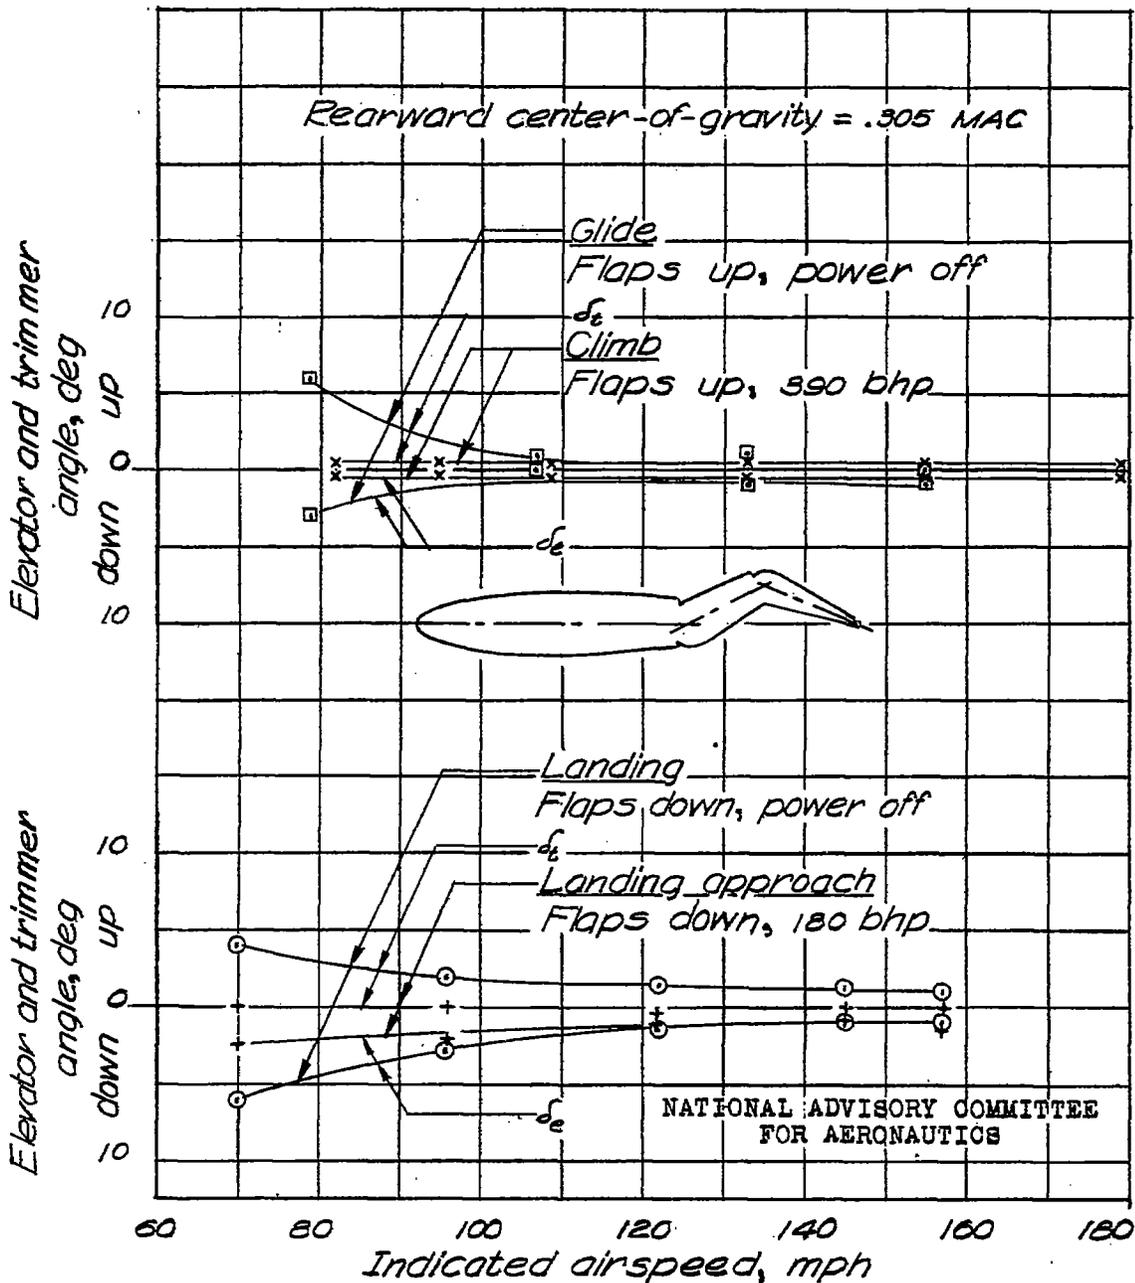
Figure 12.-Elevator and trimmer angles required to trim for various airspeeds. Center of gravity rearward. Control force equal to zero.

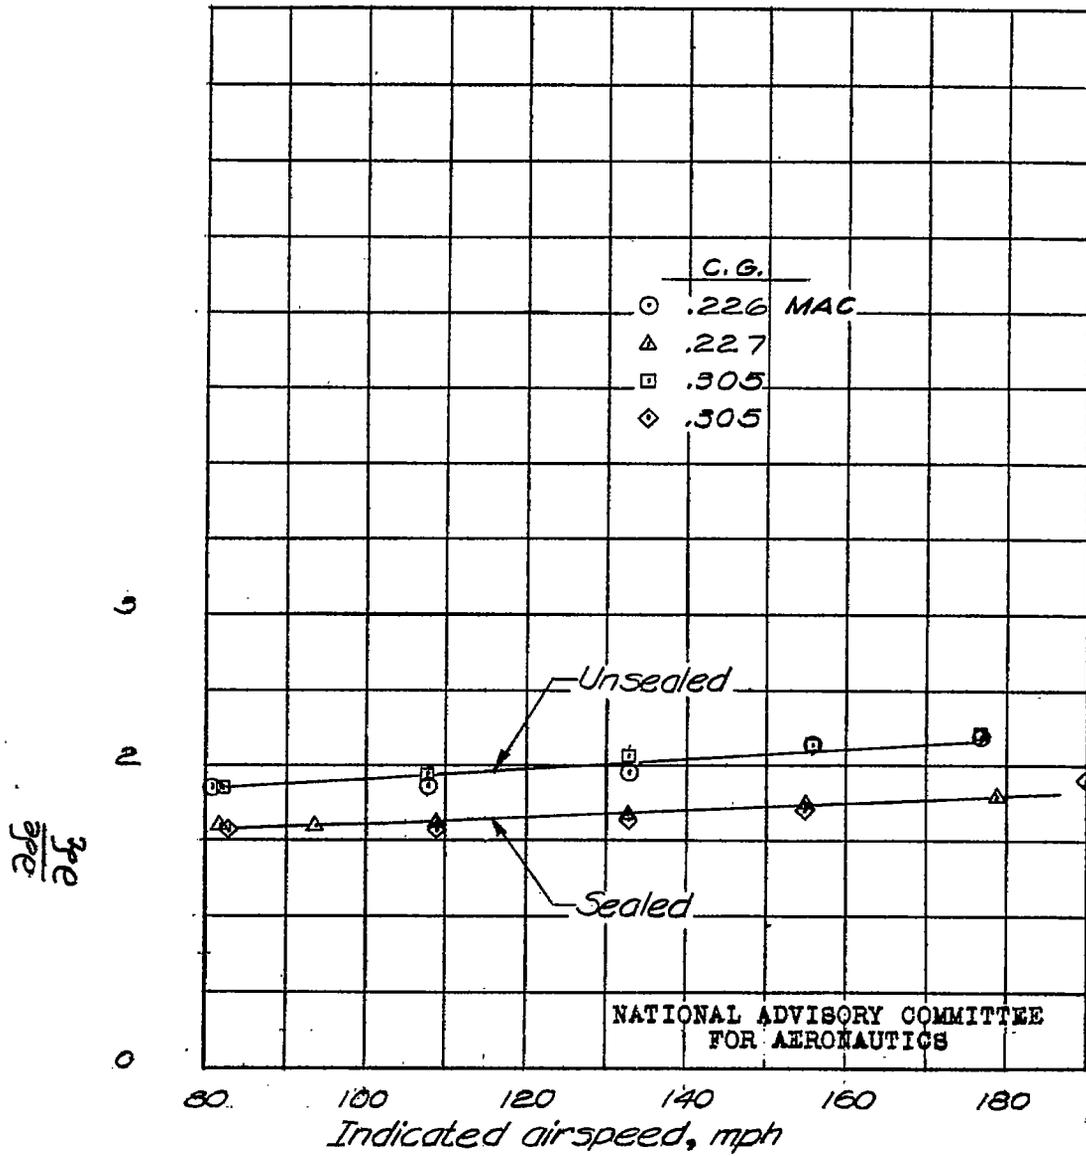
Figure 13.—Variation with airspeed of the ratio $\frac{\partial C_e}{\partial \delta_e}$ for steady straight flight. Flaps up, normal rated power.

double-hinged tail. The effect of removing the elevator seal is shown in figures 13, 14, and 15, and table II for various test conditions.

The effect of the removal of the elevator seal on the elevator control power, the trimmer effectiveness, and the elevator deflection required to offset a given trimmer deflection is presented in figures 13 to 15. These data indicate a marked reduction in the ability of the elevator to balance the airplane in the presence of the ground (fig. 15) when the elevator seal is removed. In addition, the effectiveness of the elevator in offsetting movement of the trimmer was reduced by 18 percent (fig. 13). However, this change had practically no effect on the ability of the trimmer to trim the airplane throughout the speed range and on the desirably low trim force changes due to power and flaps (table II). The number of cycles required to damp the short-period elevator oscillation was reduced slightly by the removal of the elevator seal (table I).

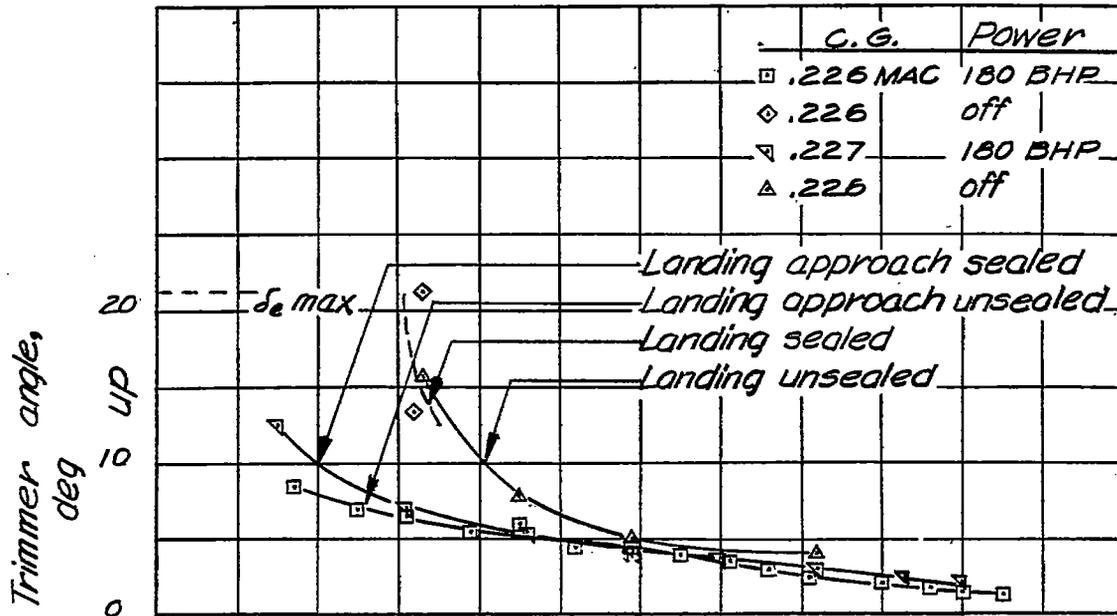
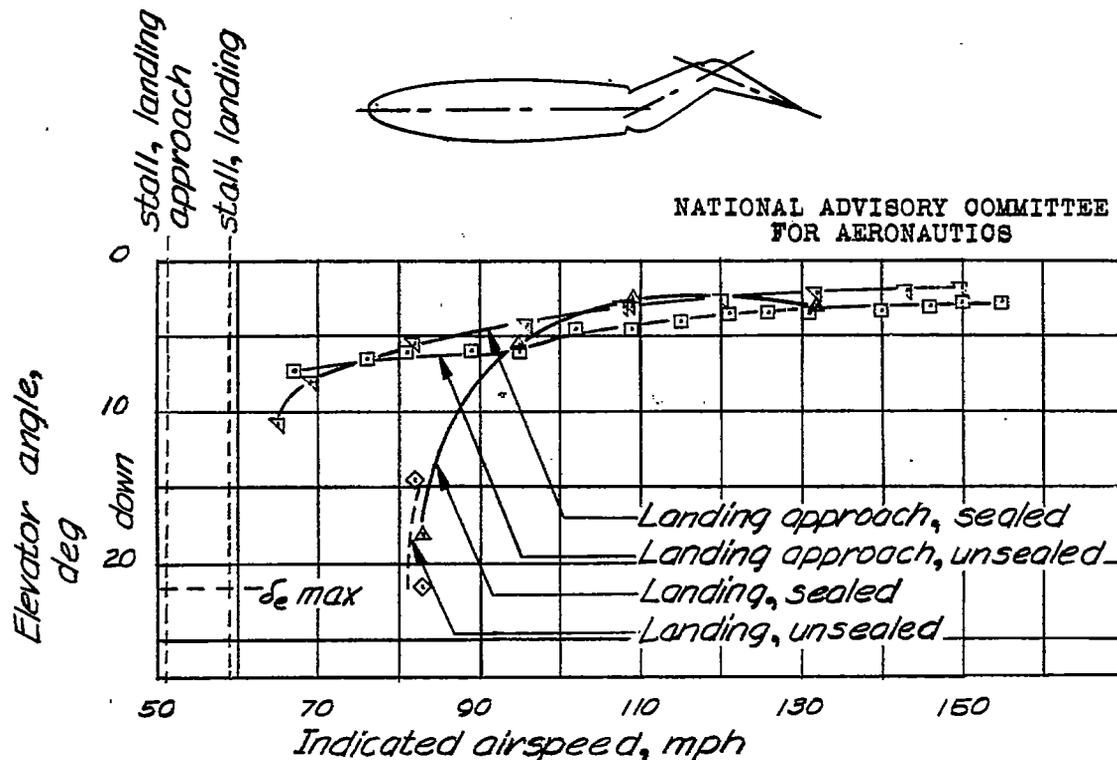
Figure 14 - Effect of elevator seal on elevator and trimmer angles required to trim for various airspeeds. Flaps down. Control force equal to zero.

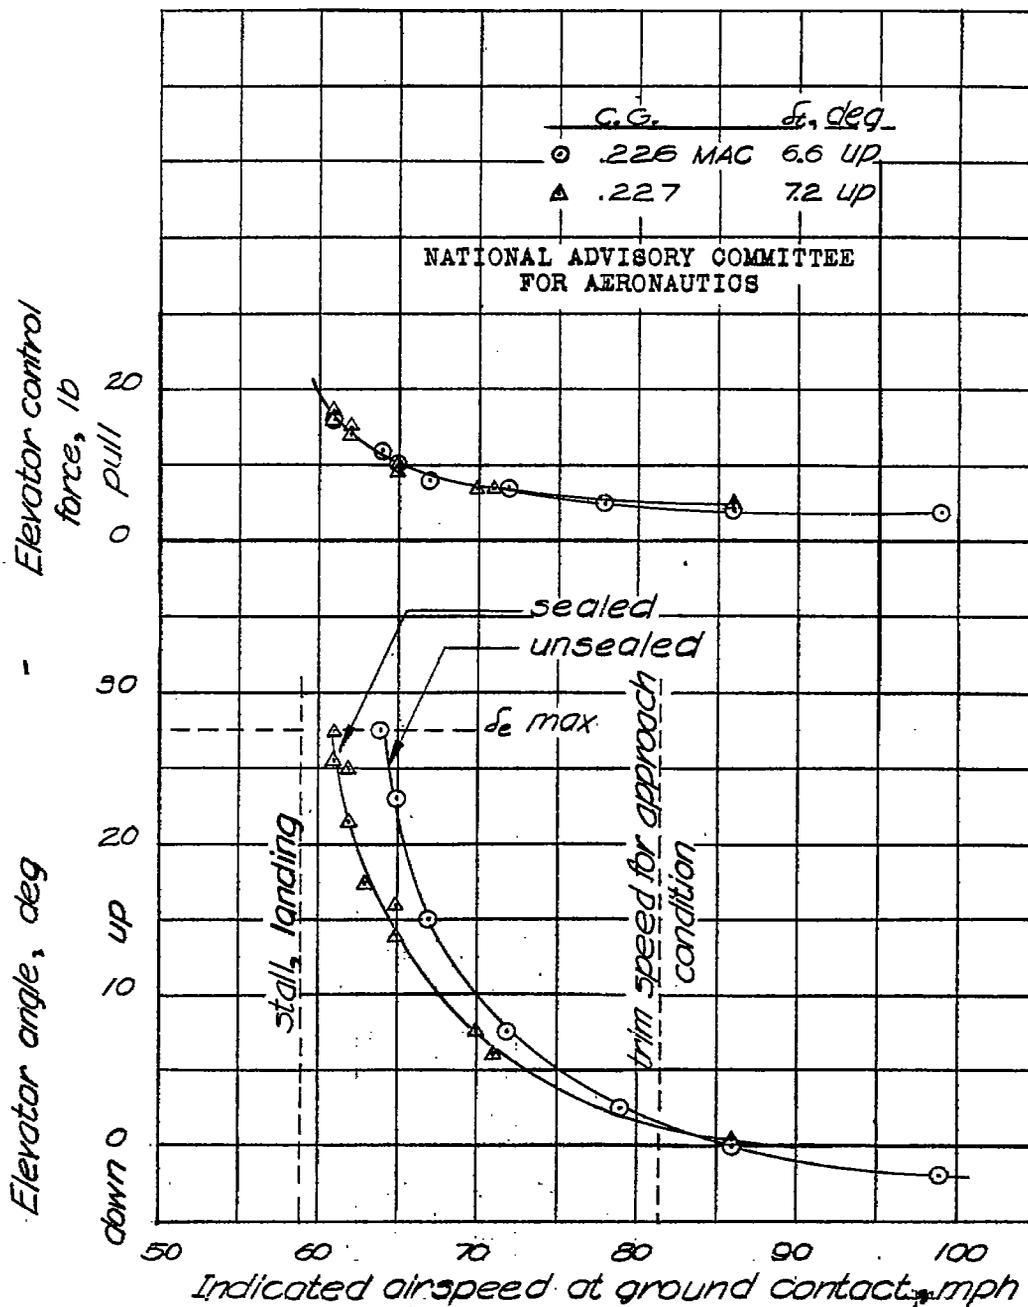
Figure 15.-Effect of elevator seal on elevator angles and elevator control force required for various contact speeds. Flaps down, power off.
