ORIGINALLY ISSUED
June 1944 as
Restricted Bulletin 4F06

AN INVESTIGATION OF THE CHARACTERISTICS OF A
PROPELLER ALCOHOL FEED RING

By Carr B. Neel, Jr.

Ames Aeronautical Laboratory
Moffett Field, California

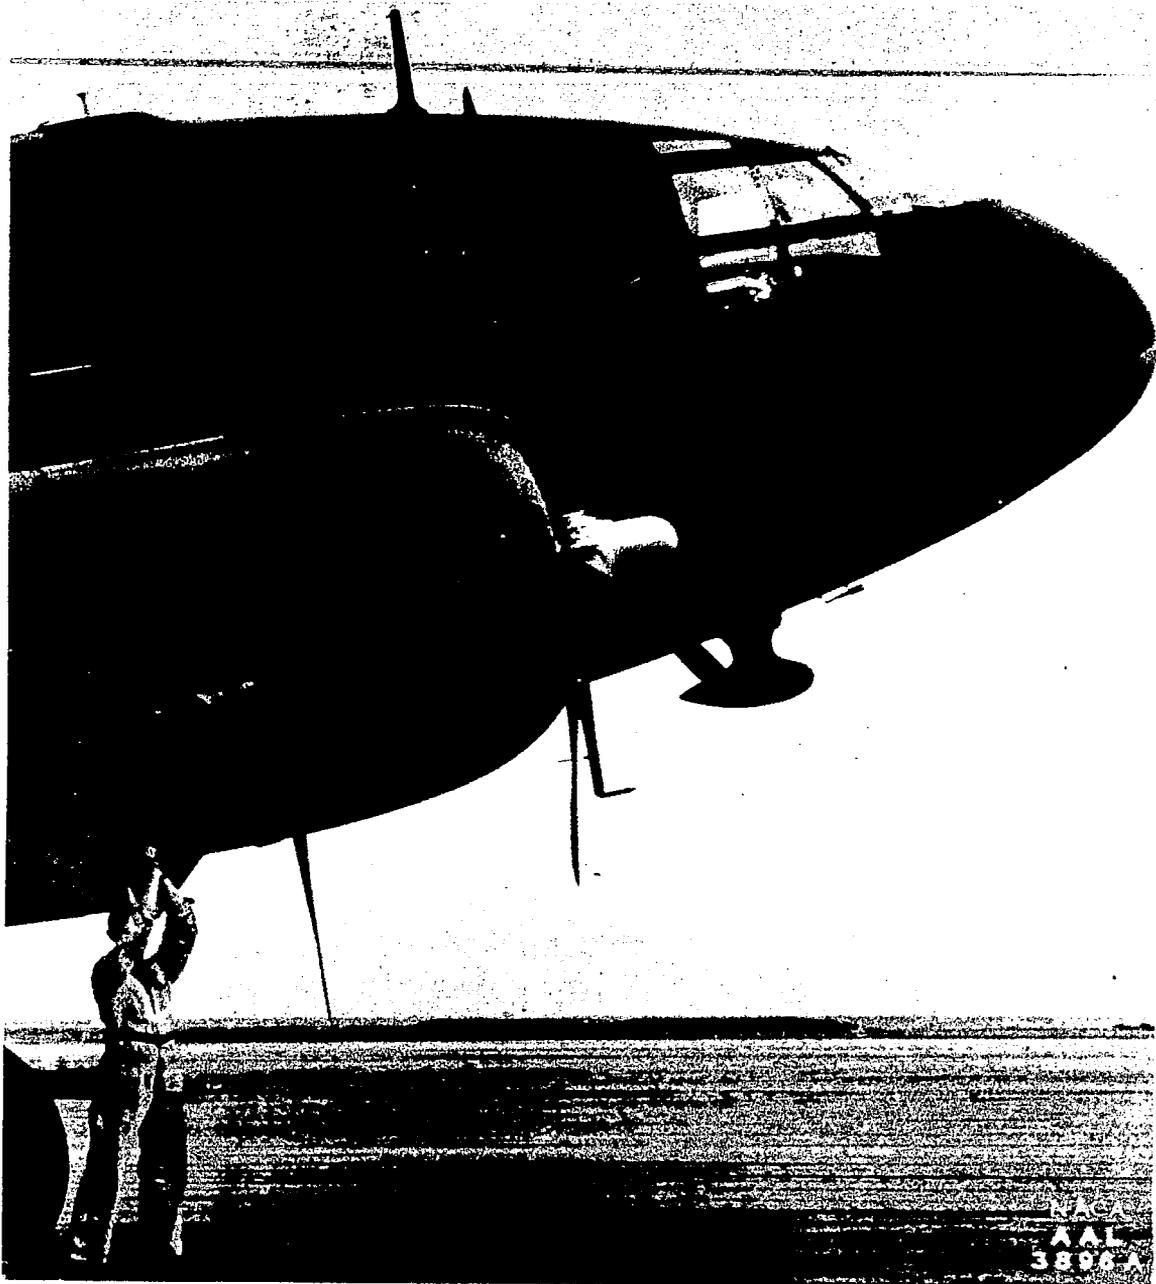
Figure 1.- The right propeller and engine cowl of the C-46 airplane on which the tests of the alcohol feed rings were made.

The propellers on which the tests were conducted were Hamilton Standard hydromatic three-blade propellers, design number 6194A-0, hub number 23E50-473, 15 feet 0 inch in diameter. Anti-icing feed shoes 52 inches in length were cemented to the leading edges of the propeller blades. Figure 1 shows the shape of the C-46 airplane cowl and its relation to the propeller, which are believed to influence the distribution of alcohol on the propeller blades. The photograph (fig. 1) was taken prior to the installation of the ice-prevention equipment on the test airplane.
