REPAIR, EVALUATION, MAINTENANCE, AND
REHABILITATION RESEARCH PROGRAM

TECHNICAL REPORT REMR-CO-7

METHODS TO REDUCE WAVE RUNUP AND
OVERTOPPING OF EXISTING STRUCTURES

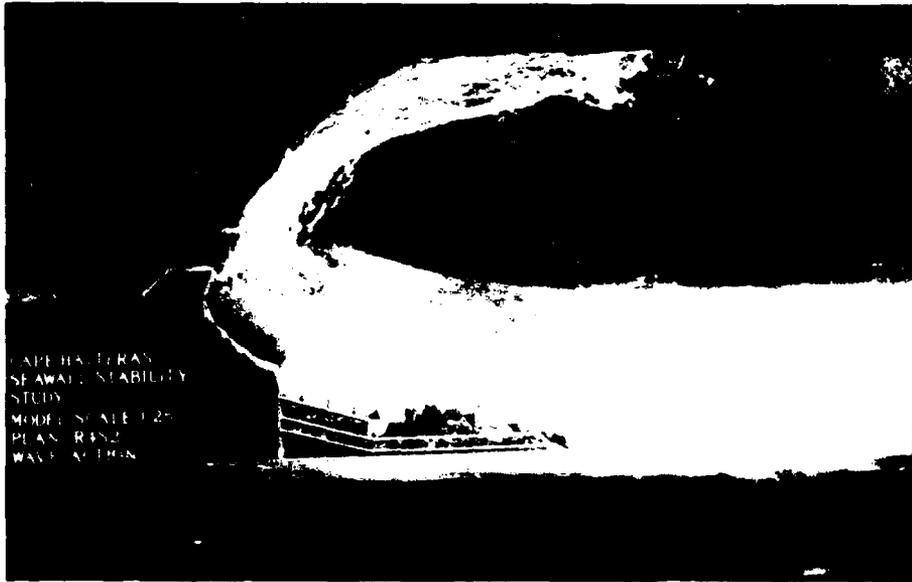
Figure 15. Laboratory tests of wave action against a Cape Hatteras seawall with a moderate recurve

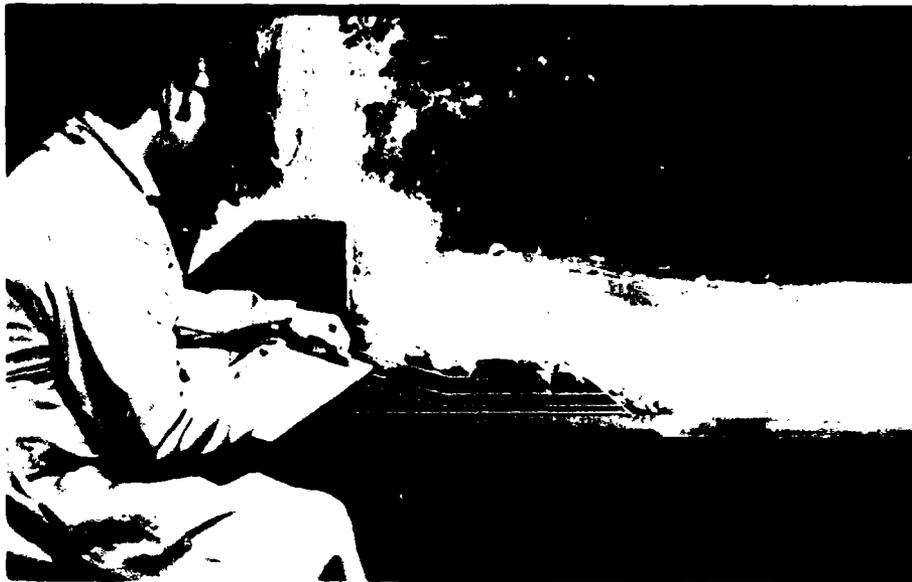
Figure 16. Laboratory tests of wave action against a Cape Hatteras seawall, vertical configuration

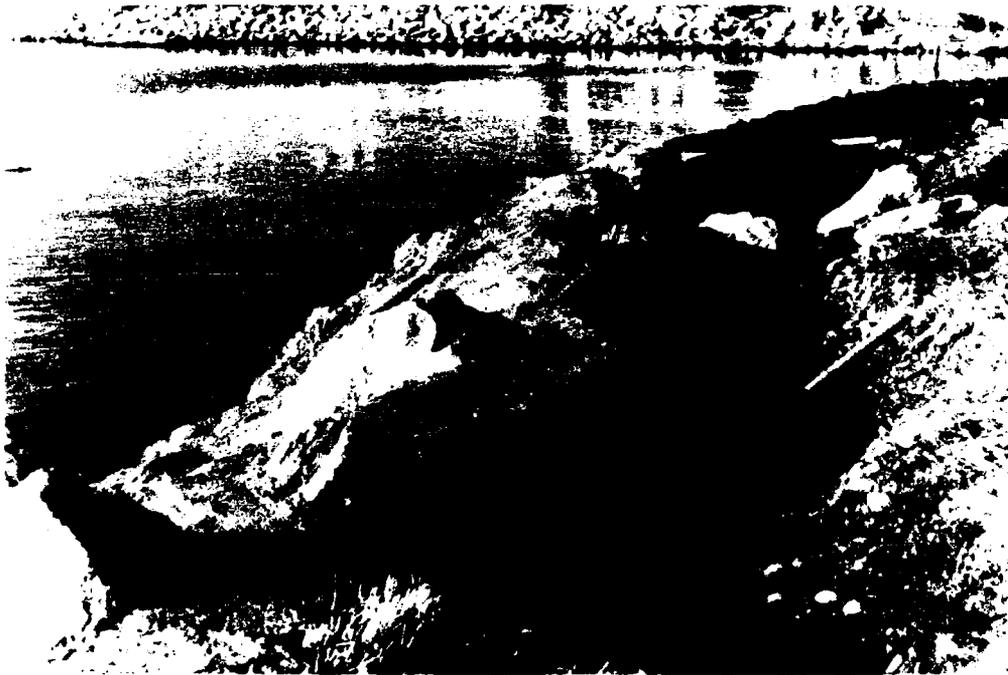
Figure 23. Damage to a grouted riprap revetment at New London, Connecticut, caused by waves generated by Hurricane Gloria, September 1985

30. In some instances wave overtopping of a revetment occurs because the extent of wave runup is underestimated. Figure 23 shows a riprap revetment in New Haven, Connecticut, which was overtopped by wave action caused by Hurricane Gloria in 1985. Grouting of this riprap might have made the wave runup problem worse by making the revetment effectively smoother and thereby increasing the amount of overtopping. Ponding due to overtopping creates a hydraulic head which will cause fine particles to migrate out through the revetment if filter layers are not properly constructed. Loss of fine material from behind the revetment will eventually cause a collapse of the structure. A similar problem is shown in Figure 24 where storm waves from Hurricane Hilda (1964) overtopped the west jetty at Panama City, Florida. Ponding behind the jetty caused sand to migrate through the structure creating "sink" holes. Generally, small amounts of sand loss are not a problem since a jetty is free standing, but deep sink holes could undermine the heel of the jetty and cause the structure to slump.

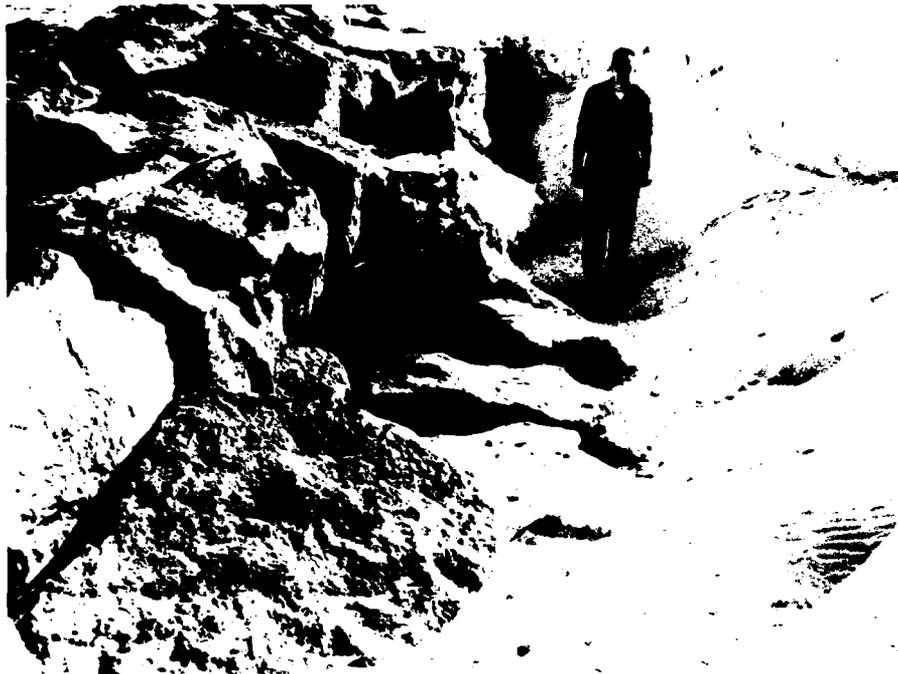
Figure 24. Damage to grouted riprap revetment at Panama City, Florida, caused by waves generated by Hurricane Hilda, October 1964
