NASA Technical Memorandum 87604

THE EFFECT OF RESIN TOUGHNESS AND MODULUS ON COMPRESSIVE FAILURE MODES OF QUASI-ISOTROPIC GRAPHITE/EPOXY LAMINATES

MARCH 1986

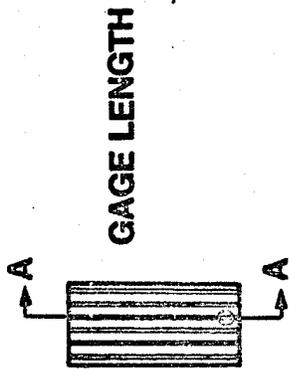
Figure 1. Partial failure in a T300/BF907 specimen loaded to 81% of the average ultimate compressive strength (UCS).

Figure 1 shows a partially failed T300/BP907 specimen which was loaded to 81% of the average ultimate compressive strength (UCS). Figure 1 (a) is the failure of a 0-degree ply as seen on an edge of the specimen. Propagation of the failure in the plane of the 0-degree ply is seen in Figure 1 (b), where the top nine plies were ground away to expose the failed 0-degree ply. The figures clearly show kinking of fibers in the 0-degree ply. No delamination is present and the adjacent off-axis plies are intact. It is therefore concluded that kinking of the 0-degree fibers precedes any other failure event. In this specimen, only the 0-degree ply shown in the figure had failed by kinking, and all the other 0-degree plies were intact.

The T700/4901/mPDA laminate was loaded to the highest relative prestress level and shows failure in two 0-degree plies. Therefore, the sequential failure of 0-degree plies may occur prior to ultimate failure of the laminate. Fiber kinking in a 0-degree ply is progressive, as shown in Figure 1 and, therefore, one might expect multiple failure initiation sites.

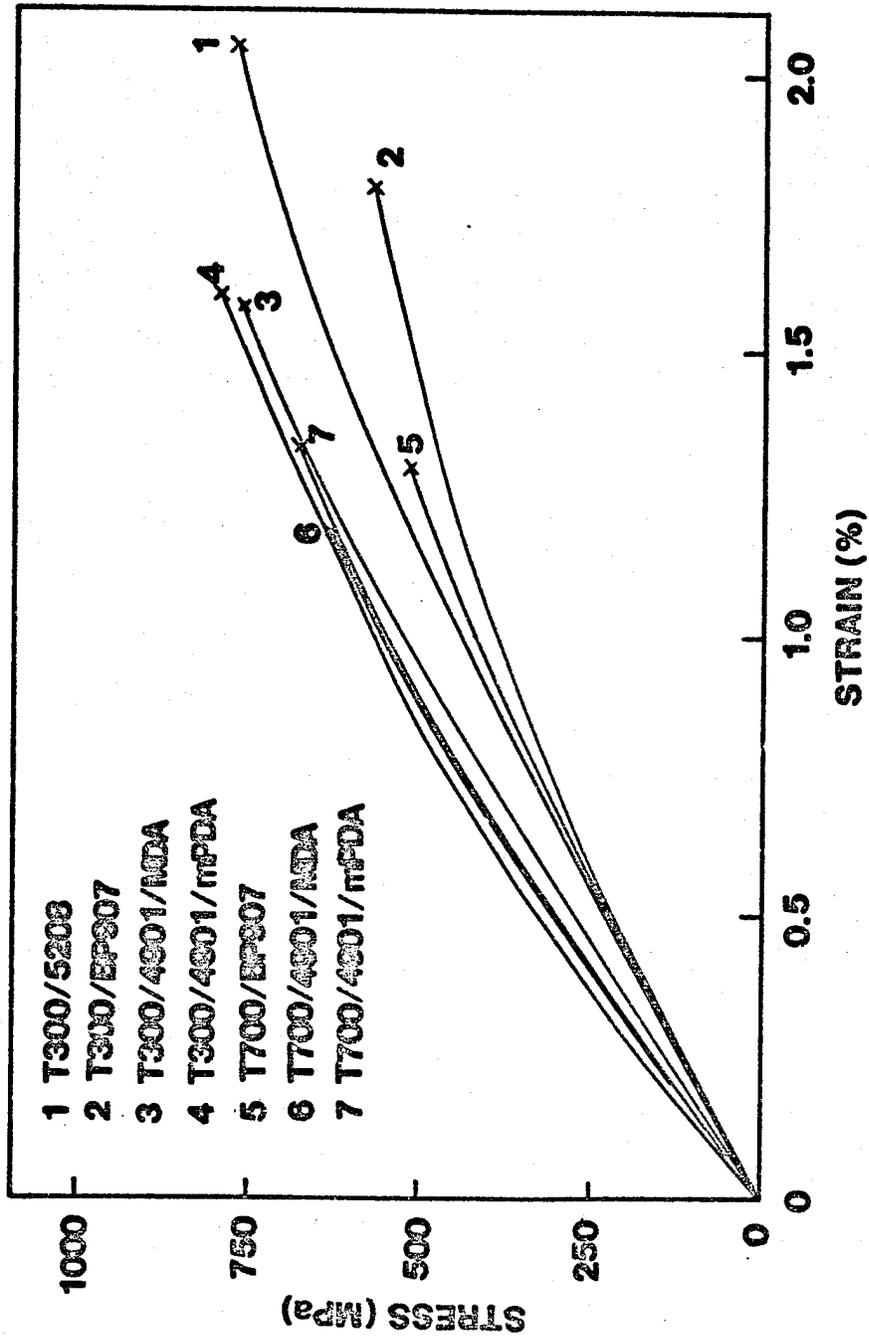
Figure 5. Typical stress-strain curves of different laminates.

Compressive Behavior - Typical stress-strain curves for the different laminates are shown in Figure 5. All the stress-strain curves exhibited strain softening which suggests the specimens did not experience global buckling. The reason is that the lateral surface on which the strain gage was to be bonded was chosen randomly and it is highly unlikely that all the gages would have been placed on the compression side by mere coincidence. The absence of global buckling was furthermore confirmed by using back-to-back strain gages on both sides of a T700/BP907 specimen. Figure 6 shows the strain outputs in which no strain reversal is observed.

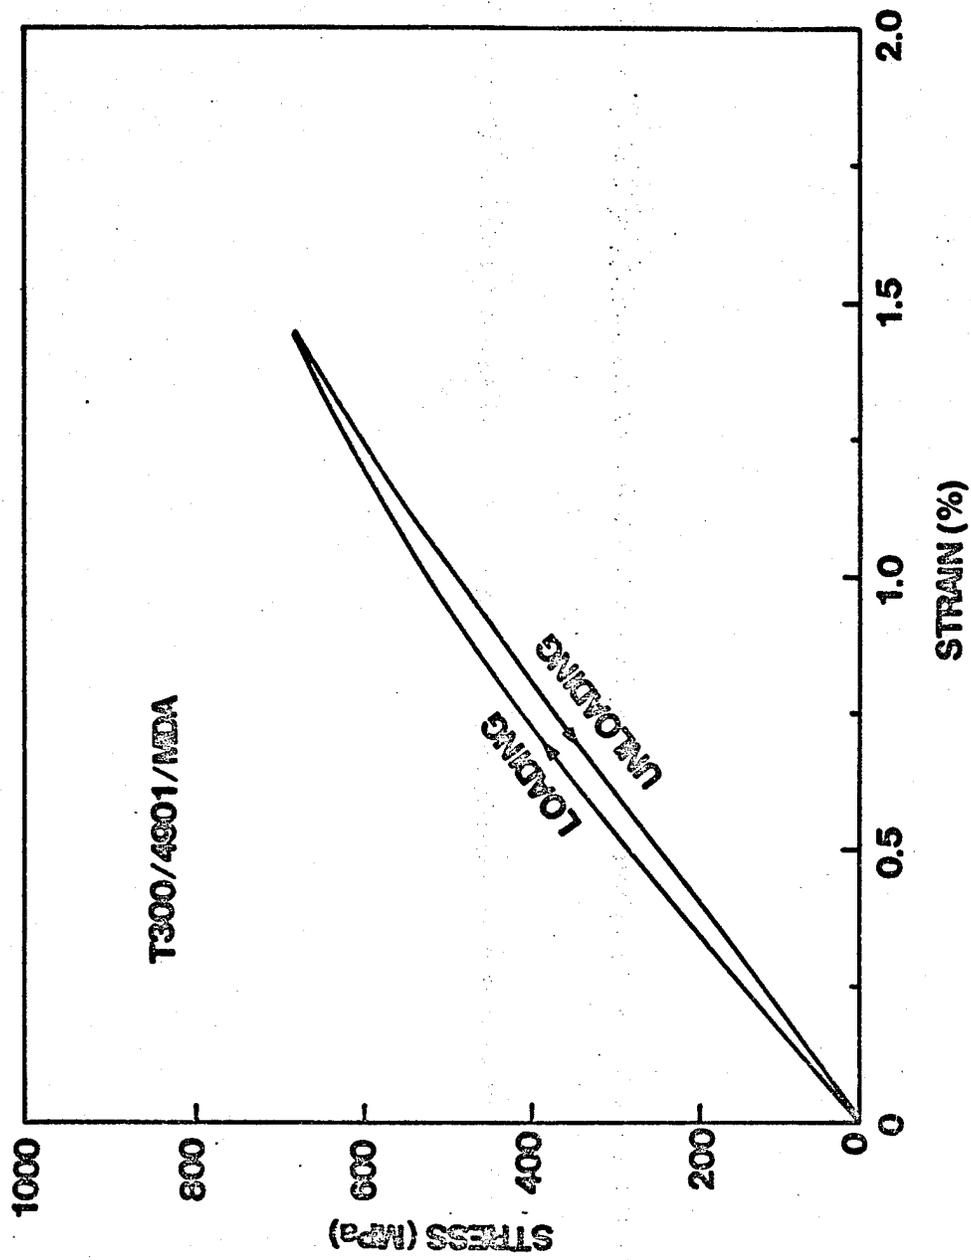
Figure 7. Loading-unloading stress-strain curves for a T300/4901/MDA specimen.

Some of the specimens were loaded well into the nonlinear region and then unloaded. The stress-strain relation during unloading was almost the same as during loading, Figure 7. Thus, the nonlinearity is not believed to have been caused by damage. In fact, the corresponding unidirectional composites also showed similar nonlinear behavior [7].

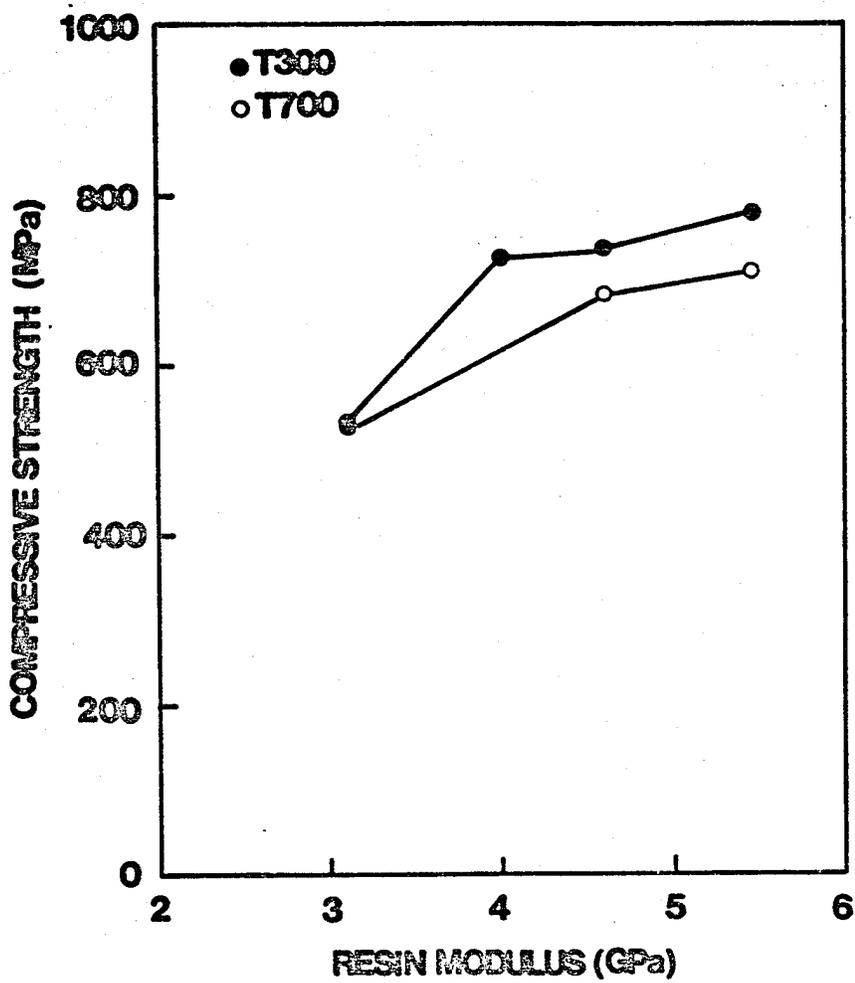
Figure 8. Effect of resin tensile modulus on compressive strength of quasi-isotropic laminates.

The average compressive strengths of quasi-isotropic laminates are plotted against the resin tensile moduli in Figure 8. As for unidirectional

composites [7], the compressive strength increases with increasing resin modulus.

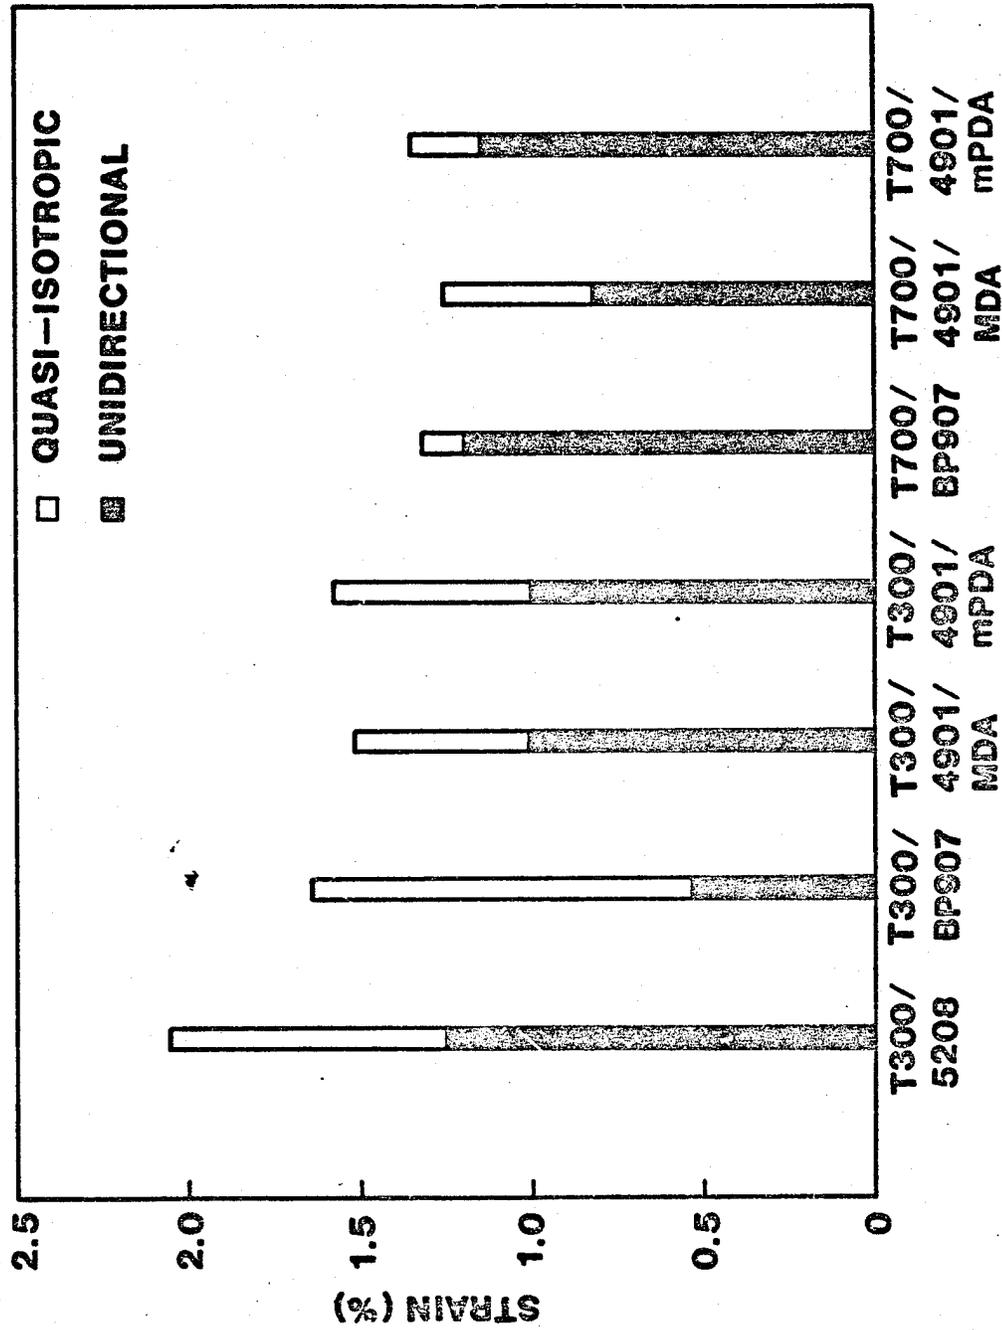
Figure 9. Comparison in failure strain between quasi-isotropic laminates and unidirectional laminates of the same material systems.

The T300/5208 laminate shows the highest compressive failure strain despite the fact that the 5208 resin has the lowest tensile failure strain of all four resins used. The failure strains of quasi-isotropic laminates are compared with those of unidirectional laminates of the same material systems [7] in Figure 9. The quasi-isotropic laminates are seen to have considerably higher failure strains than the corresponding unidirectional laminates. This is due to a better lateral support provided to the 0-degree plies by adjacent off-axis plies in quasi-isotropic laminates. The in-plane kinking in the quasi-isotropic laminate is influenced by the higher stiffness of off-axis plies normal to the loading. The out-of-plane kinking also is retarded by the off-axis fibers bridging over the kink band.

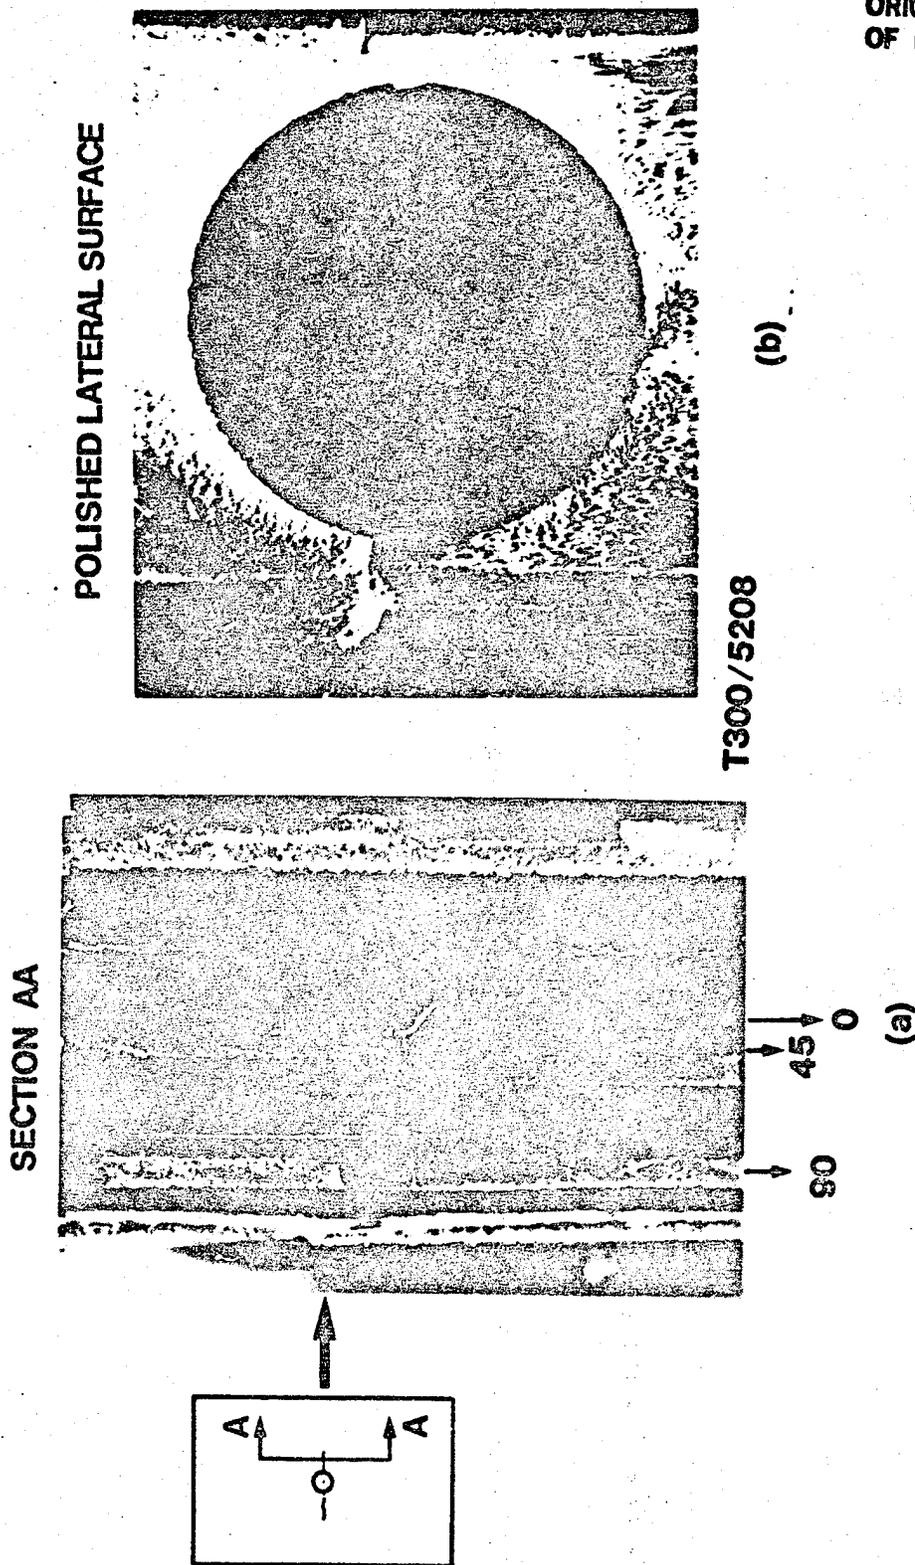
Figure 10. Partial failure in a notched T300/5208 specimen: $d/w = 0.125$.

The sequence of failure events suggested in References 4 and 10 did not include any comparison between laminates with brittle resin and with soft resin. As in the unnotched laminates, the mode of failure propagation following the initial fiber kinking changed with the ductility of the resin used. In the T300/5208 laminate, delamination immediately followed the initiation of a kink band, Figure 10. Two outer 0-degree plies failed in the form of kinking, causing local delamination of the outside 45-degree ply from the adjacent 0-degree ply. Upon further increase in load, the failure band propagated along the specimen width. The fiber kinking in the 0-degree plies, coupled with the separation of 45-degree plies, induced further delamination. Figure 10 (b) shows the polished lateral surface of the same specimen as shown in Figure 10 (a). The outer 45-degree ply was ground away to expose the fiber kinking in the 0-degree ply. Intraply cracking is also observed in a 45-degree and a 90-degree ply, Figure 10.

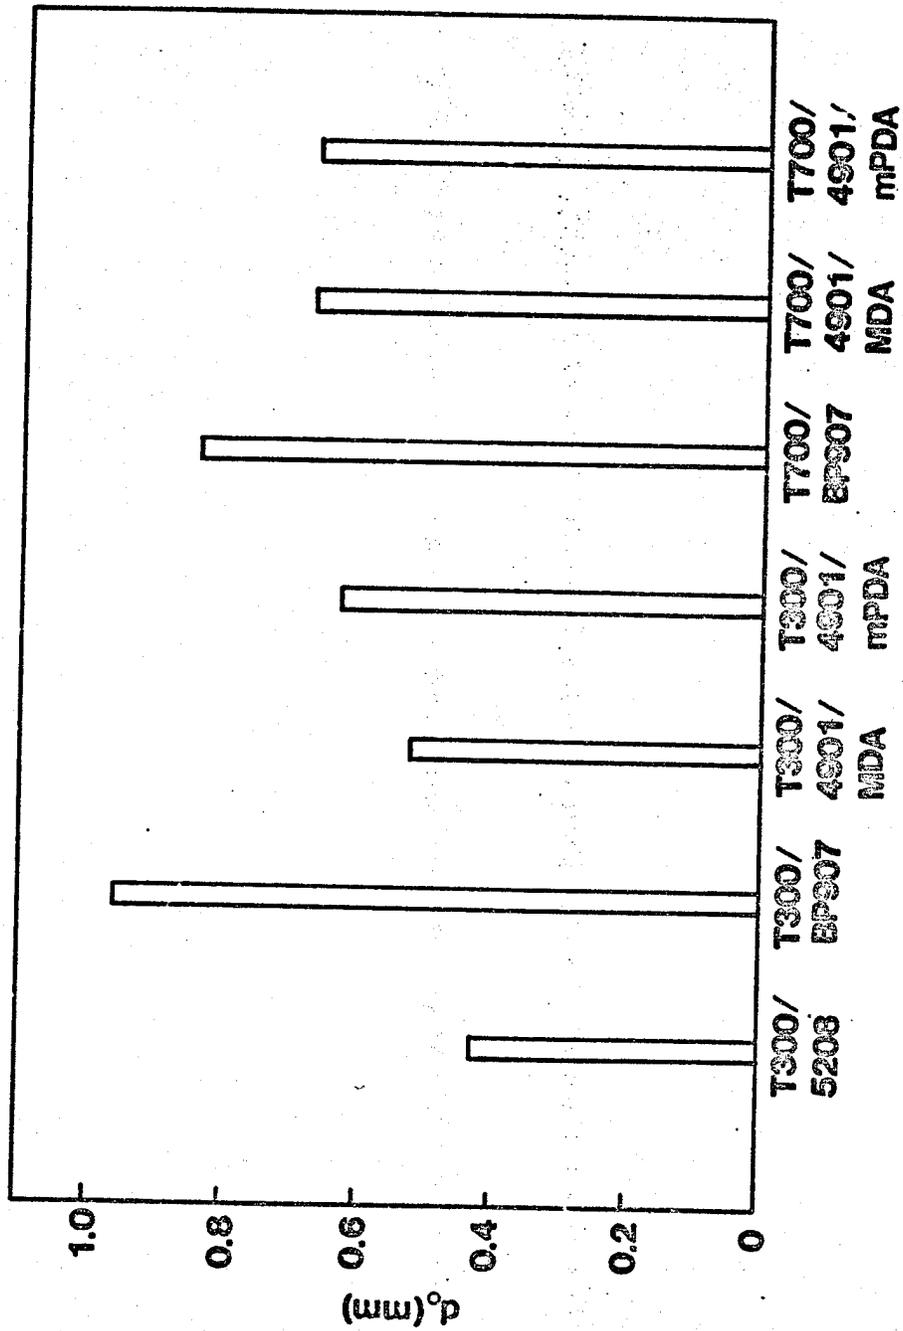
Figure 13. Average values of characteristic length d_0 for different laminates.

average value of d_0 for each composite system tested, and the results are shown in Figure 13. As can be seen from Equations (1) and (2), a higher d_0 indicates less notch sensitivity, i.e., less reduction in the normalized notched strength σ_N^∞/σ_0 with increasing hole size.

As expected, T300/BP907 and T700/BP907 laminates show the least notch sensitivity while the T300/5208 shows the most. The two curing agents MDA and mPDA yield almost the same notch sensitivity. Also, the notch sensitivity is more dependent on the matrix material type than on the fiber.

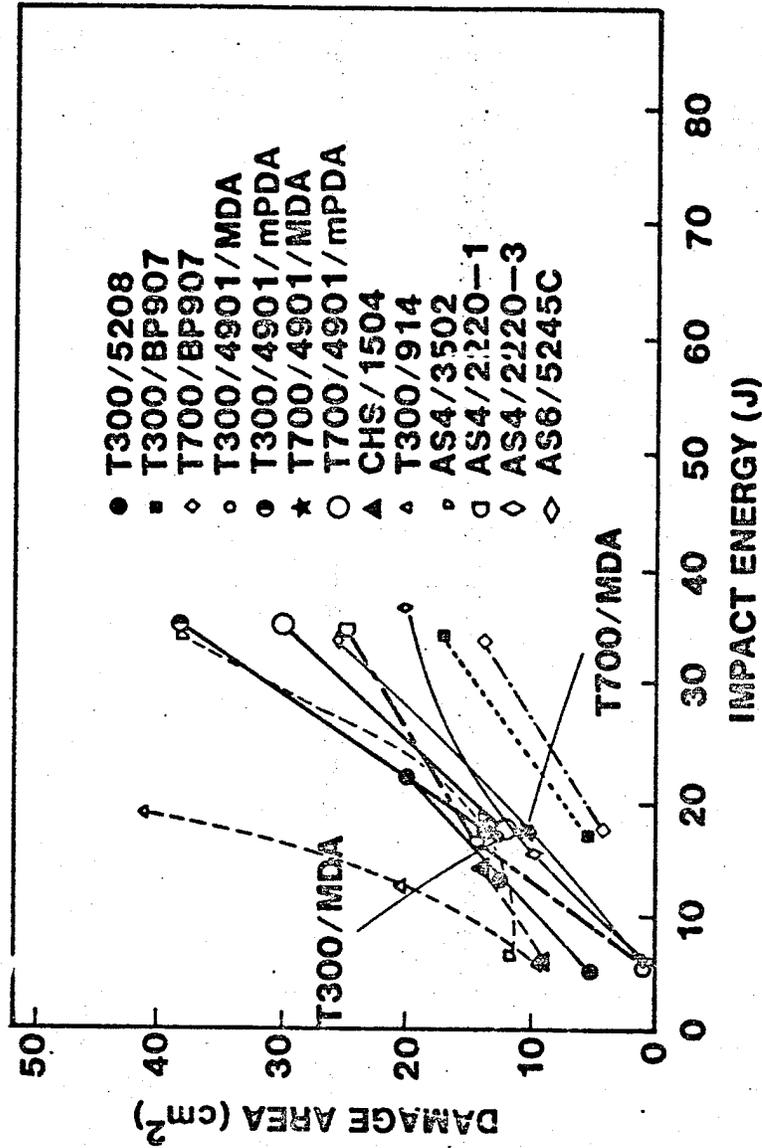
Figure 18. Effect of impact energy on damage area.

The extent of damage due to impact is shown in Figure 18, where the damage areas measured on ultrasonic C-scan records are plotted against the impact energies. The figure also includes the data for other composite systems reported in Reference 5. Whereas two different impact energies were used for the laminates made with 4901/mPDA resin, only the lower impact energy was used for the laminates made with 4901/MDA resin. Of all resins shown, BP907 gives the best impact resistance.

The T700 fiber shows better impact resistance than the T300 fiber. During impact large local deformation gradients occur which cause high

tension stresses to develop on the back surface. The T700 fiber with its higher strain capability can sustain higher back surface tension strains prior to failure than the lower strain capability T300 fiber.

The 4901 resin yields laminates which, in impact damage size, rank somewhere between the BP907 laminates and the T300/5208 laminate, the former being the most resistant to impact.

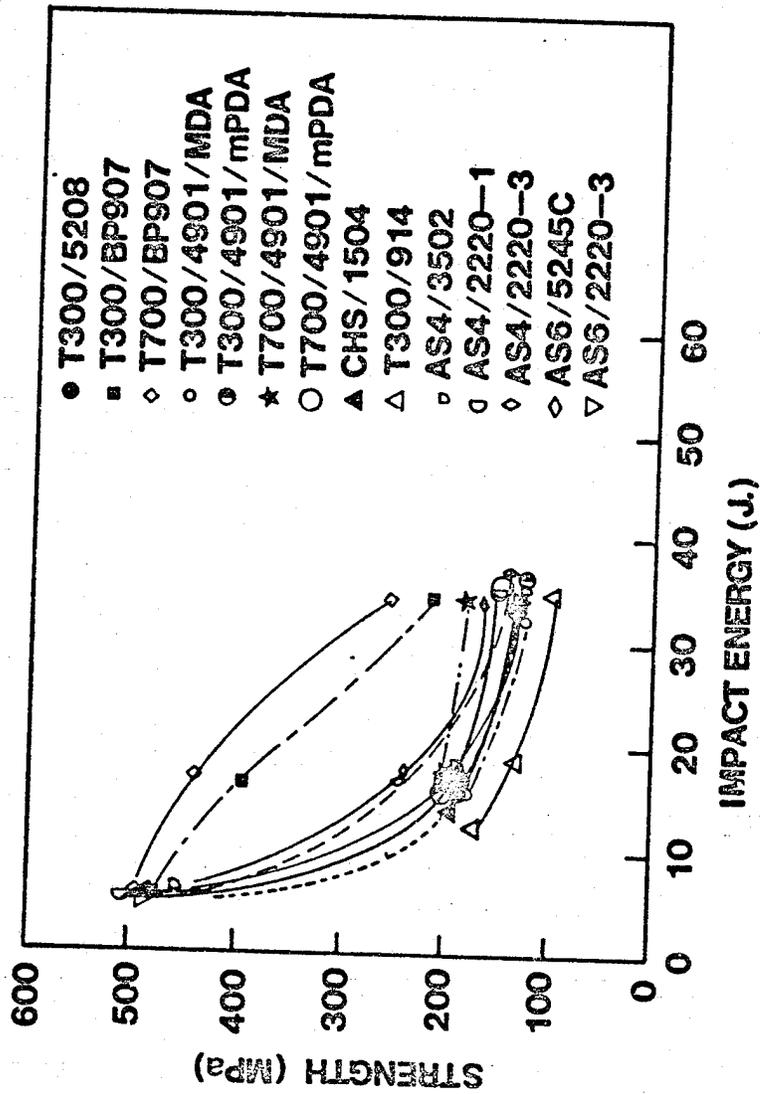
Figure 19. Effect of impact energy on compressive strength.

The failure strength for specimens loaded in compression following impact damage at selected impact energies is presented in Figure 19. Laminates constructed using BP907 resin and the higher strain T700 fiber recorded a higher failure strength than did BP907 laminates with T300 fiber.
