TITLE: RCS Analysis of the Reinforced Carbon-Carbon Tee-Seals as Potential "Flight Day 2" Candidates in Support of the Columbia Accident Investigation

TITLE: Proceedings of the HPCMP Users Group Conference 2004. DoD High Performance Computing Modernization Program [HPCMP] held in Williamsburg, Virginia on 7-11 June 2004

RCS Analysis of the Reinforced Carbon-Carbon Tee-Seals as Potential “Flight Day 2” Candidates in Support of the Columbia Accident Investigation

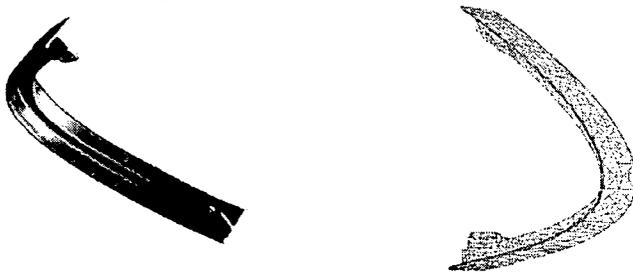
Six Tee-seals of different lengths and similar shapes were studied. In Figure 1 and Figure 2, one of the Tee-seals and its mesh are shown, respectively. The lengths for Tee-seal 006, 007, 008, 009, 010, and 011, are 53, 59, 69, 62, 60, and 59 inch long, respectively, with widths from five to six inches. At 433 MHz, the wavelength is 27.28 inches which means the length of the Tee-seals is approximately 2 wavelengths. Due to space limitations, we present numerical predictions only for Tee-seal 009 in this paper, however, similar computations were done for all six Tee-seals.

Figure 1. Tee-seal 009 (left) and Figure 2. A triangular mesh of Tee-seal 009 (right)

Since we don't know how the Tee-seals broke away from the shuttle (if they did), we assume the following four scenarios. Scenario 1 is when the Tee-seals broke away in whole as shown in Figure 1. In Scenario 2, the Tee-seals broke from the top of the flange to the apex (see Figure 3). In Scenario 3, the Tee-seals broke from the bottom of the flange to the apex (see Figure 4). In Scenario 4, the Tee-seals broke to form a 20 (Tee-seal

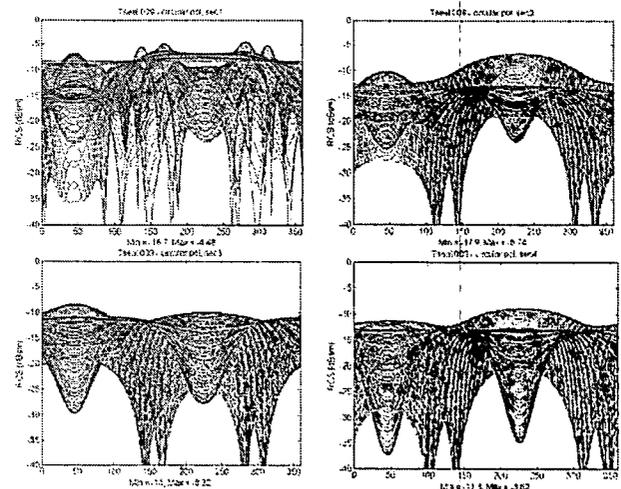
Furthermore, since the orientation of the whole or partial Tee-seal floating in space is unknown, we computed the global RCS values of each of the scenarios to find the maximum possible RCS value. Using the spherical coordinate system, we generated global RCS data by computing the azimuthal pattern (ϕ varying from 0 to 360 degrees) for each theta angle and increasing the θ angle in one-degree steps (θ varying from 0 to 180 degrees). In Figure 6, we plotted the global RCS for Tee-seal 009. The maximum value of each plot indicates the highest possible RCS value for that particular Tee-seal and particular scenario. The minimum of the "peaks" from all pattern cuts is also listed below each figure. The minimum and maximum peak values define the range of peak RCS as the Tee-seal spins in all directions. Figure 7 shows that the maximum RCS from all the Tee-seals and all the scenarios is -3.08 dBsm. This value comes from Tee-seal 008, the largest Tee-seal, at its full length (Scenario 1). Since the maximum RCS is less than -2.3 dBsm, these six Tee-seals are very unlikely candidates for "2003-003B".

Figure 6. Global RCS of Tee-seal 009

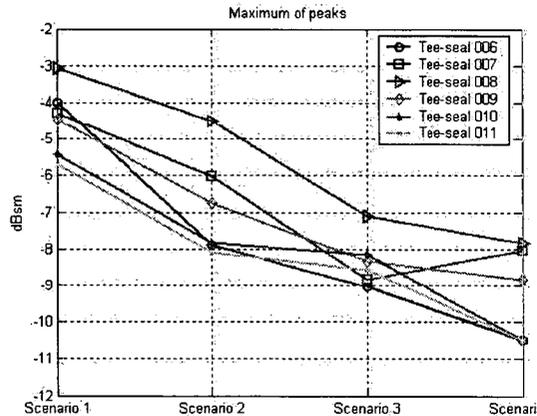
Figure 7. Maximum peaks for different Tee-seals. The highest RCS occurs for Scenario 1 of Tee-seal 008 at -3.08 dBsm

Other Tee-seals exhibit the same behavior with the largest section having the highest RCS and some intermediate sections falling into the resonance regions. From this part of the study, we conclude that the highest RCS for each Tee-seal occurs when the Tee-seal is in its full length. In other words, *no matter how you cut the Tee-seal, its RCS is going to be lower than the Tee-seal in its full length.* This again suggests that the highest RCS of all Tee-seals or any Tee-seal fragment is “-3.08 dBsm” indicating that these Tee-seals are not likely candidates for the FD2 object.

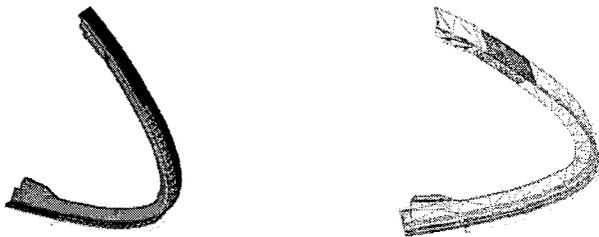
Even though the initial study with the four scenarios suggests that Tee-seals are not candidates, it is possible that at certain resonant lengths, the RCS could be higher than the maximum RCS for the four scenarios. We decided to focus on Tee-seal 009 for this study. Tee-seal 009 is approximately 62.36 inches long. Each flange portion is approximately 8 inches long. We only considered the portion of the seal without the flanges. This flangeless segment was cut into 38 sections of increasing lengths. The first section is approximately 8.66 inches long. The other sections were cut into 1 inch increments. For example, the second section was $8.66+1.018 = 9.678$ inches long, the third section was

$8.66 + 2 \times 1.018 = 10.696$ inches long, etc. The last section (number 38) is the whole flangeless portion of the Tee-seal (see Figure 8 and Figure 9). We provide a schematic drawing of the 38 sections of Tee-seal 009 in Figure 10.

Figure 8. 1-inch incremental cuts of Tee-seal 009 (left) and Figure 9 - First fragment of Tee-seal 009 (right)

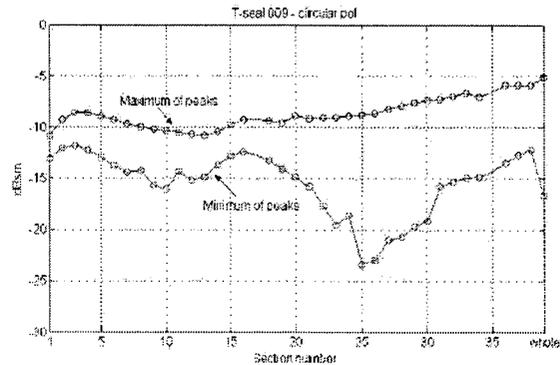
Next, we computed the global RCS of the 38 sections at 10 degree increments in the theta direction ($\theta = 10^{\circ}, 20^{\circ}, \dots, 170^{\circ}$). For each pattern cut, we determined the maximum. Thus, there are 17 such maxima for each section. By taking the largest and smallest of these 17 numbers, we can establish an upper bound and a lower bound for the largest possible RCS of each section. In Figure 11, we plot the bounds as a function of section number. Notice that the longest section has the highest RCS. There are sections of the seal that reflect the resonance phenomenon such as section 3 (~11.96 inches in length) and section 16 (~25.14 inches in length).

Figure 10. Global maximum and minimum of peaks of Tee-seals 009. Note that the highest RCS occurs when the whole Tee-seals 009 is considered.

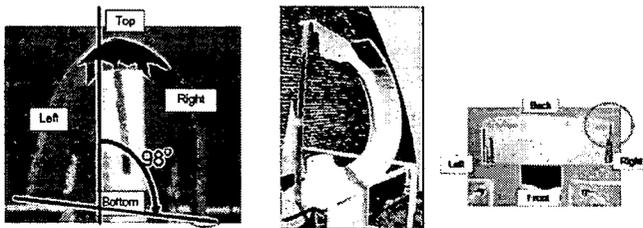
The scanned geometry has such high level of detail that it includes details of “bumps” and embossing on the inside of the Tee-seal. This particular non-flight worthy Tee-seal sample we received from NASA and measured at the ACR has a cutout at the upper right corner of the geometry as shown in Figure 12. We predicted Tee-seal 21 in the same three mounting positions as in the measurement setup. Figure 13 shows the Side mount that was 8 degrees from the plumb. Figure 14 shows the Vertical mount that was 7.3 degrees from the plumb. Although the Horizontal mount was level (see Figure 15), the “front” may not be precisely aligned to zero azimuth.

Figure 13. Side mount (left), Figure 14 - Vertical mount (center), and Figure 15 - Horizontal mount(right)

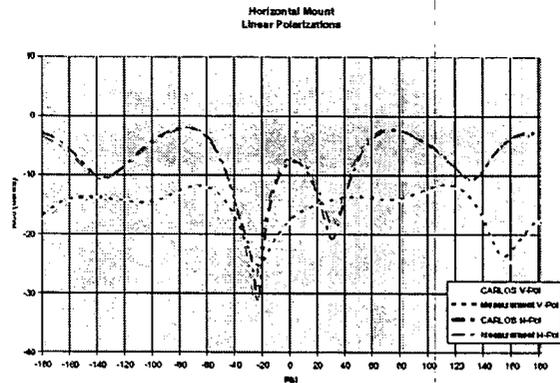
Figure 16 shows that the prediction and the measurement data have excellent agreement in magnitude for the horizontal mount case. Initially, we were concerned that the Reinforced Carbon Carbon Tee-seal may not be a perfect conductor as assumed in the computer model. This concern was dismissed once we obtained such excellent agreement with the measurement. Figure 17 shows the comparison for the Vertical mount case. Again, the agreement is excellent. Figure 18 shows the comparison for the Side mount case. The small discrepancy in the $60 \pm^\circ$ region can be attributed to the alignment difference between the measurement set up and the prediction model. Since it is very difficult to physically align the Tee-seal when the inside ridge of the Tee-seal is supported at only two points by a piece of foam, the Tee-seal can be slightly off the plane defined by the plumb and the bottom line (see Figure 13). Overall, the agreement between the predictions and measurements is excellent allowing us to validate the computational methodology with measurements and have high confidence in our conclusions from section two.

Figure 16. Predictions vs. Measurements –horizontal mount

To validate the predictions and measurement data on the Tee-seal, AFRL laser scanned Tee-seal #21 provided by NASA-JSC and compared linear RCS measurements to CARLOS predictions. The resulting data were in outstanding agreement, providing our team a high level of trust in our measurement efforts and predictions calculations for this effort.

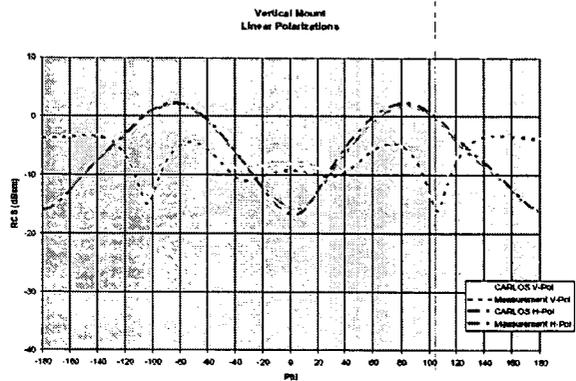
Figure 17. Predictions vs. Measurements –vertical mount

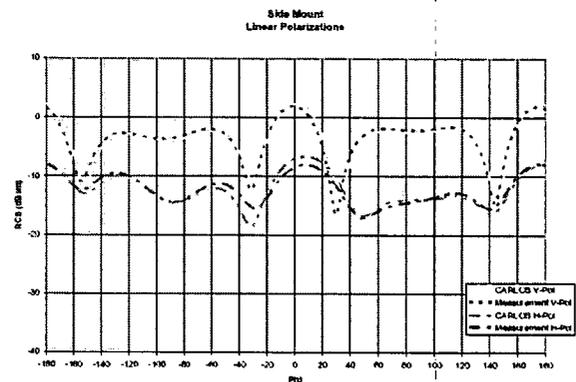
Figure 18. Predictions vs. Measurements –side mount
