EXPLOSIVE TESTS OF BLAST CELL,
NAVAL TORPEDO STATION, BANGOR ANNEX

J. M. Ferritto

Technical Report

R 823

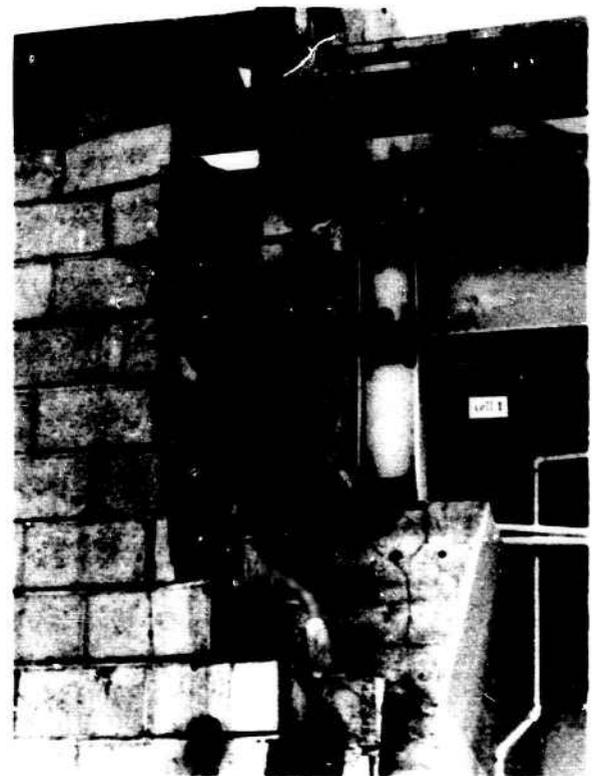
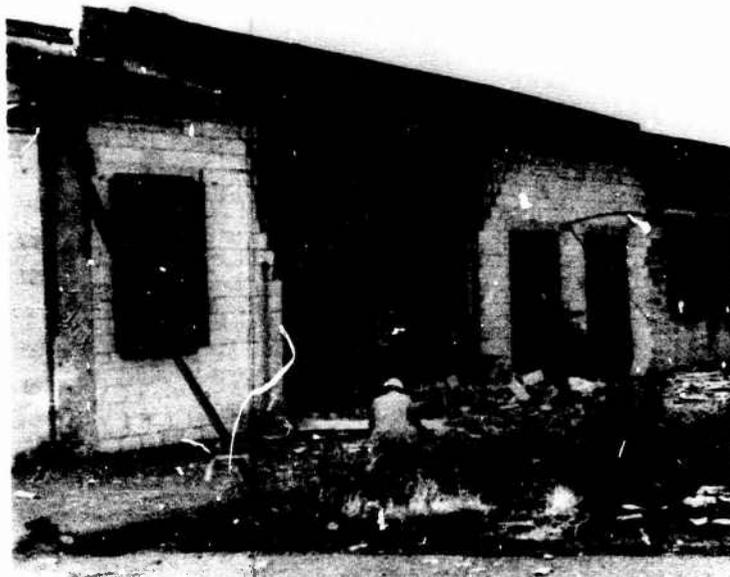
Figure 7. Observed damage after shot 1.

Shot 1—10 Pounds, Cell 1. Figure 7 gives photographic coverage of the damage caused by shot 1. The

Permanent deflections of the sidewalls were measured to be about 3/16 inch outward. No permanent deflection could be measured in the blast door or passthrough door. Window breakage is shown in Figure 9. Figure 10 shows the crack pattern observed in the blast cell walls. The numbers correspond to shot numbers. No evidence was observed of shear failure of the door frame.

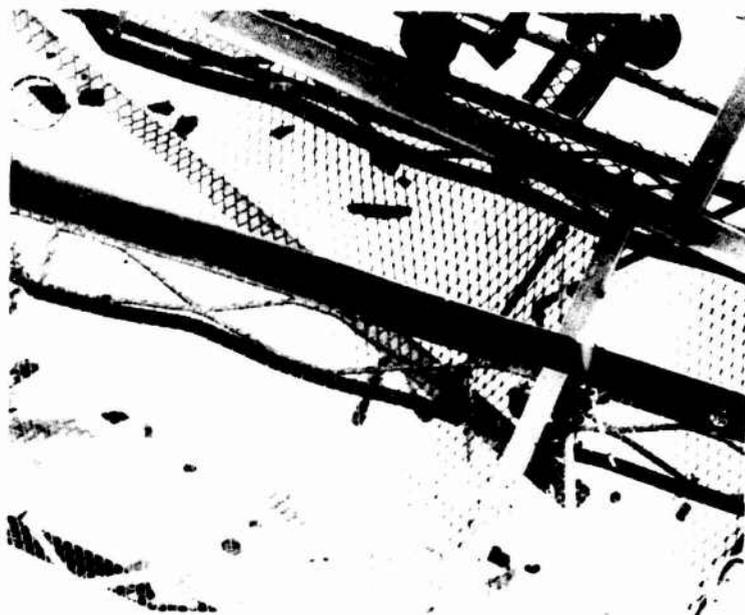
Figure 7 (cont).

View of interior of cell 3.

Interior view of exterior wall movement.

Debris net in cell 3.

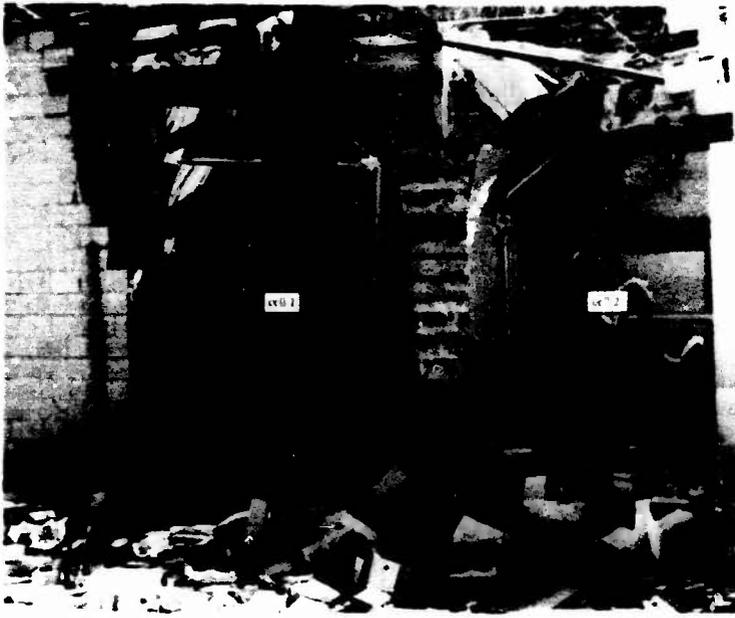
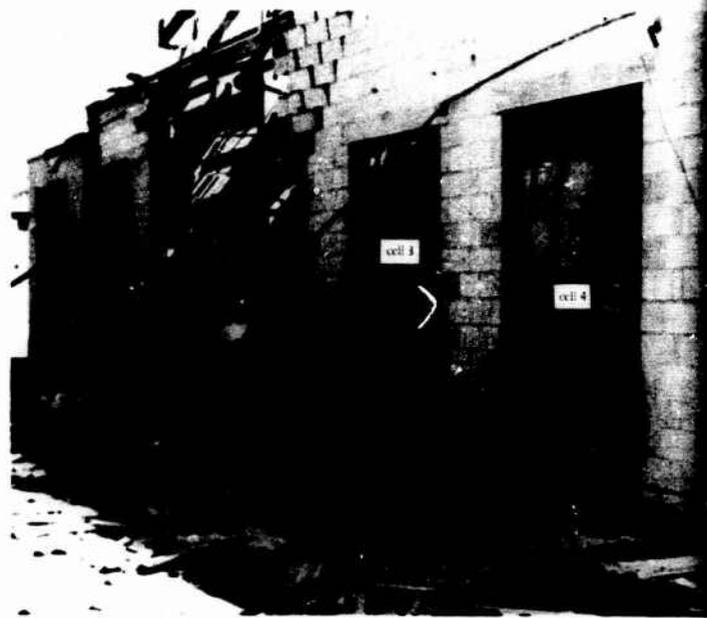
Figure 11. Observed damage after shot 2.

Shot 2 - 10 Pounds, Cell 1. For the second shot the explosive was centered between the sidewalls and between the backwall and window. This shot caused a section of the roofing behind the blast cell to be blown inward (Figure 11). Additional roofing was blown in over the pump room. The passthrough door on the sidewall rebounded off its supports, however, the door on the other side of the wall was still intact. The blast door, although still adequately supported, failed its bottom support guides by outward rebound. Roof failure was noted in the northwest portion of the middle bay. Minor amounts of ceiling were blown down. Figure 10 shows the additional cracking of the cell walls. No measurable additional permanent deflection was noted. The door to the pump room from the main room behind the cells was blown into the building by pressure spilling over the cell wall.

Cell 1 and cell 2.

Exterior of structure facing north.

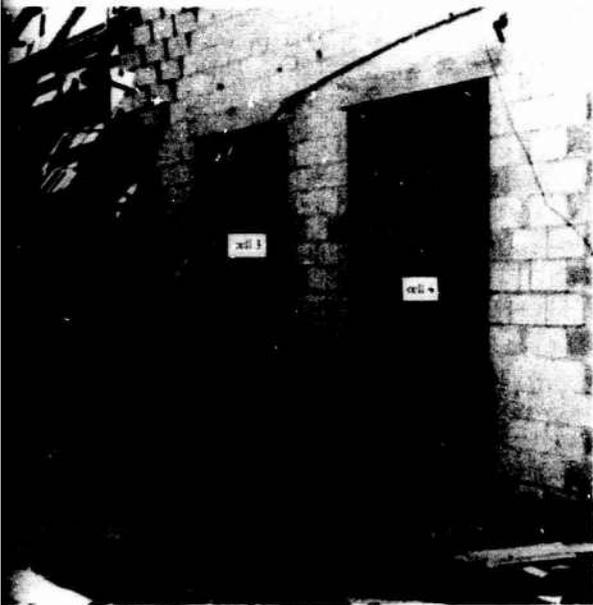
Figure 11. Observed damage after shot 2.

Exterior of structure facing north.

Exterior of structure facing south.

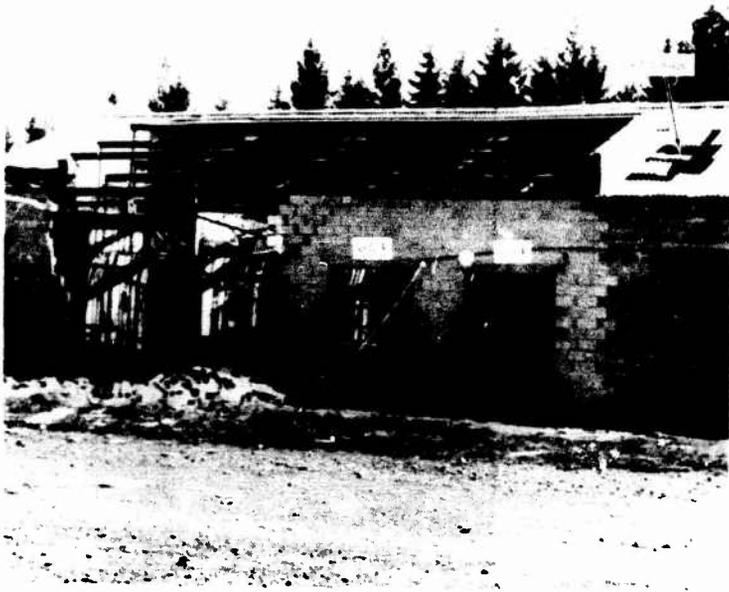
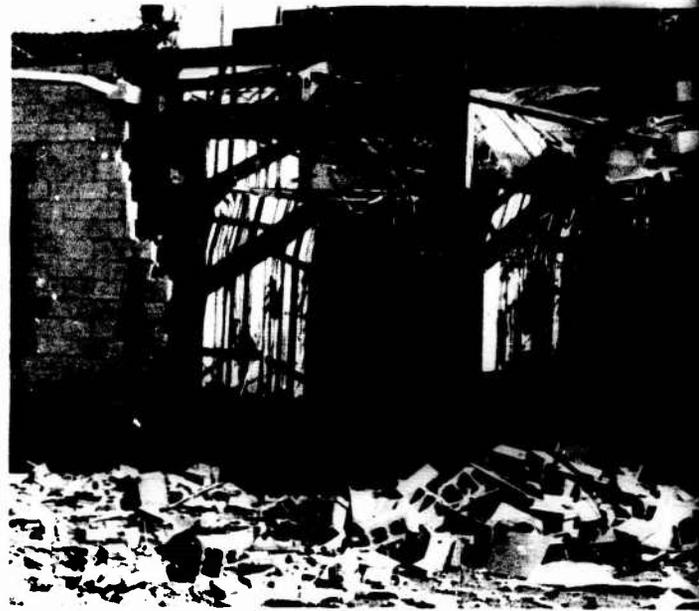
Exterior of structure facing east.

Cells 1 and 2.

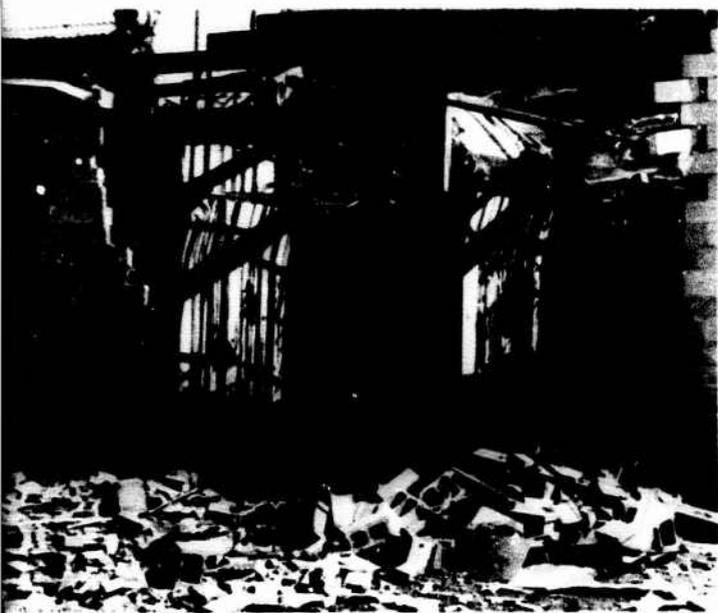
was blown off, leaving an opening into the next cell. The rebound supports of the blast door failed. Cracking of the floor was noted. Figure 12 shows post-shot damage. Figure 10 shows additional cracking to the cell walls; no additional permanent deflection was observed.

Cells 1 and 2.

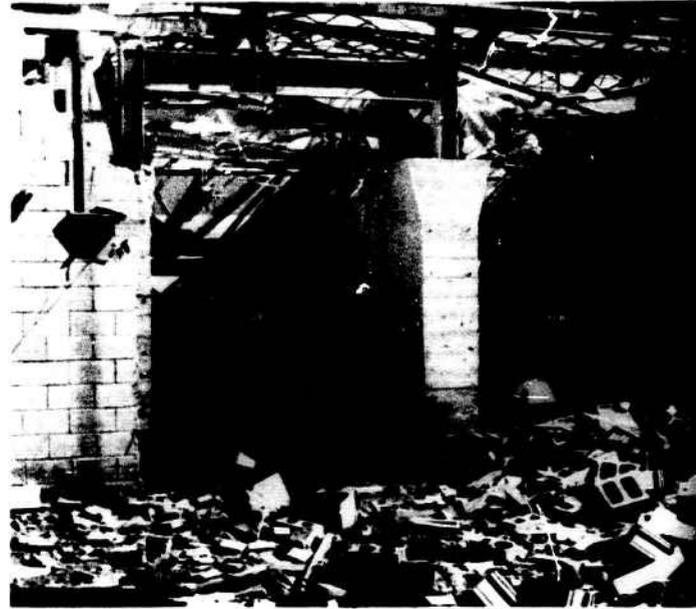
Shot 4 - 10 Pounds, Cell 1. The fourth shot duplicated the position of shot 2. This shot caused additional roof and ceiling damage. Figure 13 shows photographs after the shot. Additional cell-wall cracking is shown in Figure 10.

Exterior cells 1 and 2.

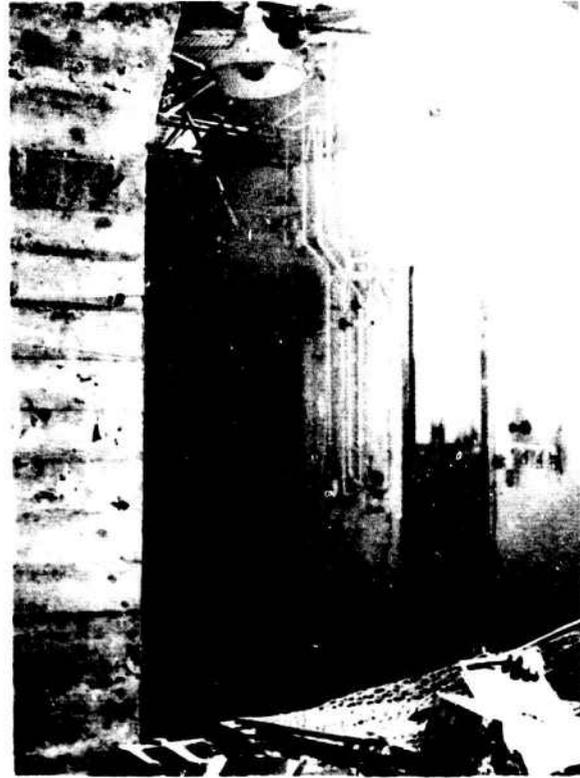
Cell 2.

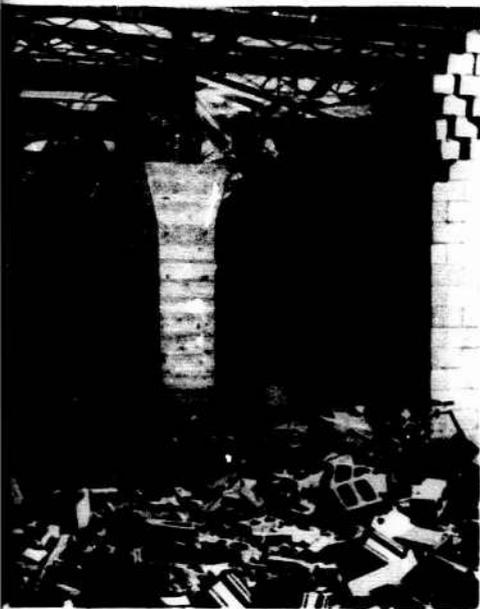
Exterior cells 1 and 2.

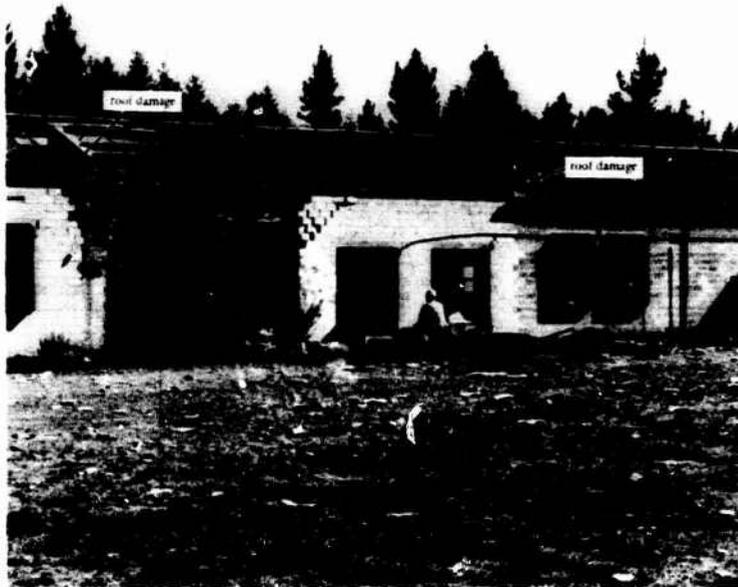
Exterior cells 1, 2, 3, and 4.

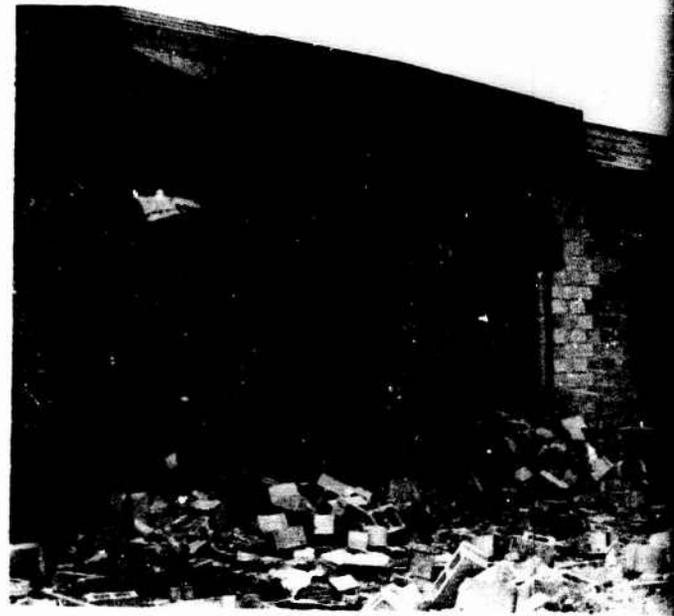
door was still operable. Figure 14 shows photographs after the shot; Figure 15 shows cracks in the cell walls. Window breakage is shown in Figure 16.

Exterior cells 3 and 4.

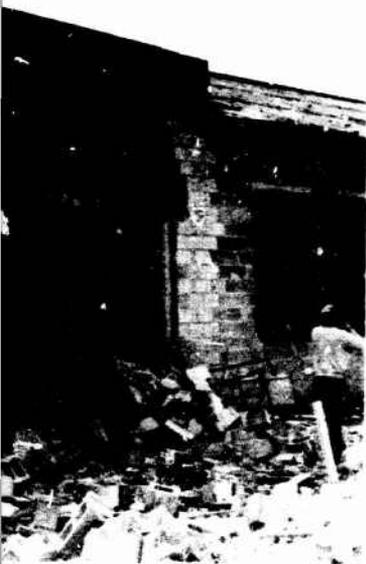
ls 3 and 4.

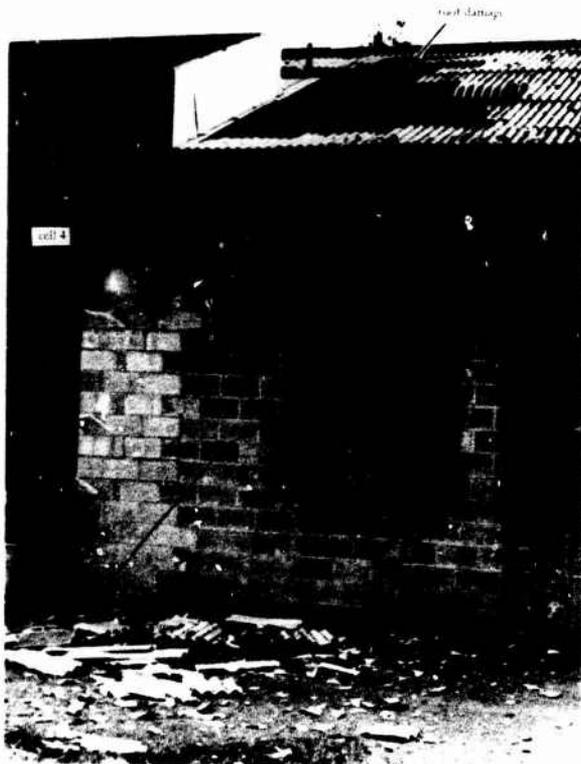
Exterior wall looking east.

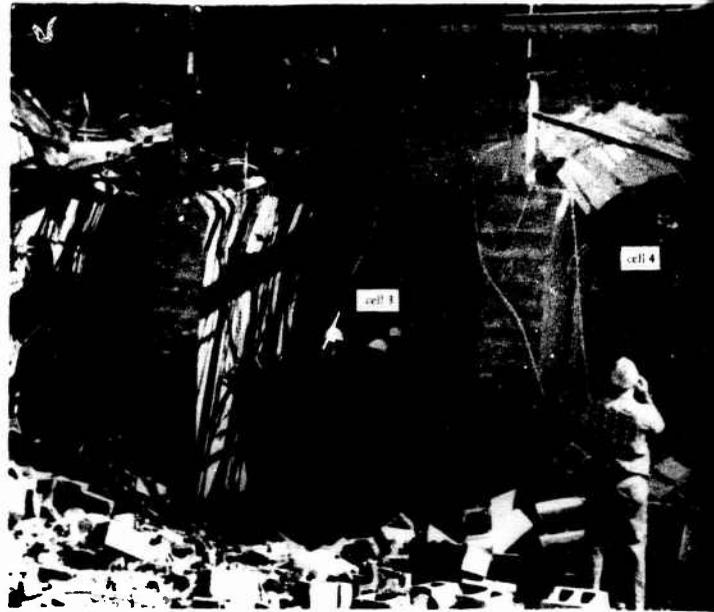
Shot 7—20 Pounds, Cell 3. This was the second shot of 20 pounds in cell 3. The charge was positioned 2 feet from the backwall and 2 feet from the sidewall between cells 3 and 2. Some roofing in the middle bay was blown in. Portions of roofing cracked by earlier shots failed. Additional ceiling was blown down; however, most of the roof on the leeward side of the building (east side) was still in place. The blast cell sidewalls had an additional permanent deflection of about 5/32-inch. The passthrough door in the backwall rebounded off its supports. This 2-by-3-foot, 1-inch-thick steel plate has a permanent deformation of 1/2 inch at its center. The blast door was still operable with no measurable permanent deflection. The rebound supports failed. Figure 17 shows photographs after the shot.

Exterior cells 3 and 4.

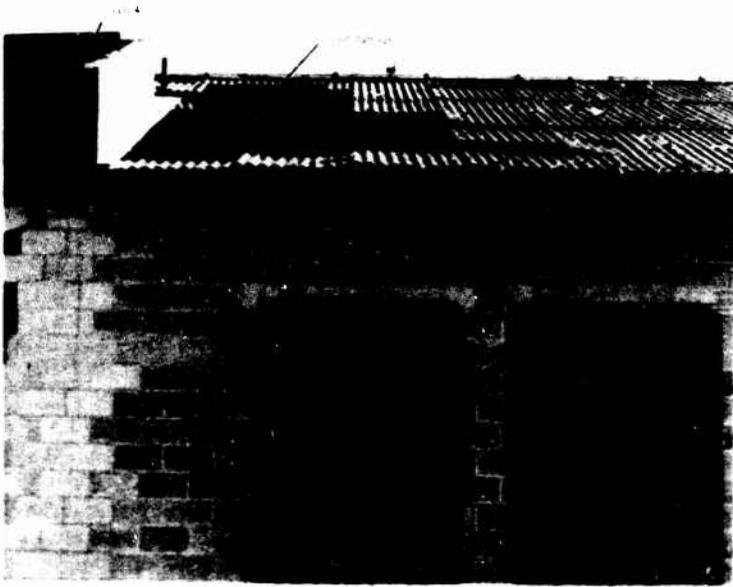
Exterior structure looking east.

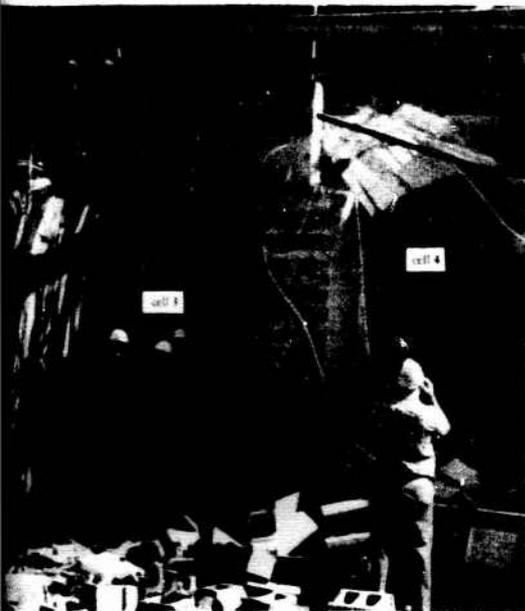
Exterior cells 3 and 4.

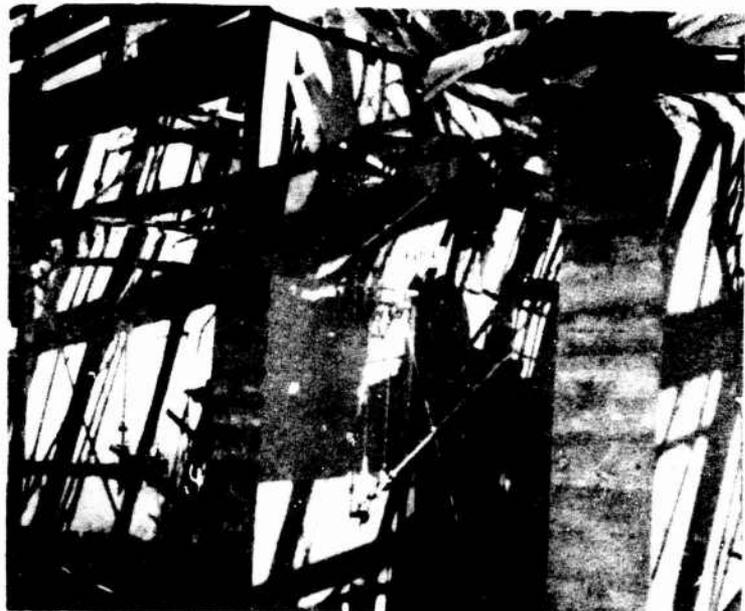
Cell 3.
