NAEC-ENG-7868

31 Mar 1976

FINAL REPORT

THE CORROSION CONTROL OF
FASTENING SYSTEMS FOR
AIRCRAFT CARRIER STEAM CATAPULTS

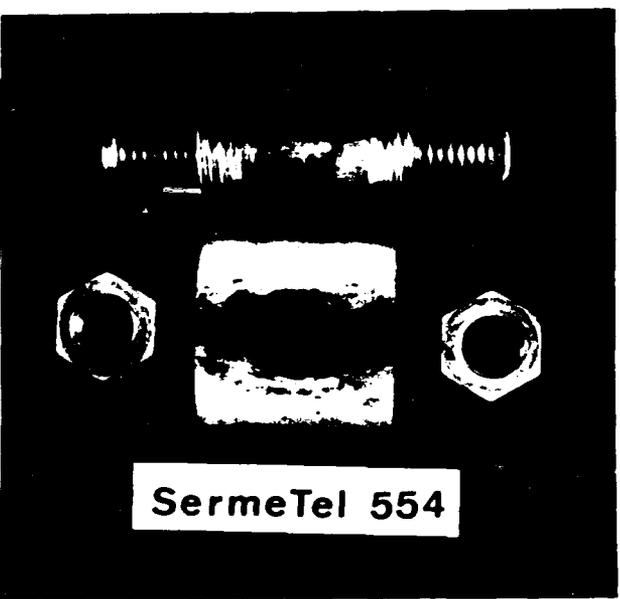
High Temperature screening test Results - 2nd run 10 Oxidation-Corrosion Cycles - Metco 120 used on cylinders.

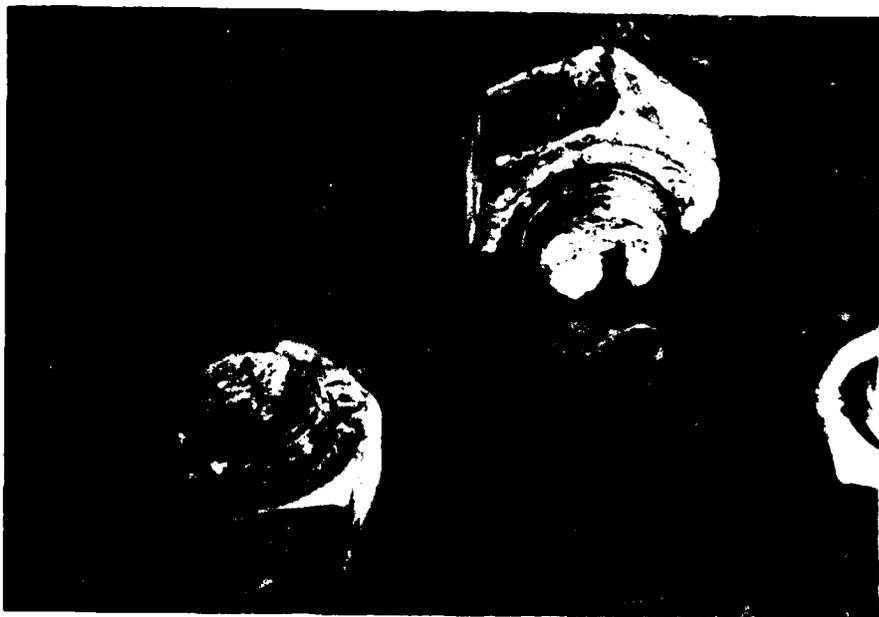
Photo 60 Diffused Ni-Cd coated studs and nuts after 6 months on the U.S.S. Saratoga exposure rack.

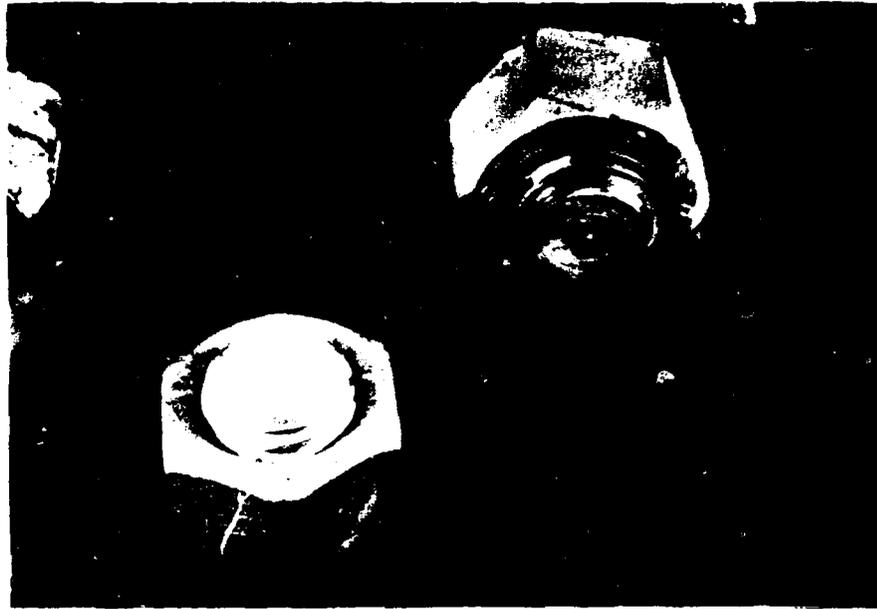
Photo 61. Studs and nuts coated with 0.7 mil electroless nickel after 6 months on the U.S.S. Saratoga exposure rack.

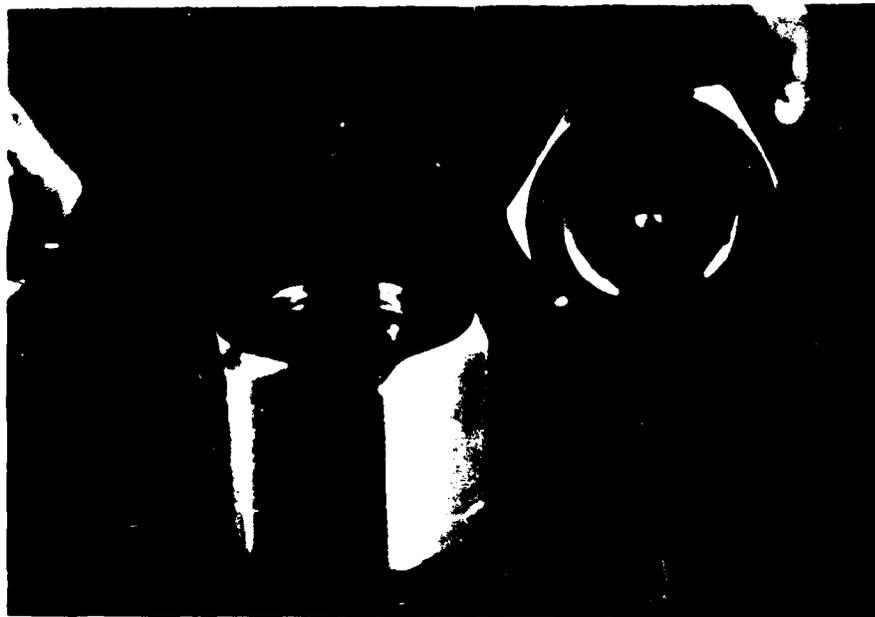
Photo 64. Inconel 718 stud and waspaloy nut after 6 months on the U.S.S. Saratoga exposure rack.
