REPORT DOCUMENTATION PAGE		READ INSTRUCTIONS BEFORE COMPLETING FORM
1. REPORT NUMBER	2. GOVT ACCESSION NO.	3. RECIPIENT'S CATALOG NUMBER
	AD A105781	
4. TITLE (and Subtitle) Phase I Inspection Report Potic Reservoir Dam Lower Hudson River Basin, Greene County, N.Y. Inventory No. 307		5. TYPE OF REPORT & PERIOD COVERED Phase I Inspection Report National Dam Safety Program

**LOWER HUDSON RIVER BASIN
TOWN OF COXSACKIE
GREENE COUNTY, NEW YORK**

**POTIC RESERVOIR DAM
NY 00307**

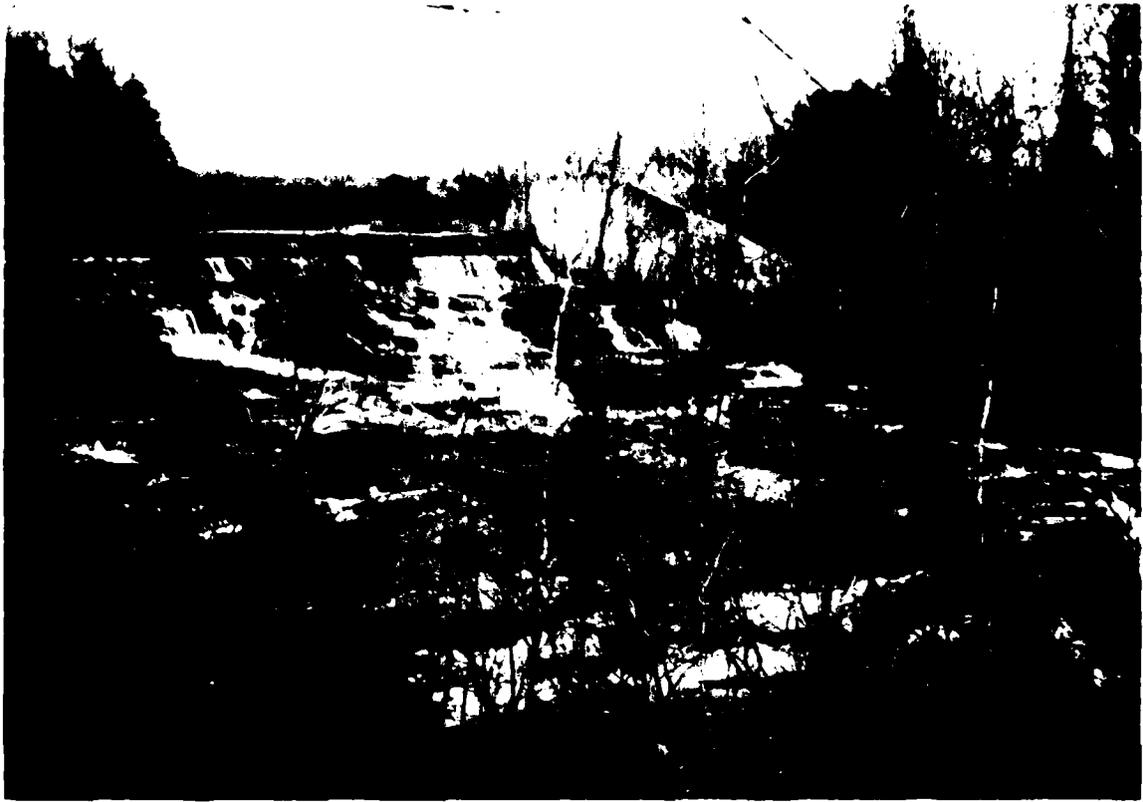
Overview Photo - Potic Reservoir Dam - 4/9/81

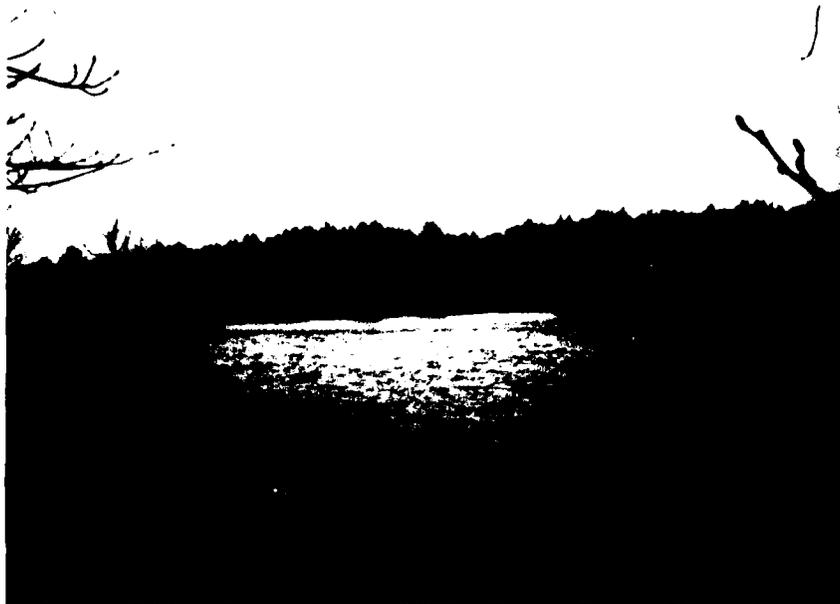
A-2A Upstream slope of dam looking toward right abutment
4/9/81

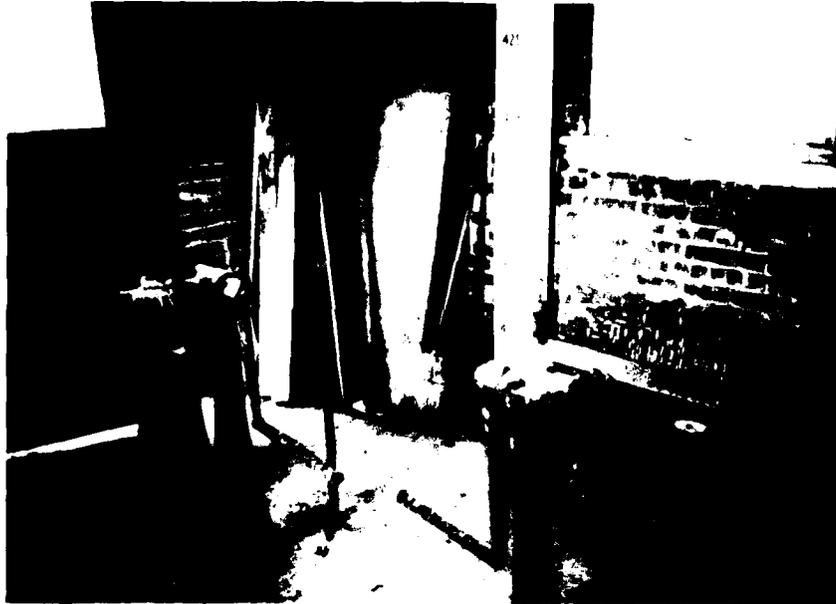
A-6A Hand crank, bevel gear floor stand controls for slide gates
4/9/81

- 9) Repair the uppermost gate stem guide on the downstream gate in the intake structure.
 - 10) Develop and implement effective routine operation and maintenance procedures for the dam and its appurtenances. The sluice gates and blowoff valve should be exercised regularly.

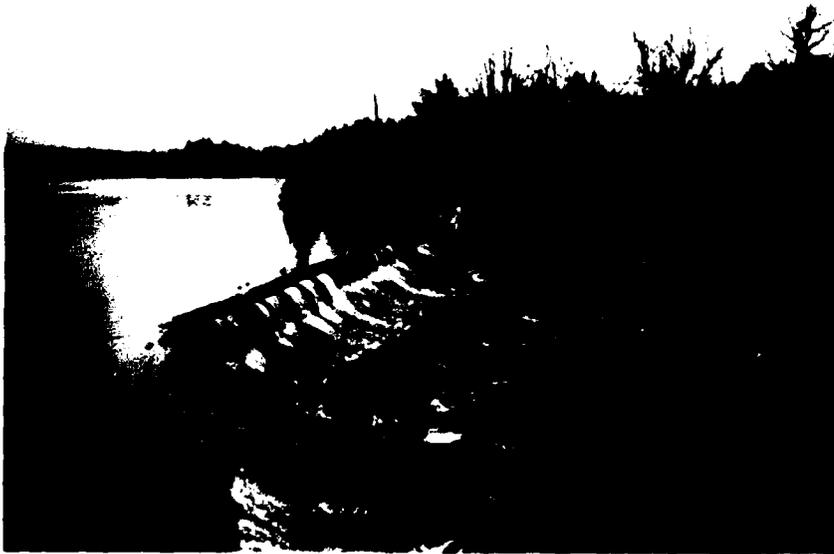
A-8B Ogee spillway weir cap looking toward left abutment
4/9/81
