# CONSTRUCTION FOUNDATION REPORT

**SOUTH PLATTE RIVER BASIN  
BEAR CREEK LAKE, COLORADO**

**VOLUME I  
TEXT AND PHOTOS**

**FEBRUARY 1983**

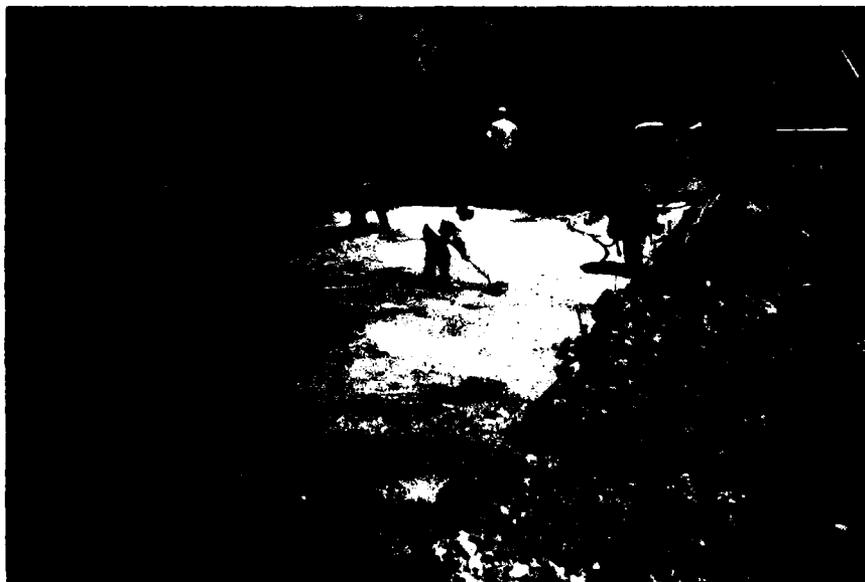
PHOTO NO.14. Outlet works floor, Sta. 0+00 to -0+40, primarily sandstone with a few fractures. Looking northeast.

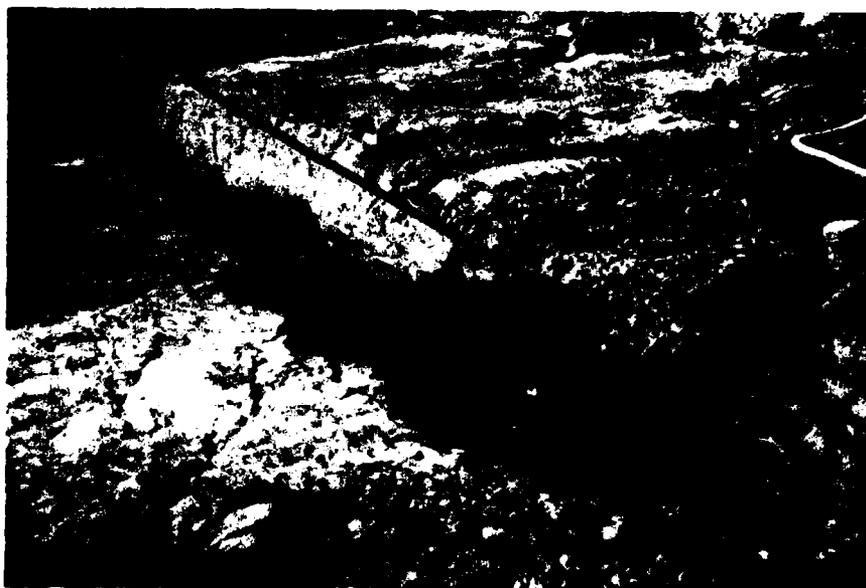
PHOTO NO. 24. Outlet works keyway at Sta. 10+68, near siltstone-shale contact. Looking northeast. 9/8/75.

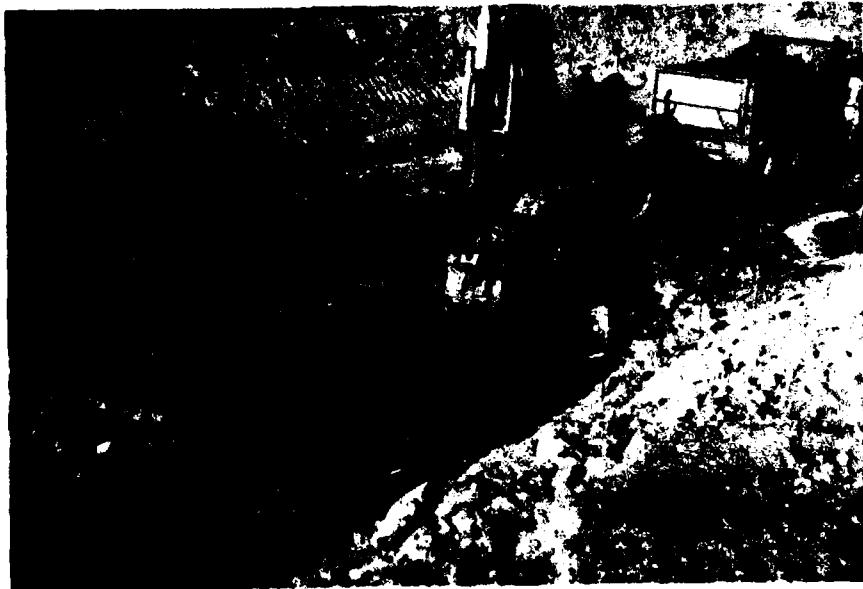
PHOTO NO. 26. Backhoe breaking up conglomerate at Sta. 3+00, outlet works trench. Looking northeast.

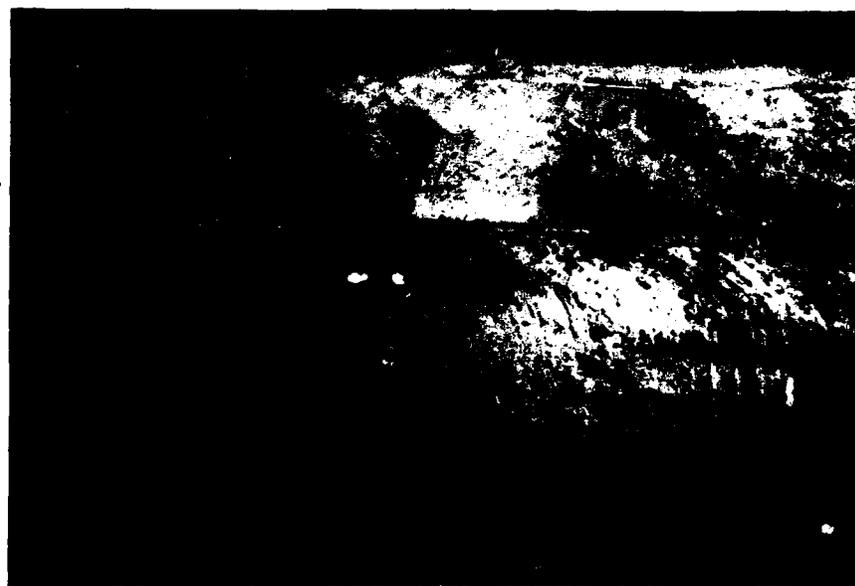
PHOTO NO. 40. Two grouted prairie dog holes in south embankment trench at Sta. 11+97, el. 5615. Looking west.

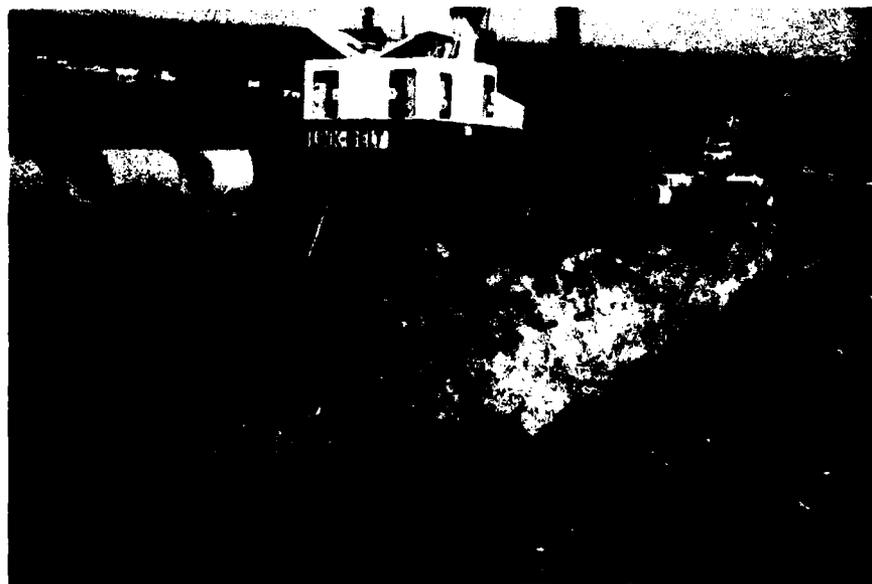
PHOTO NO. 44. Top of rock on north face of Warrior  
Ditch relocation, Sta. 56+25 to 57+25.  
Looking northeast.

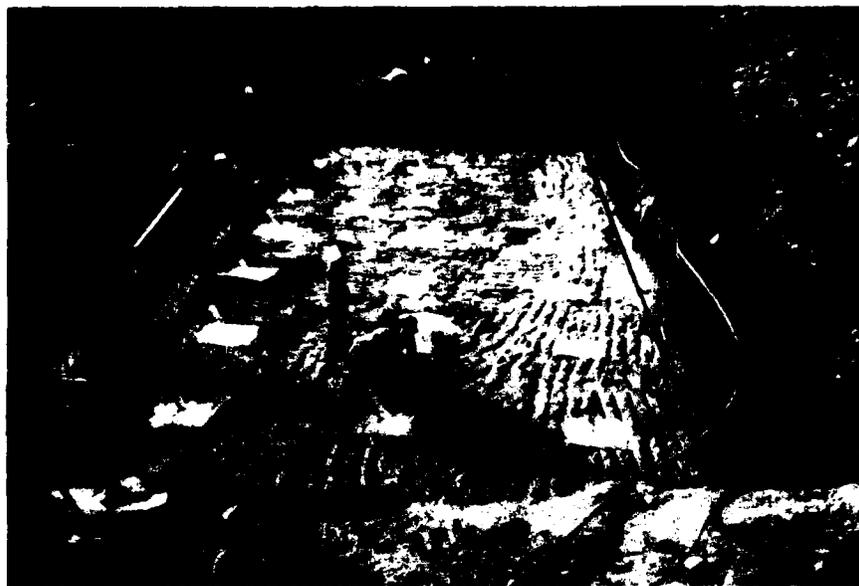
PHOTO NO. 47. Pioneer Ditch drop structure floor.  
Drains extending from sandy siltstone  
and silty sandstone floor. Looking west.  
3/18/76

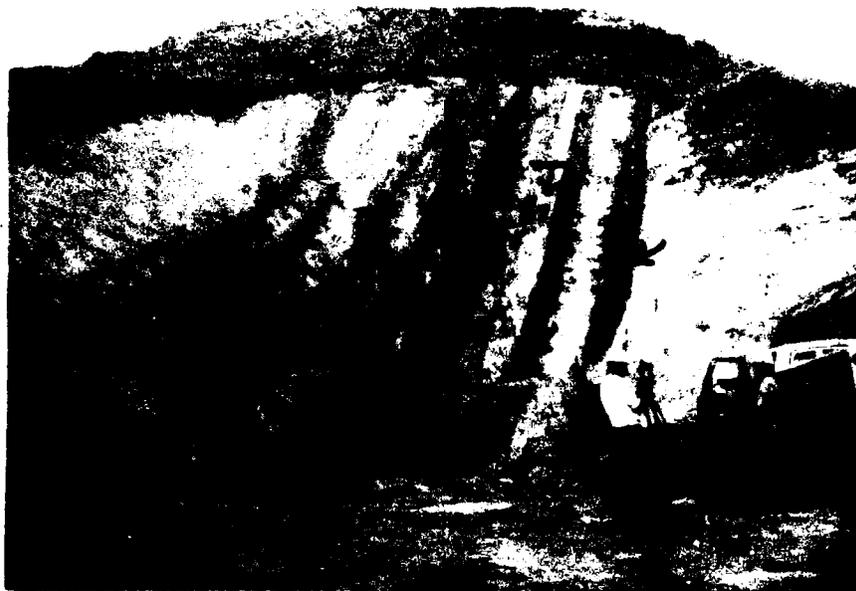
PHOTO NO. 75. Backslope of Mine #1 excavation, showing openings of drifts, raise, and a crosscut into coal seams. Looking south. 6/21/77.
