UNDERWATER FACILITIES INSPECTIONS & ASSESSMENTS

NAVAL AIR STATION,
NORTH ISLAND
SAN DIEGO, CALIFORNIA

FPO-1-84(19)

OCTOBER 1984

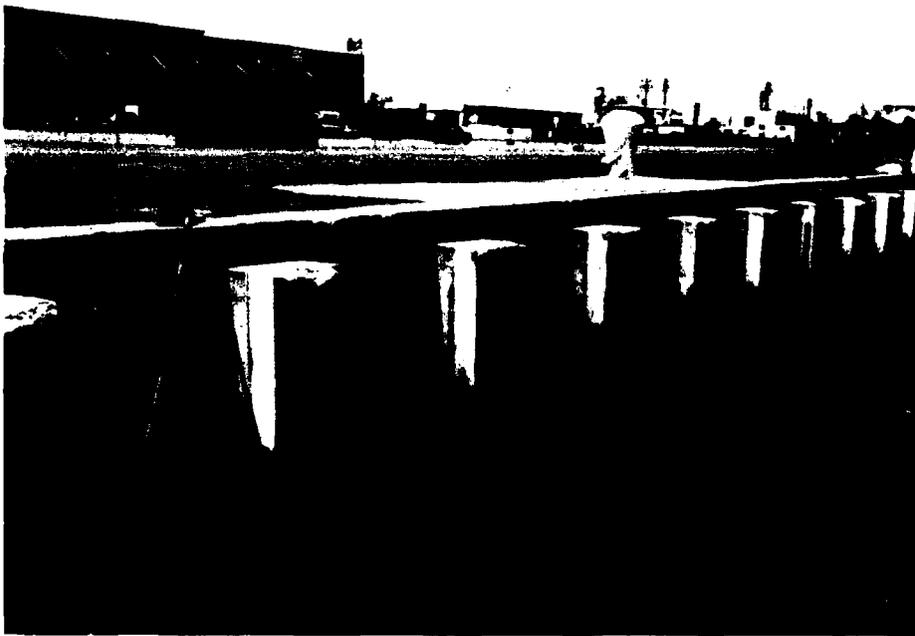
10. Carrier Quay Wall, view is to the East from about Station 16+00.
