SPILLWAY MODIFICATION GRAPEVINE LAKE TEXAS (U) ARMY
ENGINEER DISTRICT FORT WORTH TX A J MARR JUN 86

**FINAL
FOUNDATION
REPORT**

**SPILLWAY MODIFICATION
GRAPEVINE LAKE, TEXAS**

JUNE 1986

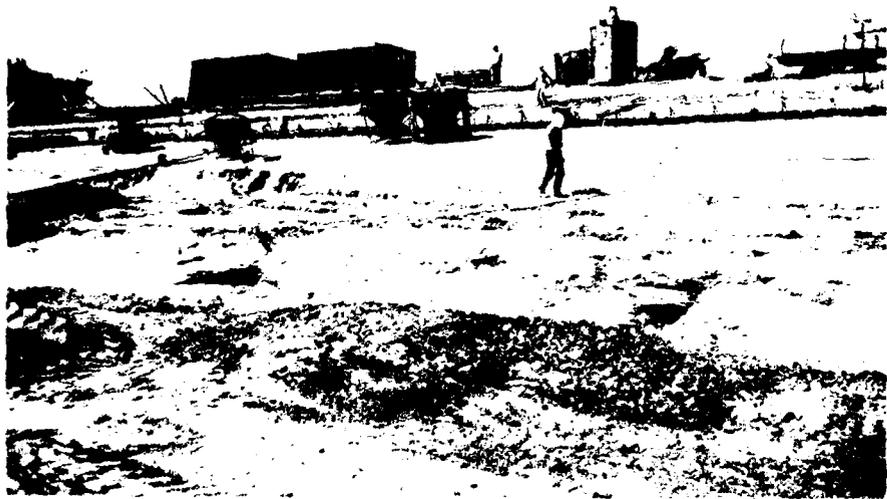
Fig. 17 - Exposed foundation surface - 25 June 1984

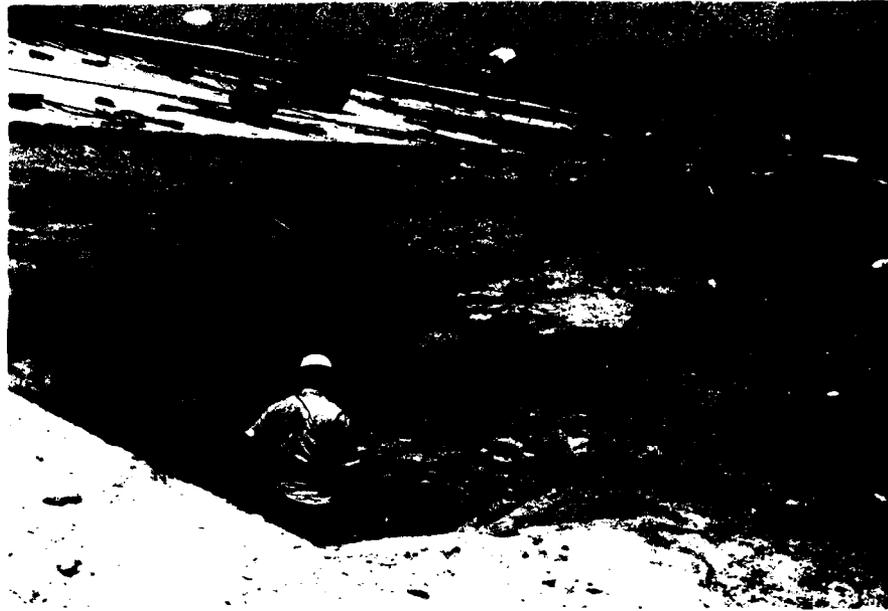
Fig. 18 - Exposed foundation surface - 10 July 1984

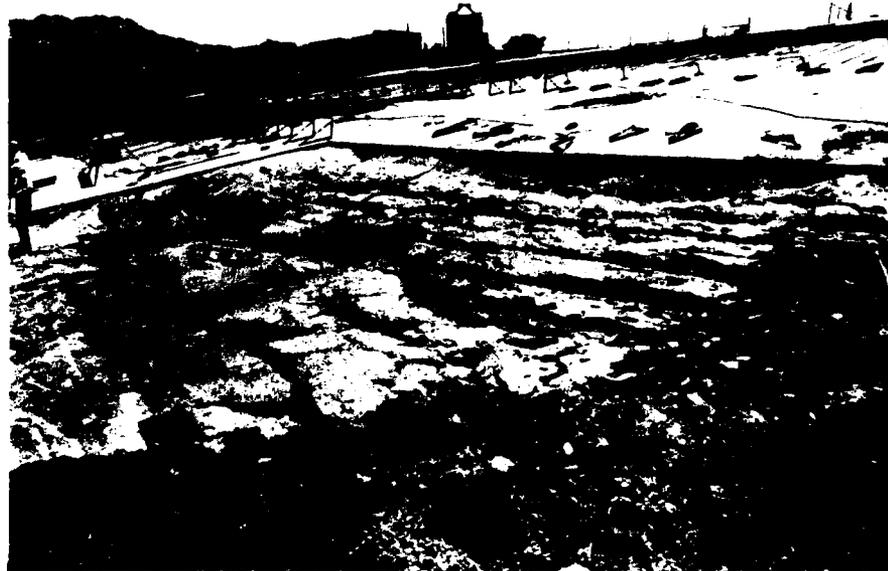
Fig. 19 - Exposed foundation surface - 10 July 1984

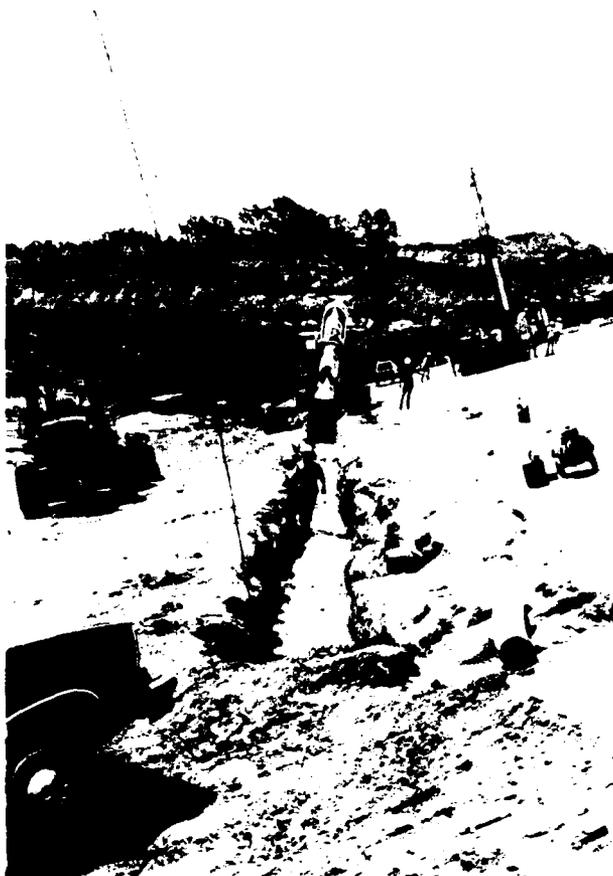
Fig. 22 - Excavation for cut off wall -
28 June 1984

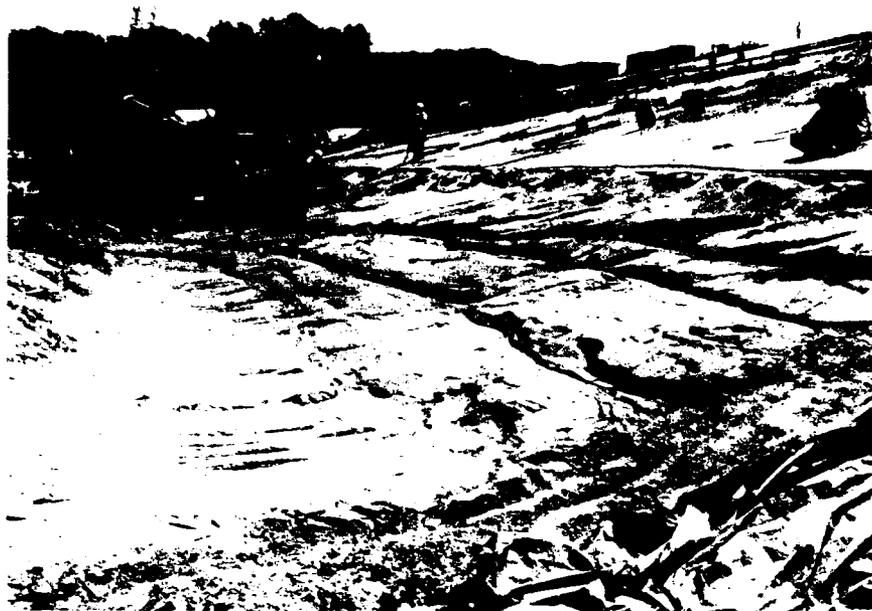
Fig. 24 - Exposed foundation surface - 10 September 1984

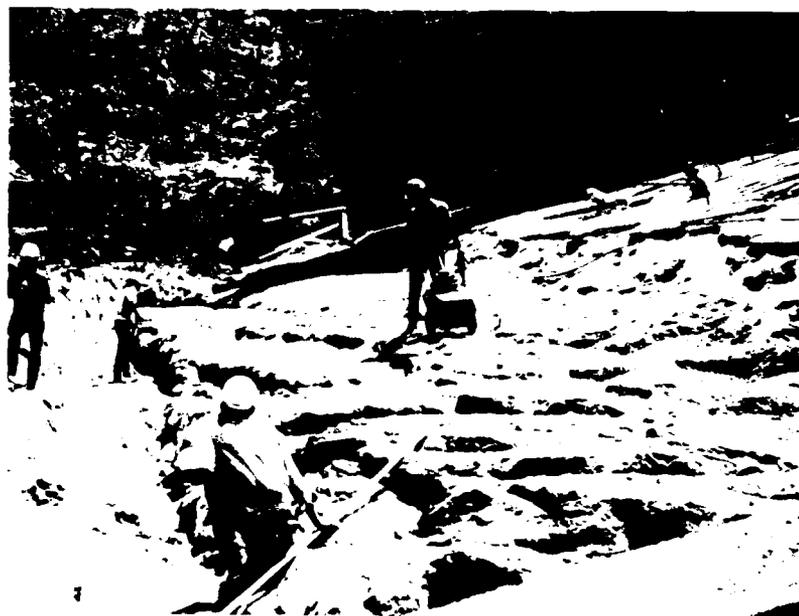
Fig. 25 - Exposed foundation surface - 17 September 1984

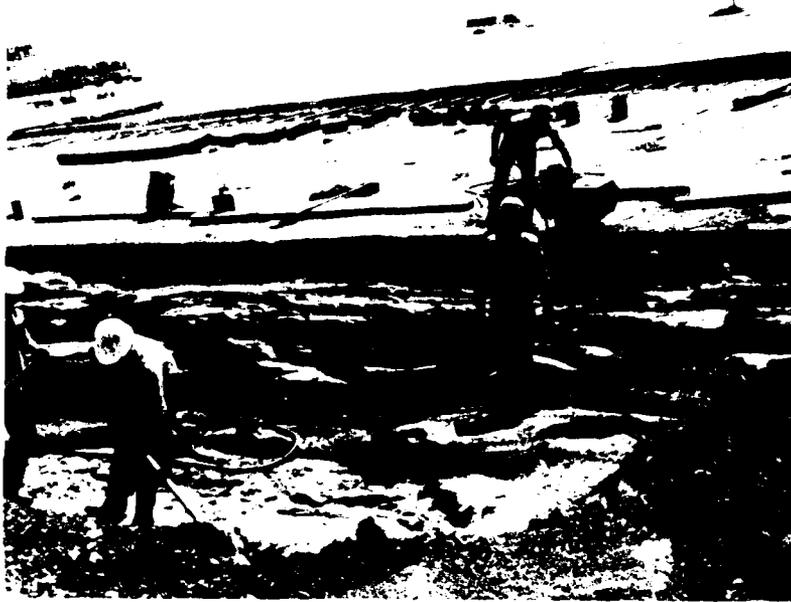
Fig. 26 - Exposed foundation surface - 9 October 1984

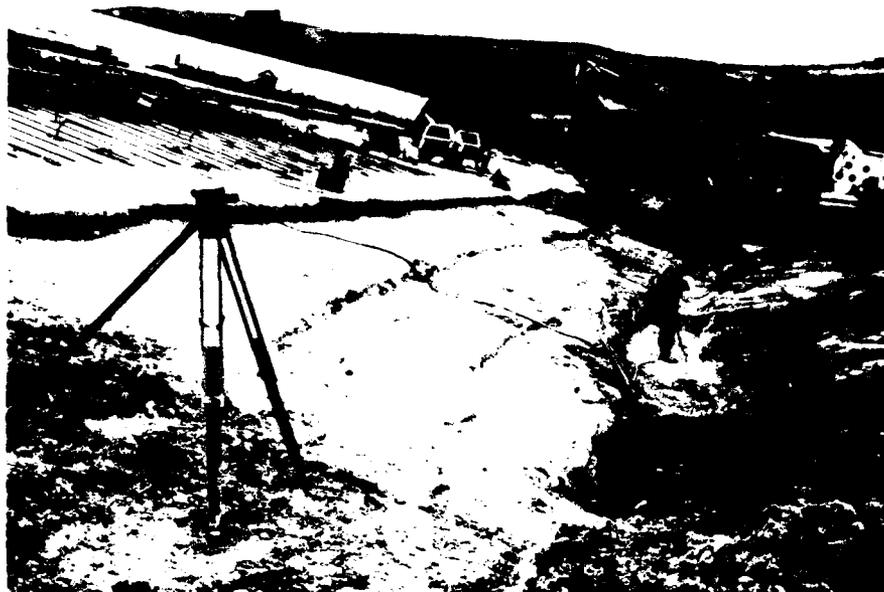
Fig. 28 - Exposed foundation surface - 20 November 1984

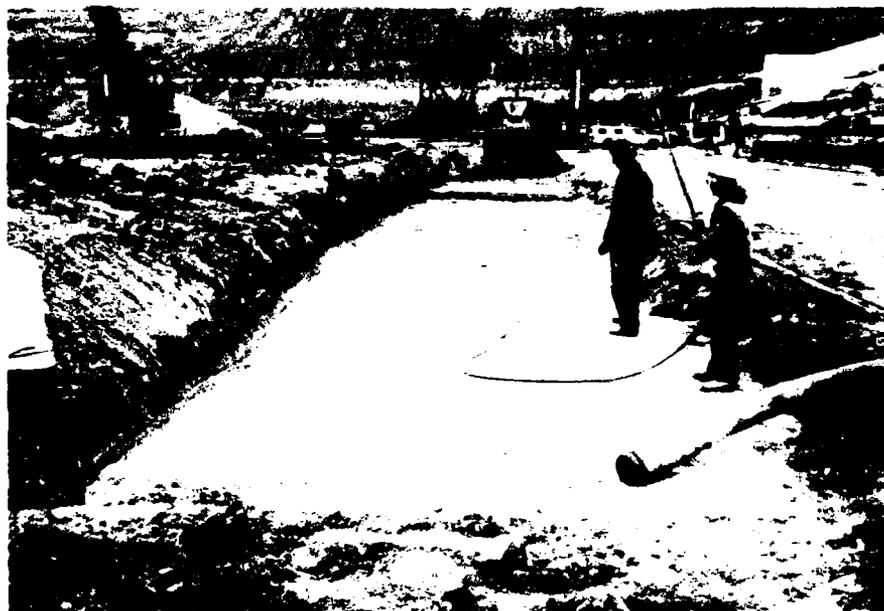
Fig. 29 - Exposed foundation surface - 6 March 1985

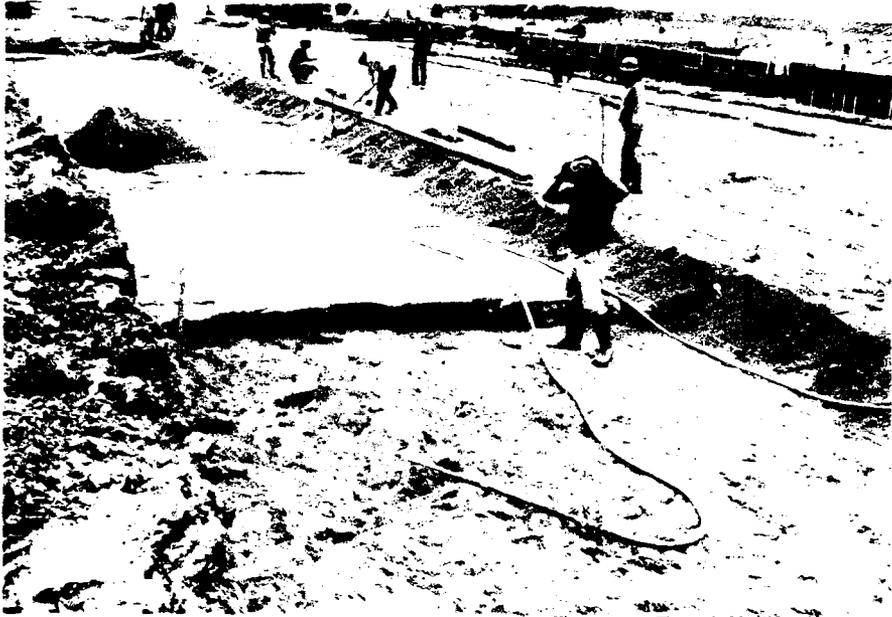
Fig. 30 - Exposed foundation surface - 6 March 1985

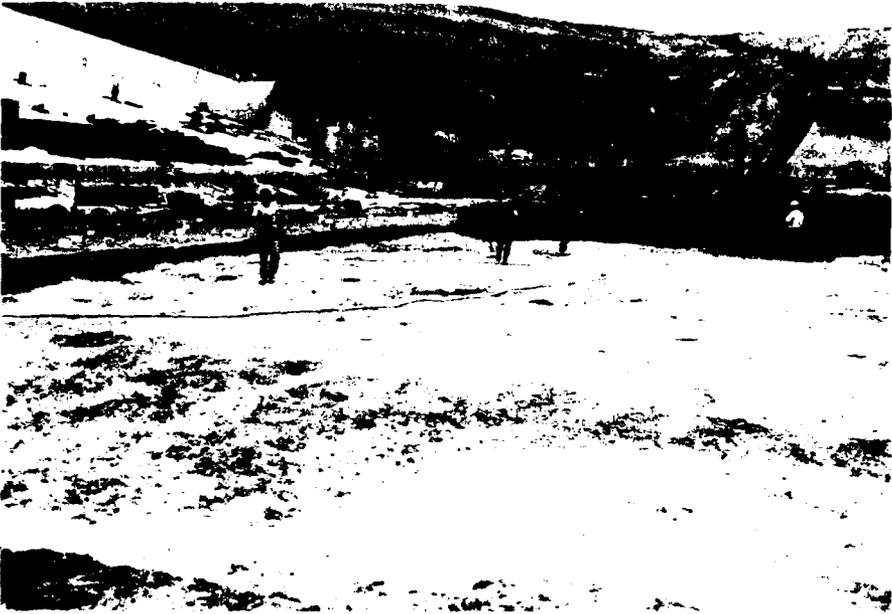
Fig. 31 - Exposed foundation surface - 7 March 1985
