CONDITION SURVEY OF LOCK NO. 2 MONONGAHELA RIVER

G. S. Wong, R. L. Stowe, J. C. Anvin, & G. J. ...
Structures Laboratory

August 1988
Final Report

DEPARTMENT OF THE ARMY
US Army Engineer District, Pittsburgh
Pittsburgh, Pennsylvania 15222-4136

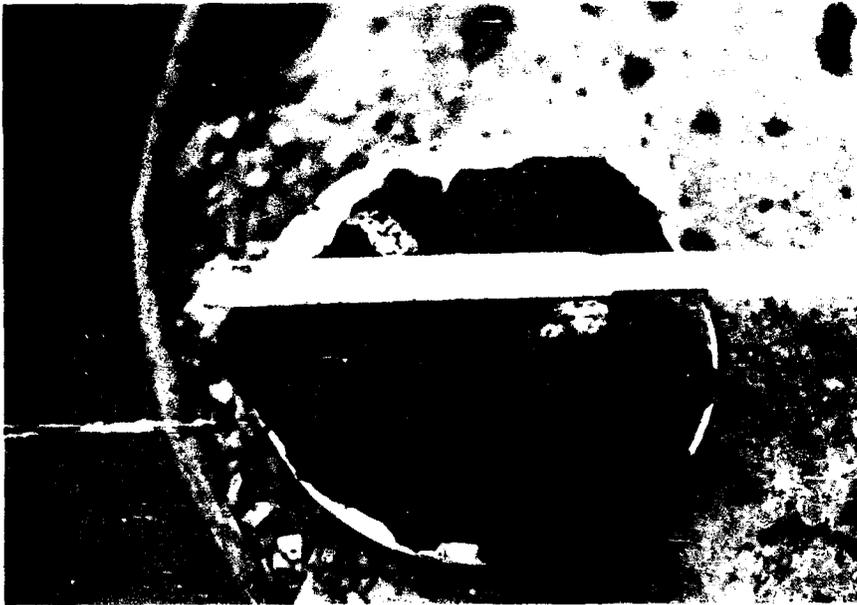
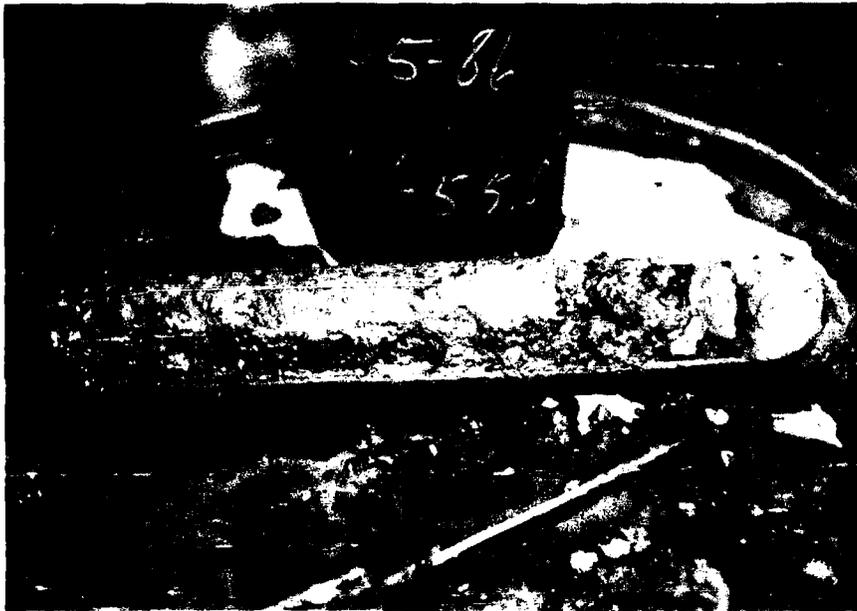
35. Samples of backfill material were taken every 5 feet. The material ranged from loosely consolidated slag particles to zones of clay silt material (Figures 7 and 8). Approximately 115 ft of backfill was drilled and sampled, much of it required casing to prevent sloughing of adjacent material. A total of 328.8 ft of concrete core and 185.95 ft of foundation rock was cored.

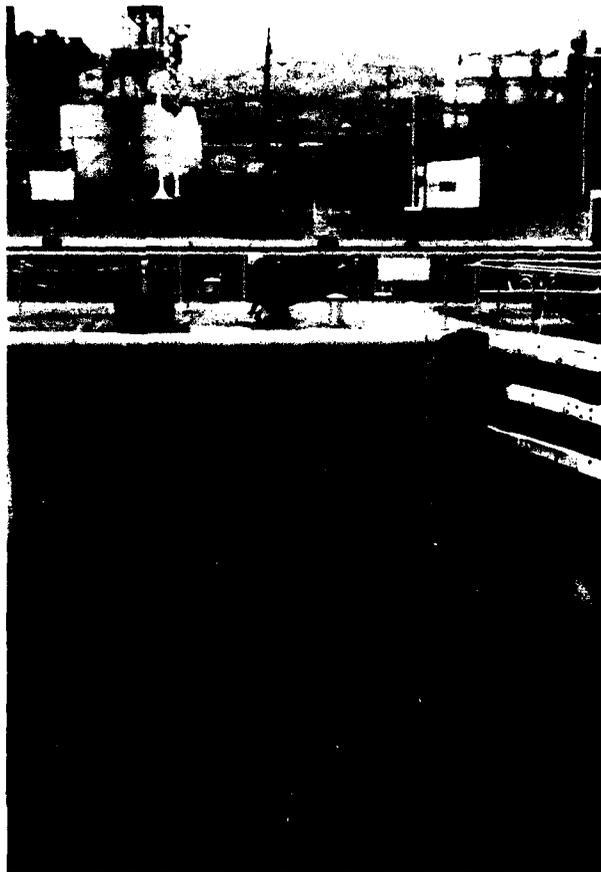
Photograph A5. Downstream of upper gate middle wall in
small lock chamber

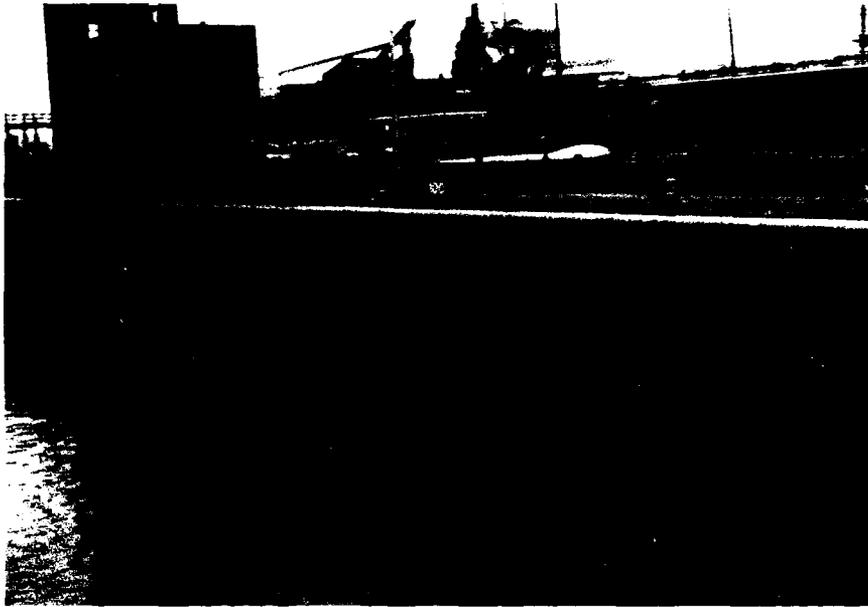
Photograph A6. Middle wall small lock chamber

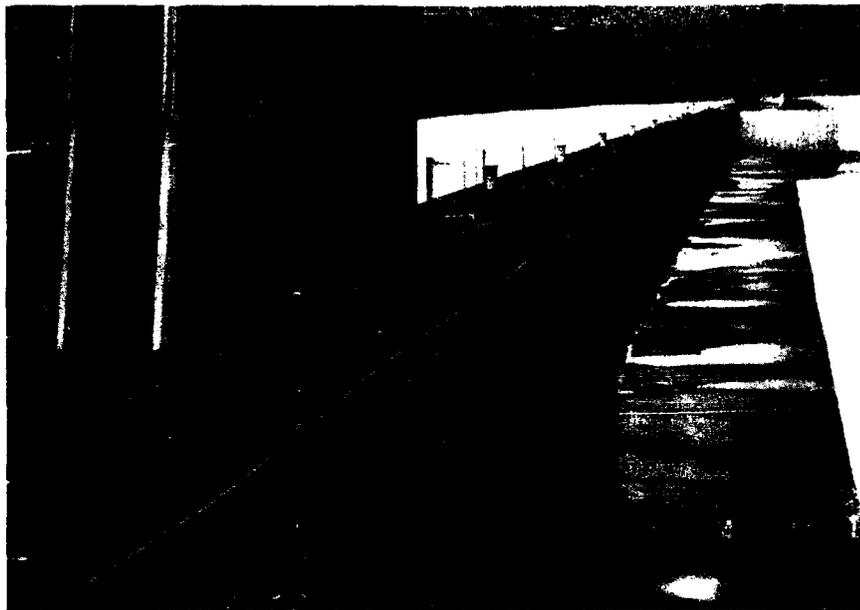
Photograph A15. River side upper guard wall

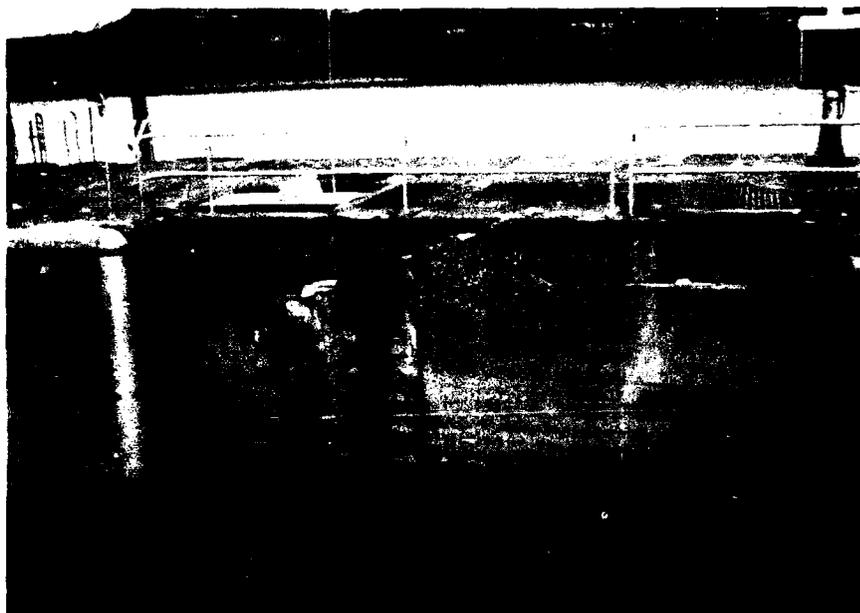
Photograph A16. Upper gate recess river wall

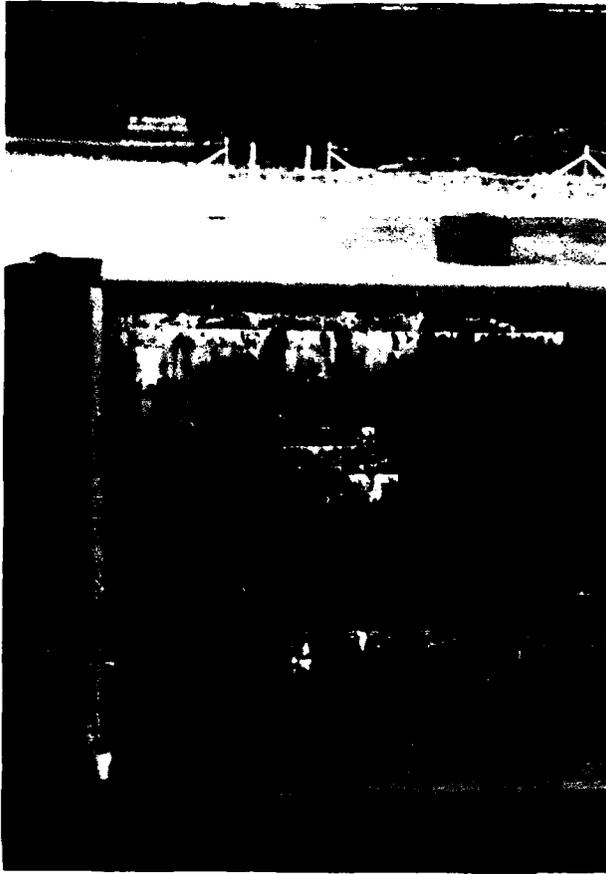
Photograph A24. River wall
below lower gate

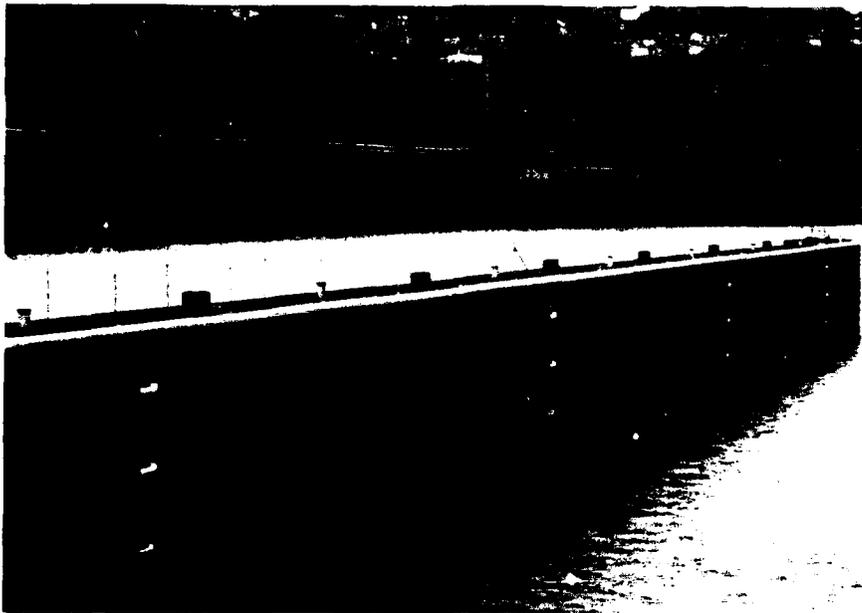
Photograph A25. Lower guard wall
